## A DETAILED SAFETY AND RISK ASSESSMENT OF PEQUENOS LIBOMBOS DAM

### ABSTRACT

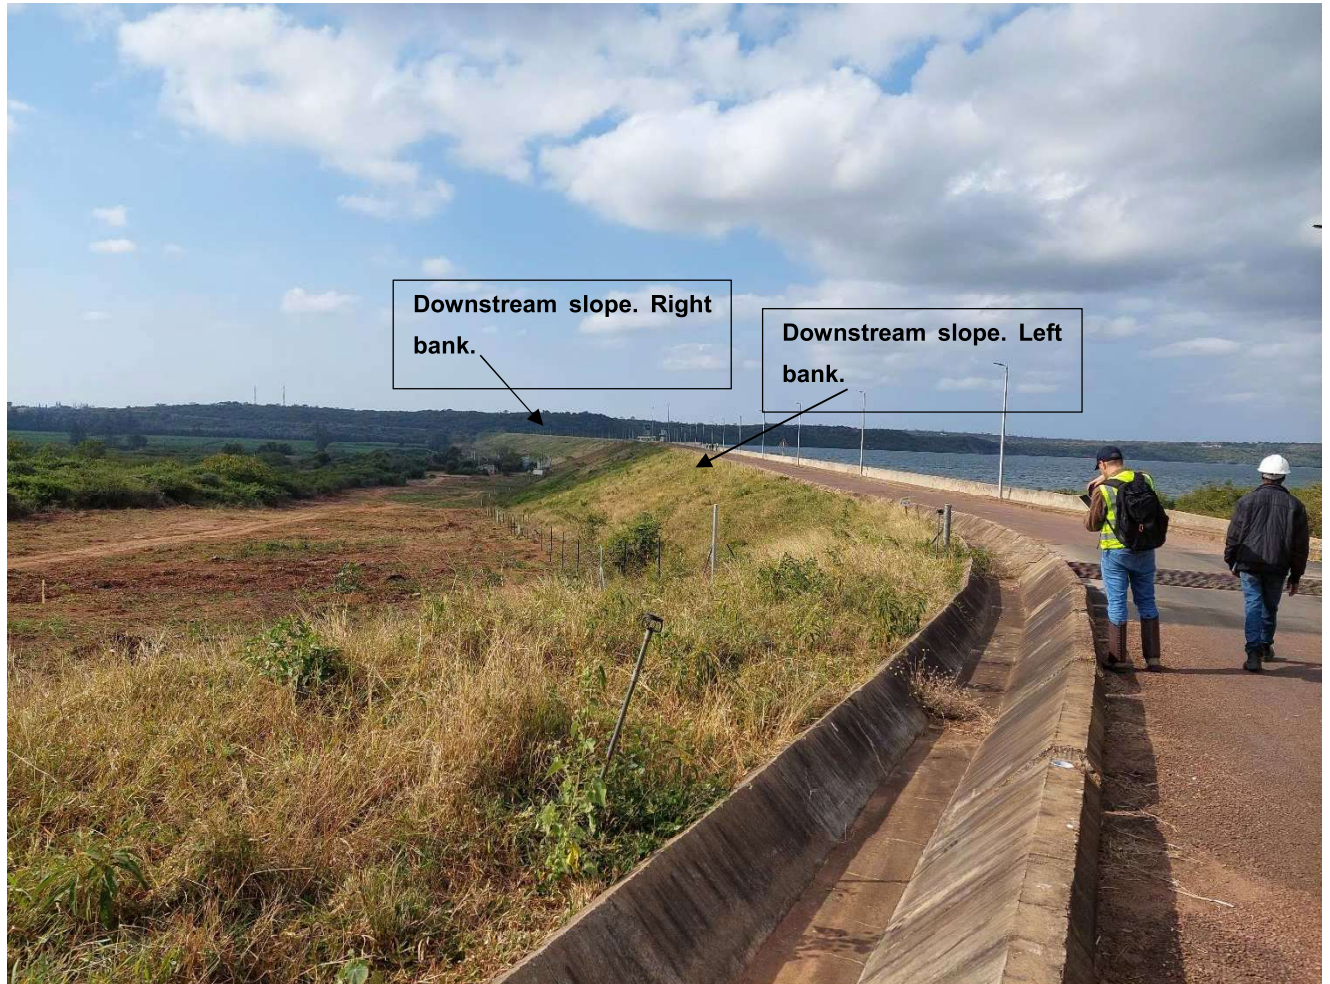
**Figure 6 – Downstream slope. General view (view towards the right bank).**

No indicators of abnormal behaviour in the dam body or its foundation that jeopardize the safety of the dam were identified. To assure longevity of the structure and to correct localised superficial landslides in the downstream face of the dam, it was recommended to improve the slope protection of the downstream slope of the embankment and to rehabilitate the asphalt road surface in certain sections of the crest. It was also recommended to assure periodic maintenance activities, mainly regarding the superficial drainage system and the irrigation system.

It is necessary to improve the surface coating of the downstream slope of the embankment dam and to rehabilitate the asphalt road surface in certain sections of the crest, keep the drainage gutters unobstructed and repair the irrigation system.

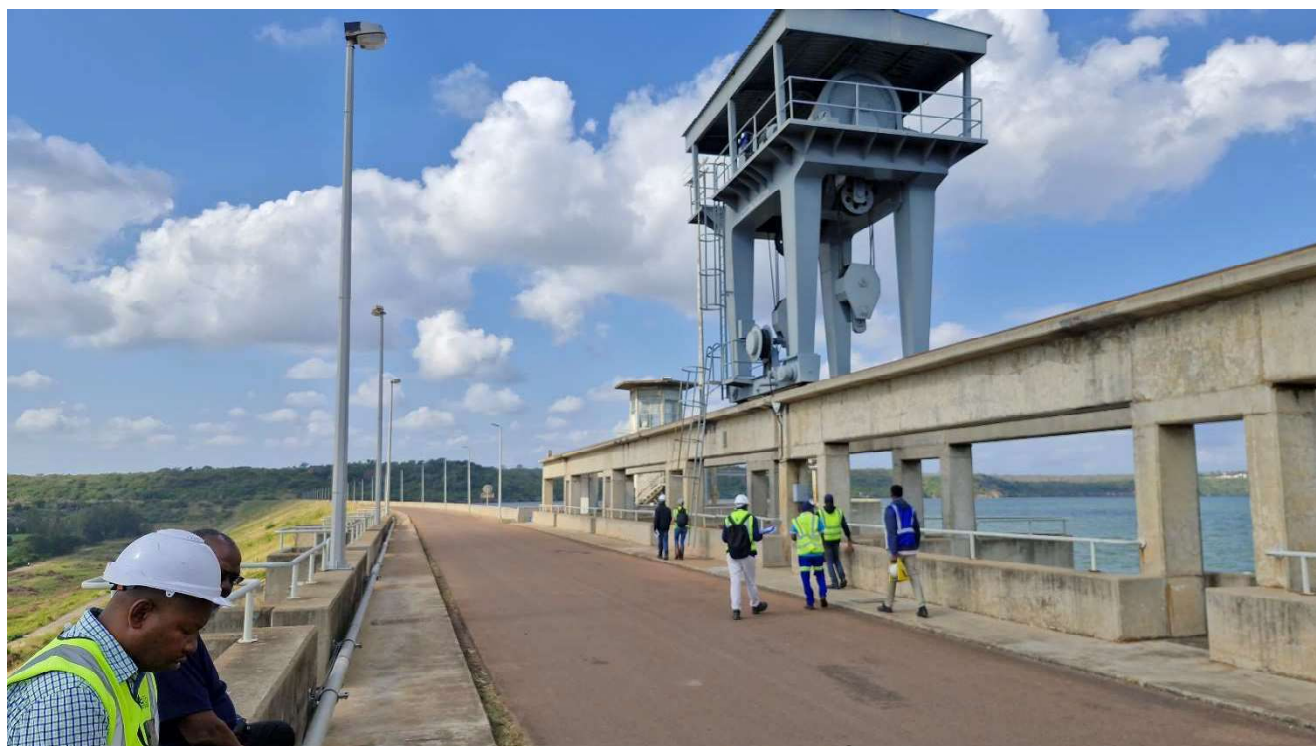
**Figure 7 – Crest. General view. Section of the concrete dam (view towards the right bank).**

The freeboard is constrained by the combination of factors related to the water level in the reservoir, estimated at the Maximum Water Level (MWL) of 49.55 m, which is assumed to be associated to a millennial flood. The current crest elevation of 51.5 m seems barely adequate to accommodate the wave run-up caused by a typical wind speed of 60 km/h (a modest value), a residual creep settlement estimated at 0.14 m, and an allowance of 0.4 m for unquantifiable factors, including seismic effects. However, for a design flood with a 2000-year return period, as specified by the MDSR for the Pequenos Libombos Dam, the current crest elevation can be insufficient.

The freeboard is presently constrained by the combination of factors related to the water level in the reservoir, estimated at the Maximum Water Level (MWL) of 49.55 m, which supposedly corresponds to a millennial flood. The current crest elevation of 51.5 m seems barely adequate to accommodate the wave run-up caused by a typical wind speed of 60 km/h (a modest value), a residual creep settlement estimated at 0.14 m, and an allowance of 0.4 m for unquantifiable factors, including seismic effects. However, for a design flood with a 2000-year return period, as specified by the MDSR for the Pequenos Libombos Dam, the current crest elevation can be insufficient.

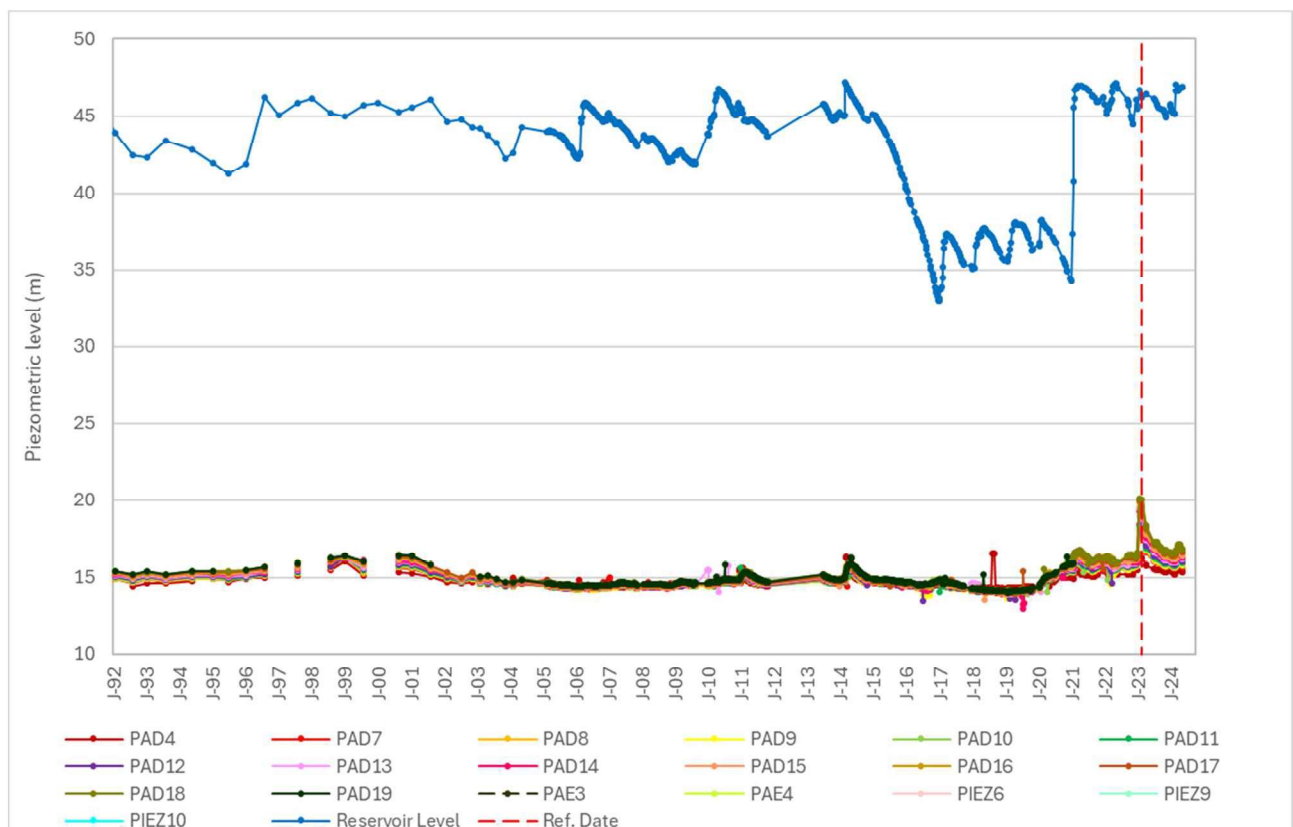
The hydraulic piezometers installed in the embankment body and its foundation generally show water levels consistent with the water level in the reservoir and their location. However, it is worth noting the limited number of piezometers installed and in operation. The water levels measured in the relief wells exhibit a similar behaviour (**Figure 8** and **Figure 9**).

**Figure 9 – Relief wells. Variation in piezometric levels from January 1992 to June 2024**

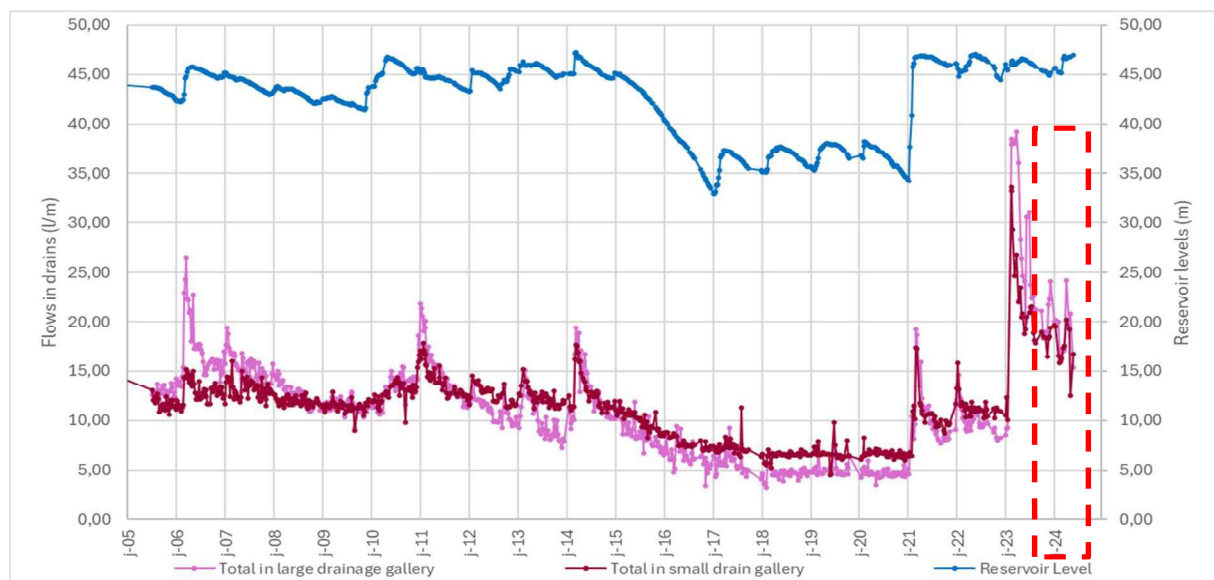
Concerning the flows measured in the drains located in the longitudinal galleries of the concrete dam, the behaviour has fluctuated over time. Between 2005 and 2014, while total flows in the small gallery remained approximately constant, in the large gallery the trend was towards a decrease in total flows. From 2014 to 2017, total flows in both galleries decreased, following the drop in reservoir water levels, stabilizing between 4 and 7 l/min from 2017 to 2021, with relatively stable reservoir water levels, ranging from approximately 35 to 37.5 m. The sharp rise in reservoir water levels at the beginning of 2021, to around elevation 47 m, was accompanied by an increase in total flows in both galleries, though the values remained lower than those previously recorded for similar reservoir water levels. Finally, in March 2023, with the reservoir water near level 47, there was an exceptional increase (of unknown cause) in the total flows in both galleries (reaching values of around 39 l/min in the large gallery and around 34 l/min in the small gallery), followed by a sharp decrease for similar water levels in the reservoir, standing at around 25 l/min and 20 l/min, respectively, higher than the total flows recorded in the past for similar water levels (**Figure 10**).

**Figure 10 – Total flows in the small gallery and in the large gallery**

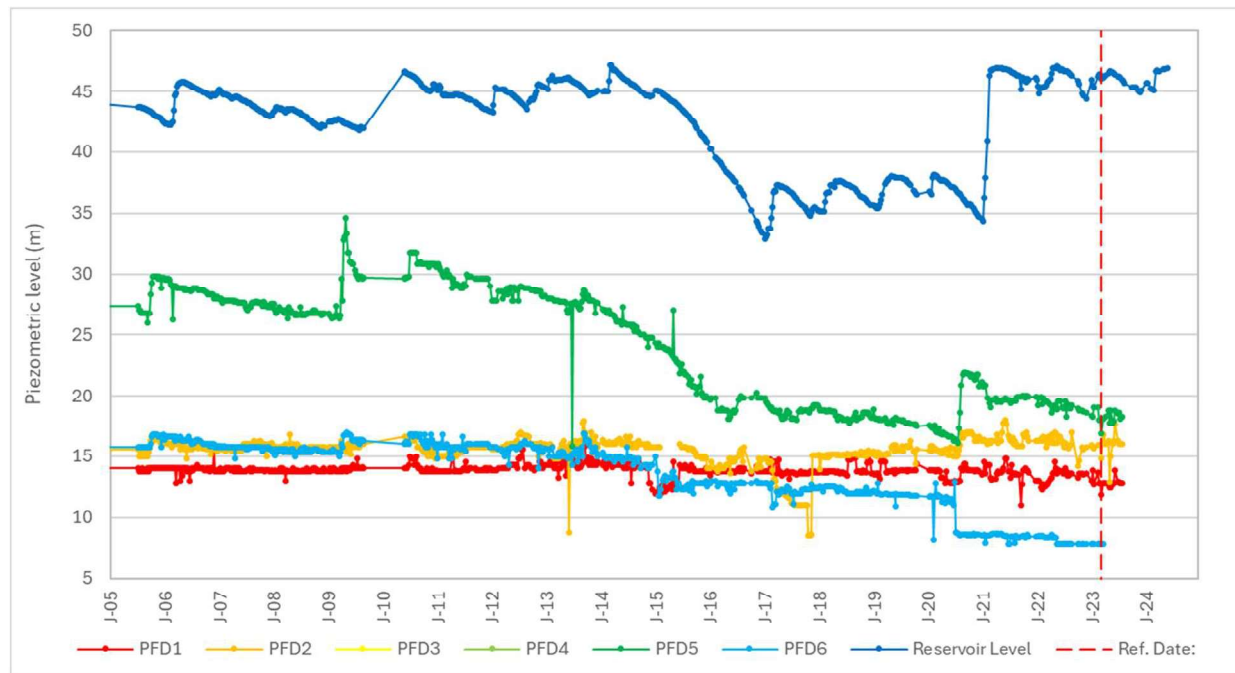
Given that no significant variation was recorded in the readings from the piezometers with manometers installed in the gallery in March 2023 (**Figure 11**), it is possible that a drain cleaning intervention occurred, which could explain the sudden increase in the flows of the drains described above. These piezometers also did not register any pressure increases during the period when the trend in the drains showed a reduction in measured flow rates, with the reservoir levels remaining approximately constant. Therefore, the concern regarding a potential rise in uplift pressures in the foundation of the concrete dam does not appear to be supported by the integrated analysis of the monitoring devices' data, considering the readings up until 2023.

**Figure 11 – Variation in piezometric levels in the spillway foundation**
