## A DETAILED SAFETY AND RISK ASSESSMENT OF MASSINGIR DAM

At the request of the Mozambican National Directorate of Water Program (DNGRH) and as part of the National Climate Resilience Program, a study aimed to evaluate the current safety of the Massingir dam and downstream valley was developed by the Consortium COBA/LNEC/SALOMON. The objectives encompassed a range of activities designed to ensure a thorough assessment and enhancement of dam safety, a critical issue to guaranty the integrity and reliability of this key water infrastructure in Mozambique. In this paper, structural and hydraulic-operational safety results are presented, as well as its adaptation to the new Mozambican dam regulations.

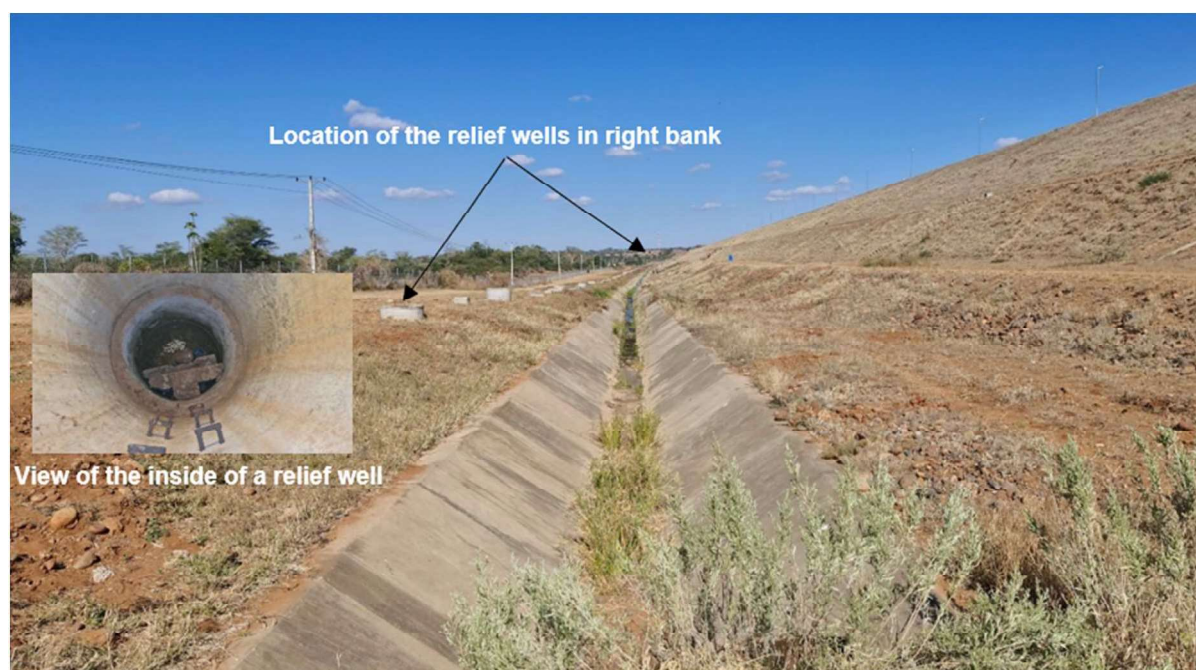
**Figure 4 – Relief wells in the right bank**

Additionally, the process for measuring the relief wells must be changed to ensure the necessary health and safety conditions at work of the operators. For measuring the inflows to the relief wells, operators must enter these wells and descend ladders to the depth where the measurements are taken. During this process, operators face life-threatening dangers due to the presence of venomous snakes, scorpions and spiders that shelter inside (**Figure 4**). The high number of observation relief wells also makes this task physically exhausting, in addition to being hazardous.

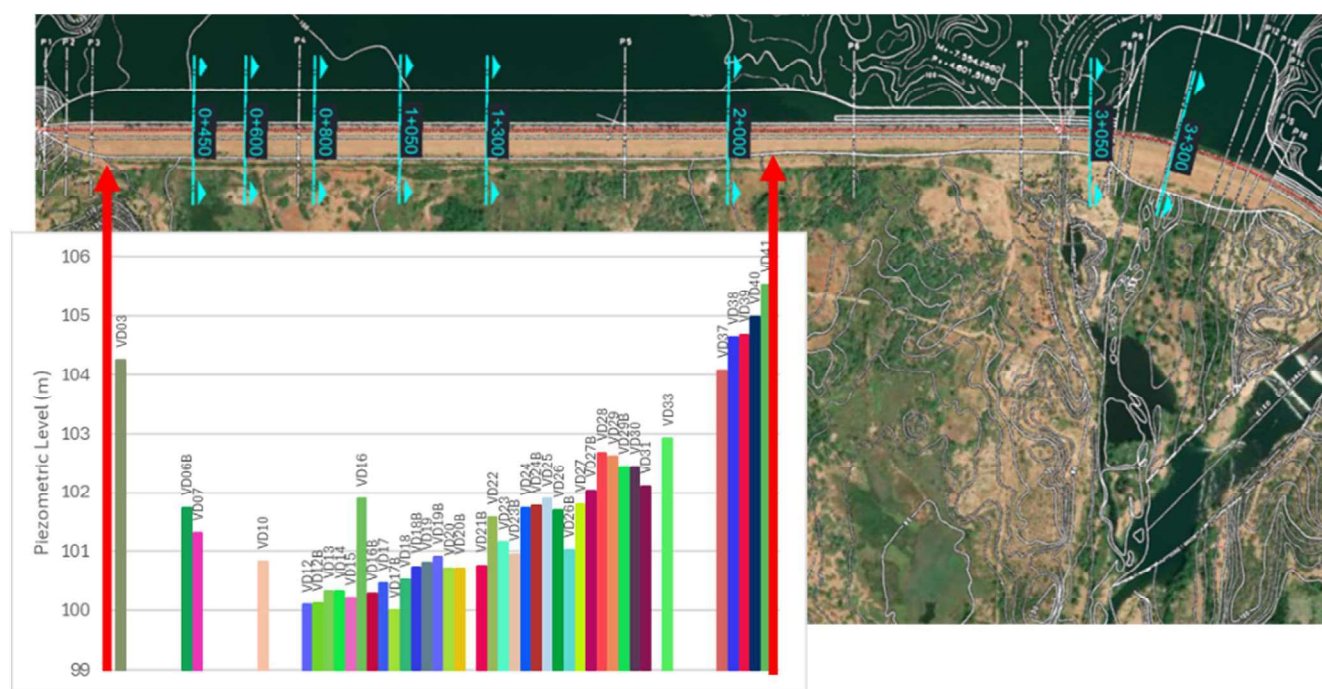
**Figure 5 – Piezometric levels measured downstream of the dam on 2023-10-30**

As shown in **Figure 5**, the piezometric levels are read in 60 wells, between Stakes 0+212 and 2+112. The piezometric readings indicate a greater pressure near the higher levels of right abutment and in the vicinity of Stakes 2+000 where an upper limit is reached, at VD41. On 30/10/2023, the piezometric level at VD41 was 105.52 m, while the reservoir was at an elevation of 120.34 m.

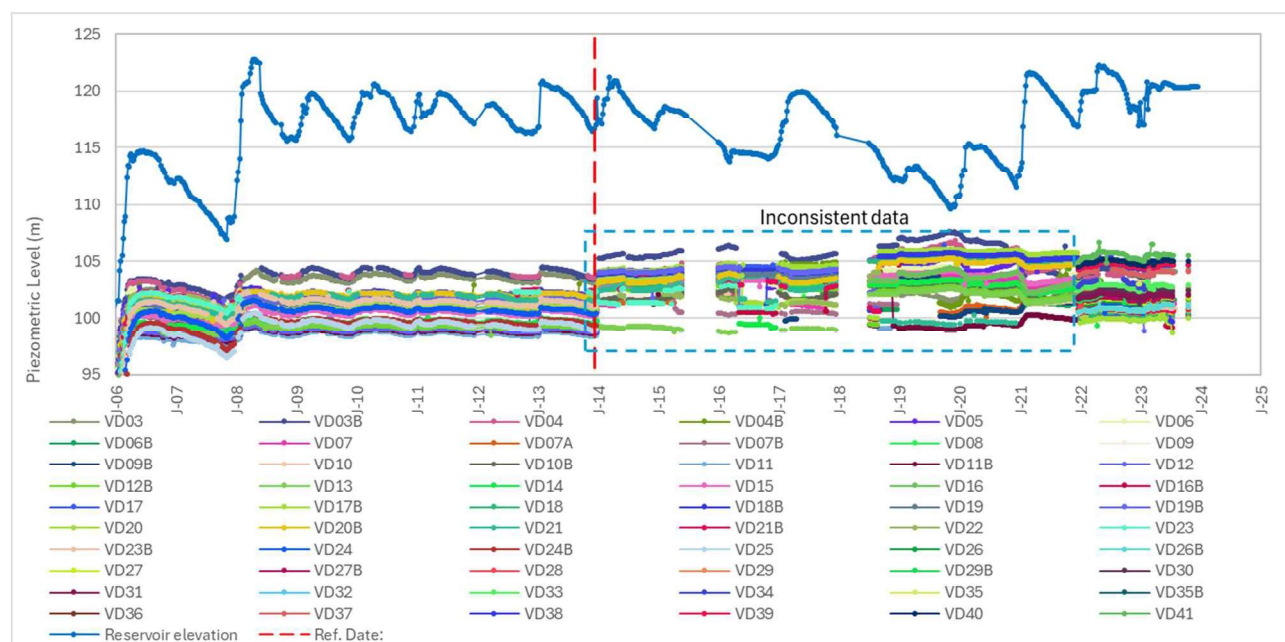
**Figure 6 - Historical piezometric levels downstream of the dam, between 2006 and 2023**

**Figure 6** shows the history of the readings taken between January 2006 and October 2023. In the period between 2014 and 2022, the data is somewhat inconsistent; however, from 2022 onwards, the measurements show greater consistency. Nevertheless, it is possible to identify a gradual increase in piezometric levels when comparing the initial data with the most recent.

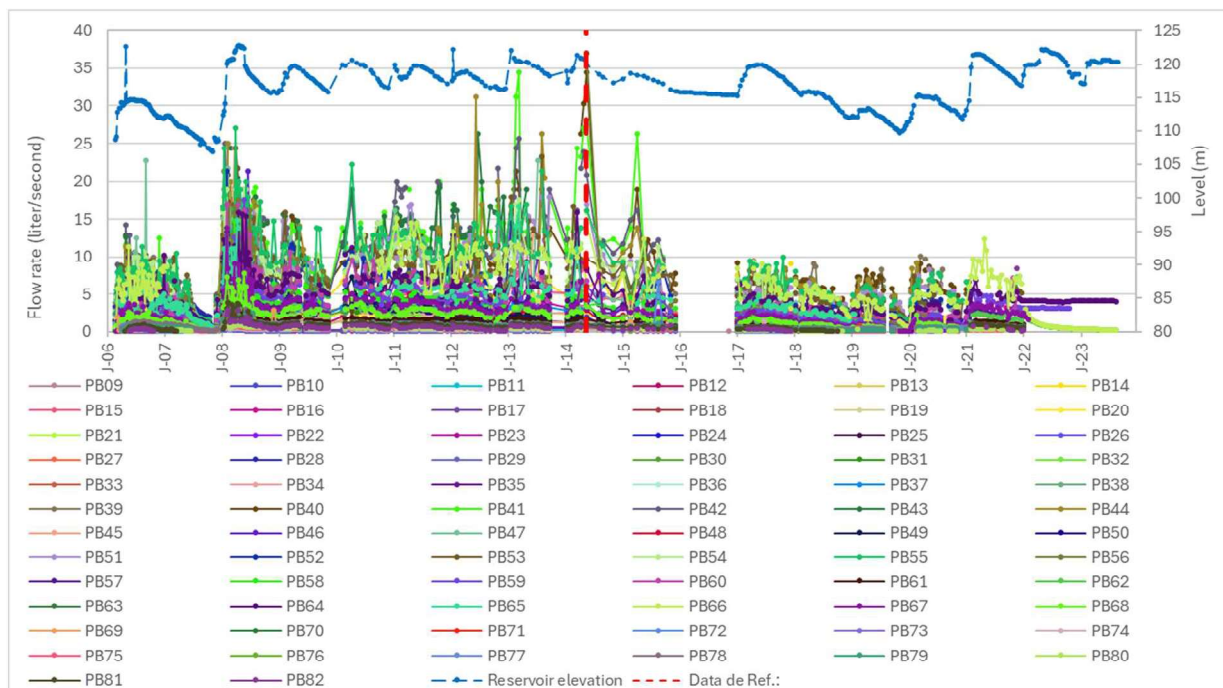
**Figure 7 - History of the flows in the relief wells, between 2006 and 2023**

Concerning the flow rates measured in the relief wells - there are a total of 74 devices in operation at right bank, distributed between stakes 0+200 and 2+025 - these devices show a downward trend, as can be seen in **Figure 7**.

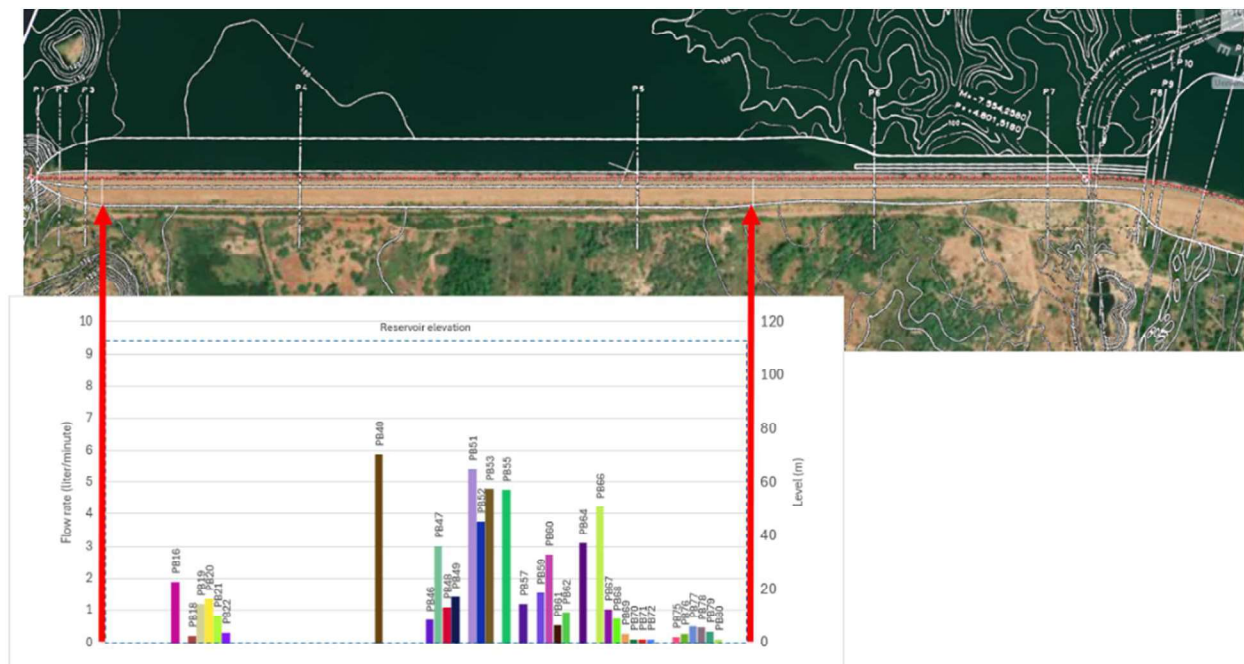
**Figure 8 - Measured flows in the relief wells on 20/10/2020**

**Figure 8** shows the location and the values of the measured flows on 2020-10-20, when the reservoir was at an elevation of 113.12 m. The flows are significantly higher in the central area of the right bank (pattern that repeats for other reading dates), in contrast to the piezometric levels, which are higher at the extremities. This phenomenon may be associated with the clogging of drains near the areas with higher piezometric levels.

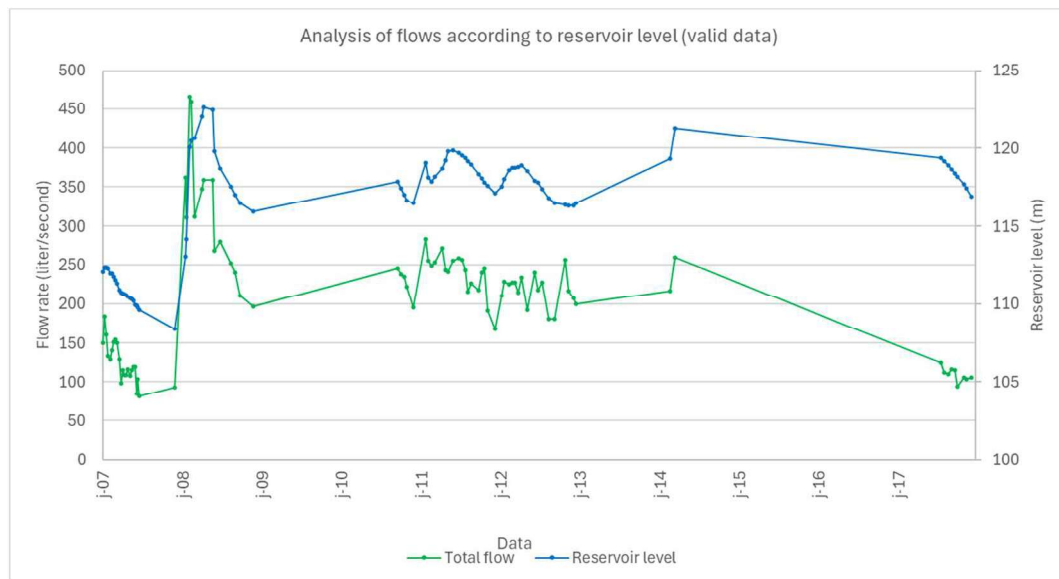
**Figure 9 - Total flows on the right bank versus reservoir water level**

For the analysis of the total flows percolating through the foundation of the dam on the right bank, periods were selected in which readings were taken from at least 60 relief wells. **Figure 9** presents a graph of the total flow observed in these wells, showing a directly proportional relationship between flow behaviour and reservoir levels. Based on the most reliable data series, the trend curve that best represents the relationship between flows and reservoir levels was analysed. As shown in **Figure 10**, the estimated flow for current reservoir levels is approximately 344 l/s. At the Normal Retention Level (125 m), the flow is estimated at 784 l/s, and at the Maximum Flood Level (128.5 m), the flow is projected to reach around 1,394 l/s.

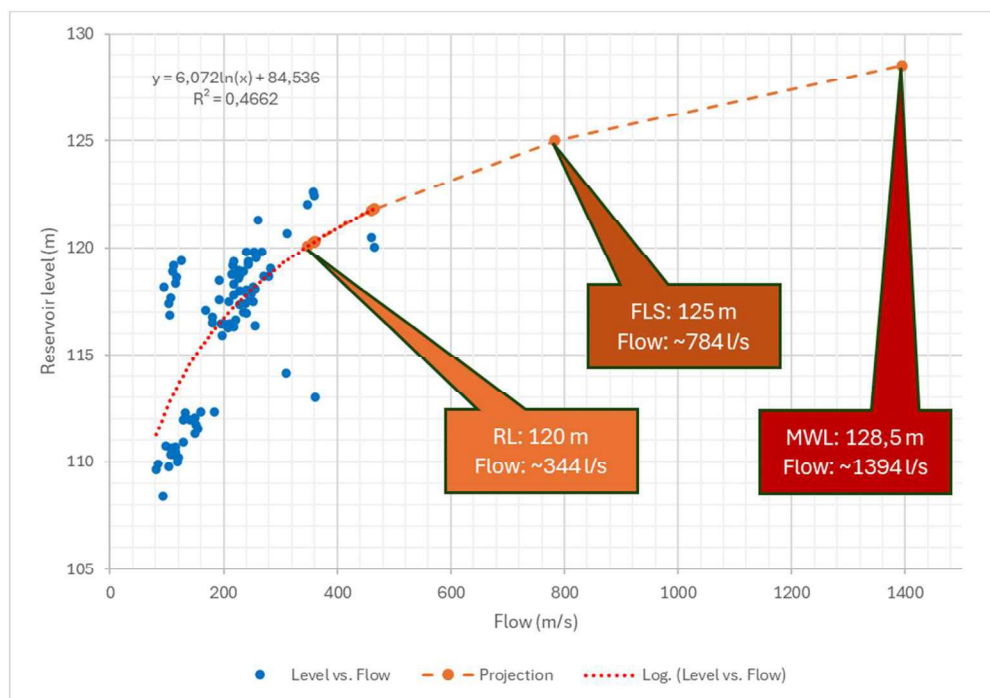
**Figure 10 – Extrapolated flows downstream of the dam on right bank**

Considering that the wells are distributed over approximately 1,900 meters and the flow occurs along this entire length, a specific flow rate of about 25 l/min/m is observed at a reservoir level of 125 m, and around 44 l/min/m at a level of 128.5 m. These values represent a potentially hazardous condition, further aggravated by the fact that these are average values, as significantly higher flow rates are observed in sections with greater inflows to the relief wells
