# 7th Historic Mortars Conference (HMC 2025), Padova

## ***Macro- and microstructural characterisation of rendering mortars from the 18th century Fishing House of the Recreational Farm of Marqueses de Pombal (Portugal)***

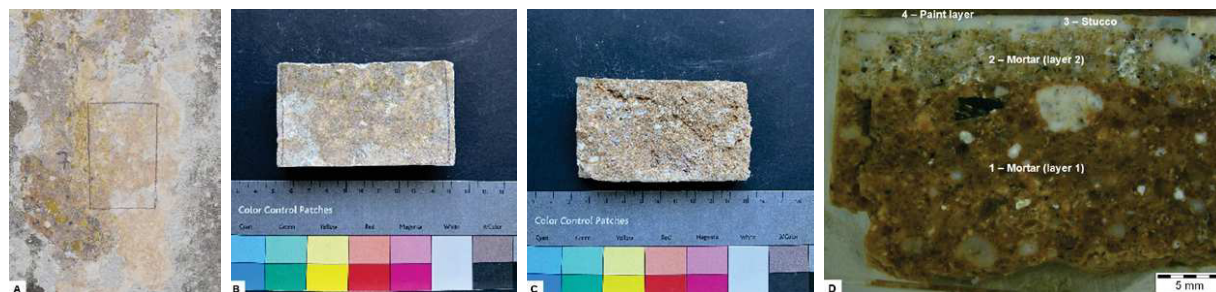
Figure 1. Collection area for one of the samples from the north-facing wall of the staircase (A); external (B) and internal (C) faces of the rendering mortar collected from (A); and stereozoom microscope image of the rendering mortar sample (D)

The rendering mortars studied generally consist of four layers: (1) a calcium aerial lime-based mortar with a cream-orange colour, containing siliceous and carbonate sand aggregates with traces of clay minerals, possibly of marine origin due to the presence of shells in its composition, with a binder/aggregate ratio between 1:5 and 1:5.5 (by mass); (2) a mortar with a composition similar to that of the first layer but lighter in colour; (3) a white calcium lime-based stucco; and (4) a lime-based paint finishing layer, typically consisting of a single coat with pigments of mineral origin (likely natural earths), ranging in colour from red-ochre to yellow-ochre (Figure 1). The first two layers – 1 and 2 – are present in all the samples collected.
