# Application of the OSOM+ Systematic Observation Methodology to Maritime Structures at the Port of Sines

This paper compares results from inspections carried out in 2018, 2020, 2022, and 2023 at the west breakwater, based on visual and drone inspections, and supported by a critical analysis of georeferenced photographs, orthomosaics, point clouds, digital surface models, and profiles.

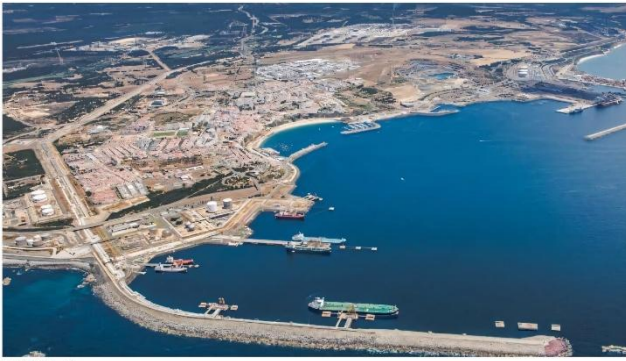
Figure 1. The port of Sines

The Port of Sines is the largest artificial harbour in Portugal, functioning as a deep-water port with natural bathymetries reaching depths of up to -28 metres CD (Chart Datum), see Fig. 1. Owing to its strategic geophysical characteristics, it serves as the country's main maritime gateway for energy supply of Portugal, handling the import and export of containers, liquefied natural gas, coal, crude oil, and petroleum derivatives.

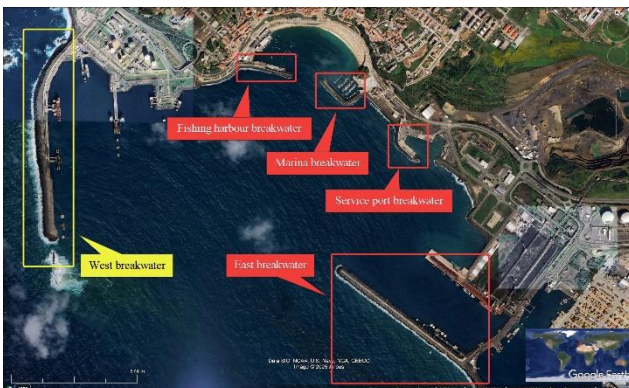
Figure 2. Rubble-mound breakwaters in the port of Sines

Among these, the west breakwater is the case study presented in this paper (outlined in the figure in yellow, while the others are shown in red). This breakwater suffered severe storm damage during years 1978 and 1979, with progressive failure episodes that broke and displaced large dolos armour units and undermined the superstructure, culminating in extensive reconstruction works (Reis *et al.*, 2011). Subsequent repairs included the use of heavy Antifer-type cubes on widened sections and smaller slopes before final redesign to meet updated 100-year sea states, making it clear how unit mechanical strength limits, placement density, and storm climate underestimation are important. These lessons align with broader reviews of concrete armour integrity that emphasize size-effect fragility and the need for structural and hydraulic checks beyond notional stability numbers (Scaravaglione *et al.*, 2022 and Leone *et al.*, 2024), which motivates systematic monitoring as described here.

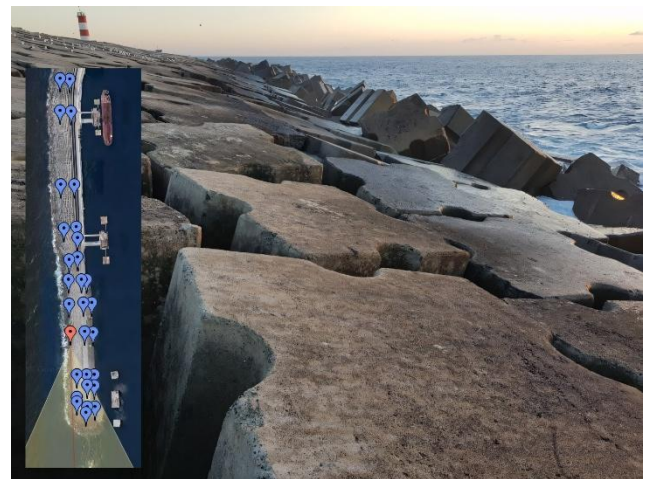
Figure 6. 2018 visual observation at Point 27F (F – Front direction) of Sines west breakwater (outer armour layer)

Figs. 6, 7 and 8 show, respectively, photographs taken on 2018, 2020 and 2022, at predefined points of Sines west breakwater (point 27, located in the seaward side of section G; point 28, in the inner ward side of section G and point 37 at the head of the breakwater, section I).

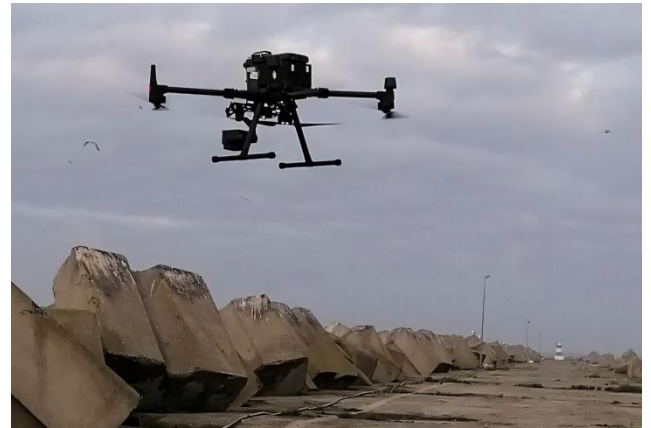
Figure 11. LNEC's DJI Matrice 300 RTK drone

For the aerial inspection of the structure, required equipment consisted of a UAV system, operated in conjunction with dedicated control software. The initial survey campaign conducted in 2018 employed a DJI Inspire V1 platform equipped with a Zenmuse X3 camera (12 MPixel). In the subsequent surveys of 2020 and 2022, the system

was upgraded to a DJI Matrice 300 RTK with a Zenmuse H20 camera (wide-angle + zoom 20 MPixel cameras, with laser rangefinder), which significantly improved flight stability and operational safety, particularly under moderate to strong wind conditions (Fig. 11).

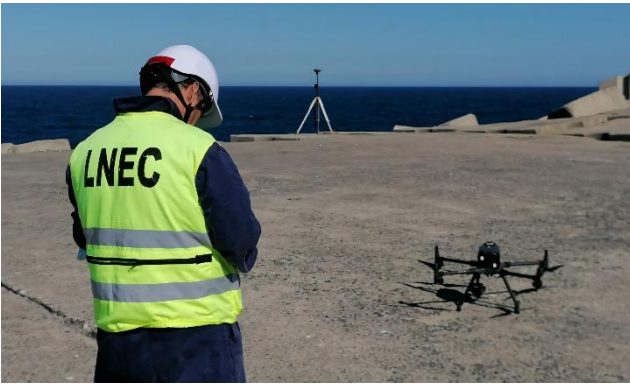
Figure 14. Drone operator preparing the flight on Sines west breakwater. Shown on top of this image is the RTK GNSS antenna base

Flight control was managed via the DJI Pilot app (DJI), primarily used for configuration, calibration tasks and mission planning, to ensure optimal image capture. It also controls the UAV during the flight, alerts the proximity of obstacles, and stops it to avoid collisions. (Figs. 13 and 14).

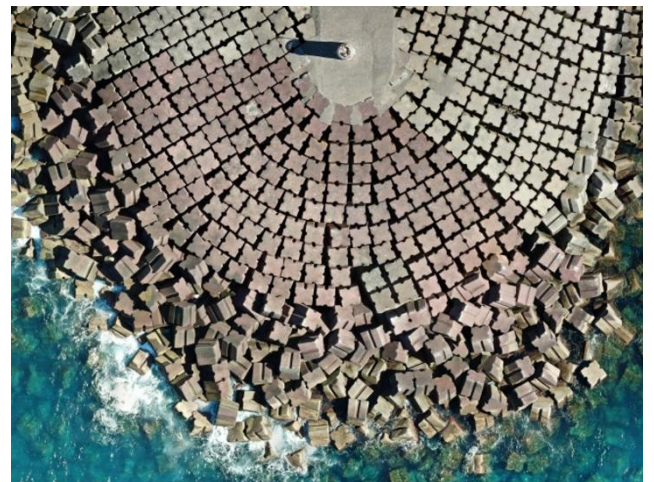
Figure 17. Detail of the orthomosaic of Sines west breakwater (head section)

survey: first, the point cloud is generated; next, the DSM is computed and stored in matrix form (see Fig. 16); finally, the orthomosaic is produced (see Fig. 17 for a detail of it).

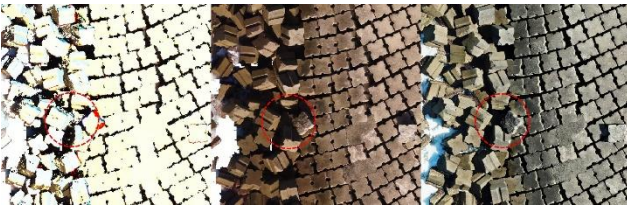
In the following Figs. 19 and 20, the map of differences and the respective orthomosaics for 2020 and 2022 are shown, as an example, for the sections where changes were detected. The color scale used in the comparisons is as follows: in red when, between 2020 and 2022, there was material removed; blue when there was material deposition. This comparison was carried out using QGIS, which is also the software used to visualize the orthomosaics, as it offers superior capabilities for displaying georeferenced information (DSM and orthomosaics). It also allows for chromatic manipulation of DSM's, which enhances the visualization of topography and surface changes.

Figure 20. West breakwater. Changes found between 2020 and 2022 – Occurrence 3 – Section G
