# 7th Historic Mortars Conference (HMC 2025), Padova

CATARINA BRAZÃO FARINHA, ROSÁRIO VEIGA, ANTÓNIO SANTOS SILVA,  
JOEL MOEDAS-MIGUEL

## ***Characterization of the interior and exterior coating materials from 18th and 19th century of Casa do Moscadim. Case Study***

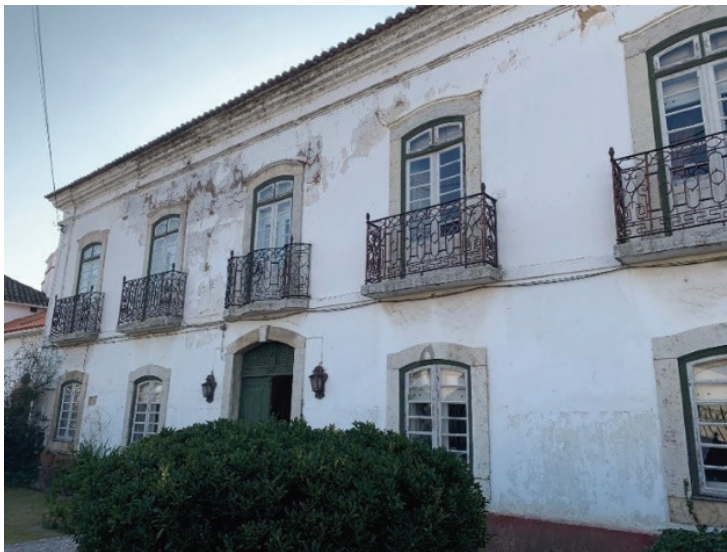
Figure 1a. Casa do Moscadim: general view of the façade.
