# Thermal Effect of Firebrand Accumulation in Ceramic Roof Tiles

**Abstract:** This paper presents investigations concerning the thermal firebrand reaction due to its accumulation in the top of ceramic roof tiles, commonly applied to the exterior of dwellings in southern Europe. A large-scale fire experiment is conducted, wherein firebrands are placed above the tiles and temperature readings are taken from multiple layers of the building components. The selection of materials for the roof layer assembly was based on recommendations for either fire resistance or high temperature behaviour. The test follows the fire setup recommended in the California Building Code for firebrand deposition. This investigation will allow for a more accurate verification of the firebrand reaction in the roof, including the type of ignition, the creation of smoke and droplets, and even their mechanical ability to withstand elevated temperatures.

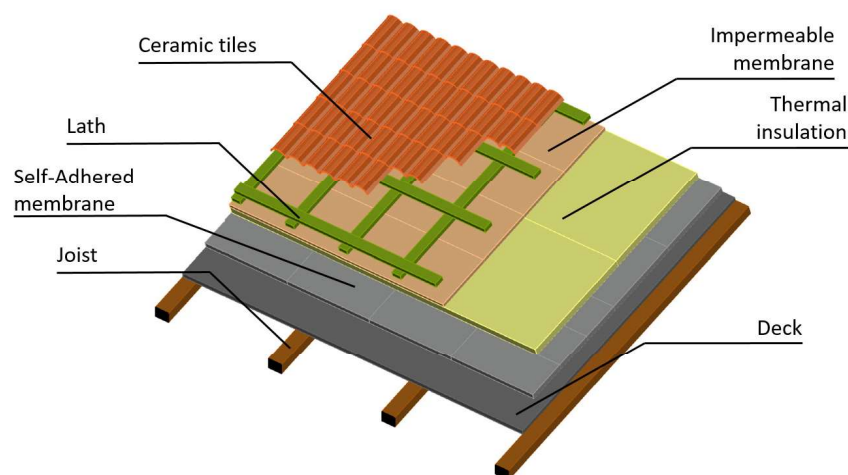
**Figure 1.** Description of roof layers in southern Europe.

In this study, specimens representing eight roofs were selected, each assemble with a varying combination of materials, as presented in Table 2. The roof specimens, measuring approximately  $55 \times 30 \text{ cm}^2$  per section with the depth varying depending on the material type, were used. Each roof specimen consists of a base layer of tiles, with variations in insulation materials, as show in Figure 1. There was no single combination of ceramic tiles and membranes since the adoption of this single material layer does not abide by the construction code in Europe.

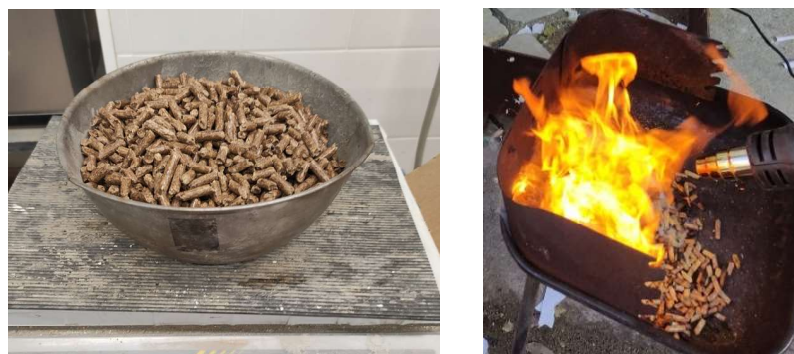
**Figure 2.** Illustration of firebrand ignition process under simulated wind conditions.

Chapter 7A-4 [45,46] of the California Building Code provides guidelines that were followed for this test setup, which involves depositing 1.0 kg of firebrands into construction materials or element specimens, which are a ceramic roof tile element used in this study. The roof specimens are equipped with thermocouples (RS PRO-Type K thermocouples, 2.0 m long and 1/0.3 mm in diameter). These thermocouples were strategically positioned on each layer to monitor the transmission of temperature from the firebrands to the specimens. The temperature data are meticulously recorded at a frequency of 1 Hz for a maximum period of 200 min, providing comprehensive data into their behaviour during the cooling stage. In light of findings from multiple research studies [18,47–49] indicating that compressed wood pellets generate more severe firebrand temperatures, they were chosen to simulate the thermal action of firebrands. The process begins by placing 1.0 kg of firebrands in the metal cup and exposing them to an industrial wind blower to simulate the action of the wind at a speed of  $(1.31 \pm 0.13) \text{ m/s}$ , which in turn increases the duration and thermal action of the firebrands, causing a pyrolysis process until achieving full ignition, as

illustrated in Figure 2. These firebrands are introduced into a cylindrical ignition control area with a 200 mm diameter and placed on the top according to suggestions from previous studies [47] and illustrated in Figure 3a, which found that larger diameters tend to result in greater thermal heat flux and maximum temperatures. The roof specimens had ceramic tile, sub-tile, and thermal insulation materials equipped with eight thermocouples, with two in each layer, while the other roof specimens, equipped with nine thermocouples, had three in each layer, as depicted in Figure 3b.

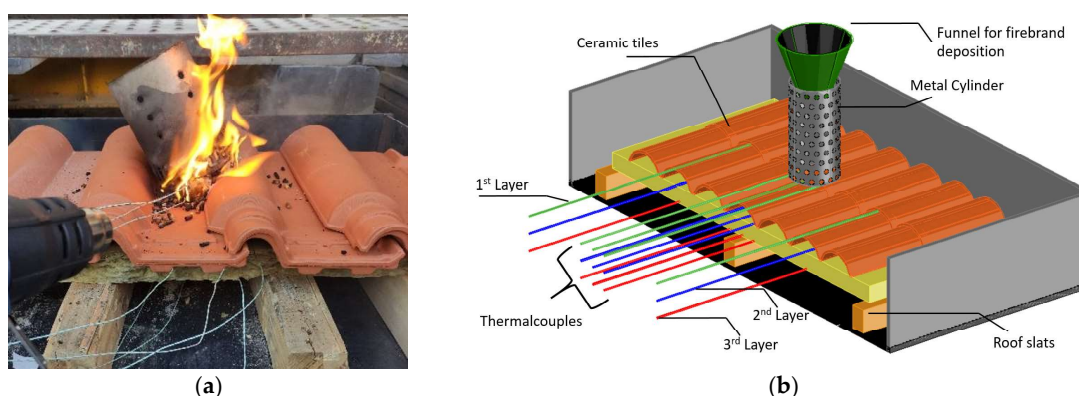
**Figure 3.** Test setup for firebrand accumulation in construction elements specimens with 3 layers. (a) Roof firebrand accumulation test. (b) Representation of thermocouple location in the roof specimens.

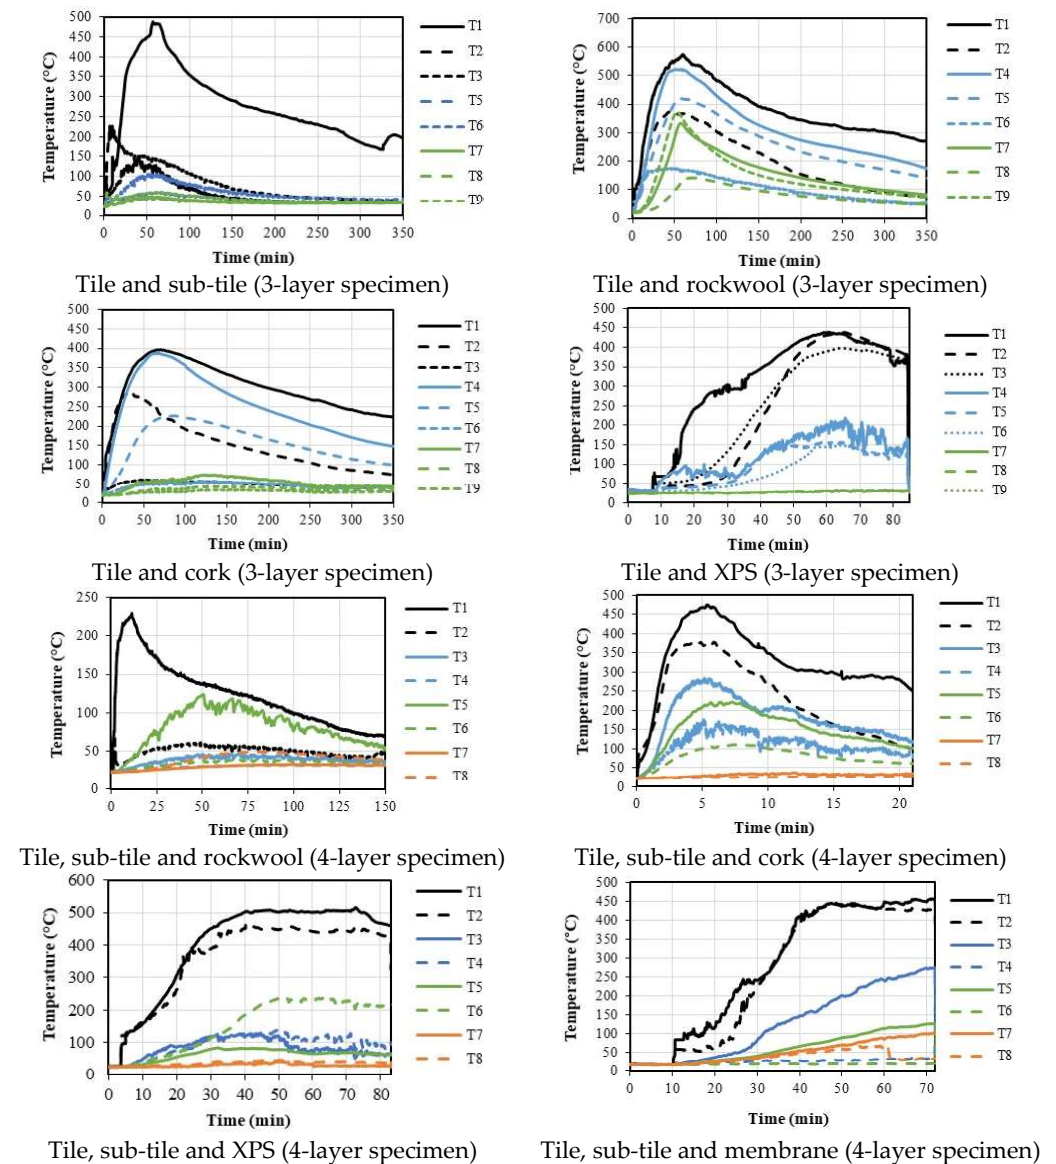
**Figure 4.** Temperature evolution measured at each layer for all roof specimens tested during exposure to firebrand accumulation.

From Figure 4, it can be noted that the higher temperatures were observed in the first layer, with discernible variations among the different roof specimen tests. Also, a decrease in the maximum temperature of each descending layer was observed across all specimens, except for the TSR and TSX specimens, where the maximum temperature recorded in third layer was higher than that in the second layer.

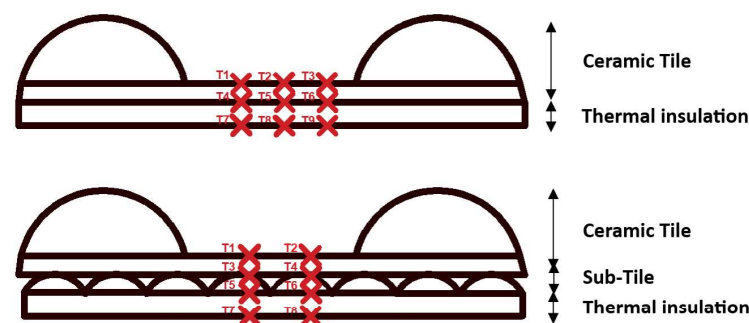
**Figure 5.** Position and numbering of the thermocouples for 3 and 4 layers.

The climatic conditions varied for each test; therefore, the ambient temperature ranged between 20 °C and 30 °C, depending on the day of the experiment, but this had small importance for the thermal output. Figure 4 depicts the temperature measurements obtained from each layer across all tested roof specimens. The results from Thermocouple T5 were excluded from the curve for the tile and sub-tile specimen due to destruction during the test, making the data unreliable. The colours of the first, second, third, and fourth layer are black, blue, green, and orange, respectively, and their positions are depicted in Figure 5.

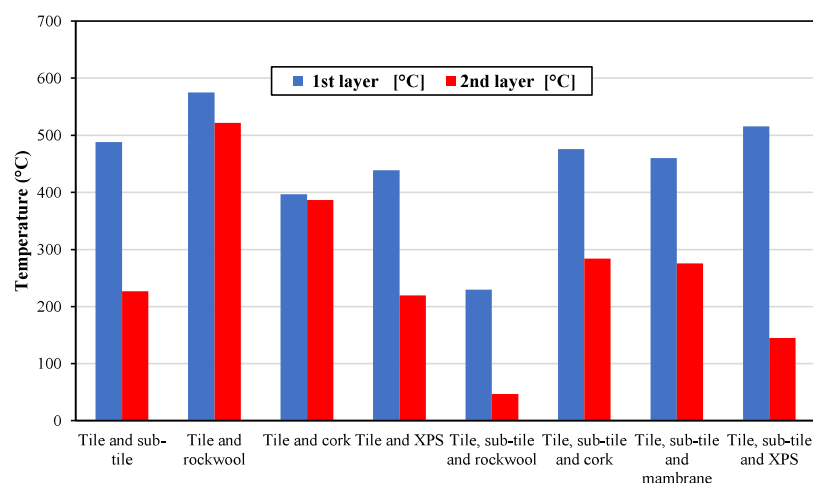
**Figure 6.** Maximum temperatures recorded in the 1st layer and 2nd layer for all roof specimens.

Figure 6 presents bar graphs showing the maximum temperatures recorded at both the top and bottom of the ceramic tiles for all roof specimens tested. It is evident from this figure that there is a high difference in the maximum temperature within the first layer of roof specimens, ranging from a minimum value of 229.53 °C to a maximum value of 574.84 °C. This difference can be attributed to differences in the climatic conditions during the test. Therefore, this result can be seen as an outlier and it will not be used for future analysis. The maximum temperatures are around 478.8 °C for the first layer (surface contact heat) with a standard deviation of 52.3 °C. This value is aligned with previous temperature readings from prior experimental and numerical campaigns for firebrand accumulation [17,18]. For the second layer, the results tend to be more scattered, with an average maximum temperature of 294.2 °C and a standard deviation of 115.5 °C. This higher scatter is clearly due to the different fire reaction of the insulation materials when subject to high temperatures, something already expected and reported in prior works [21]. From the recordings of the maximum temperatures of the second layer, the impact of using sub-tile (bituminous tile) becomes apparent. It is noteworthy that the temperatures in the roof specimen with sub-tile (bituminous tile) were lower compared to those without it, considering the same thermal insulation material. This can be attributed to the bituminous tile's low combustion rate.

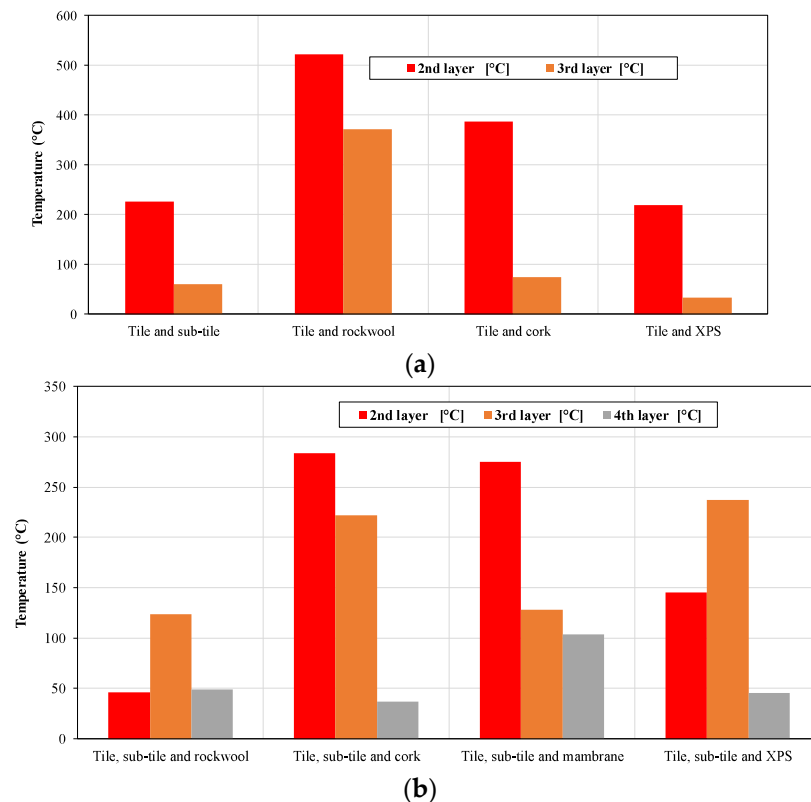
**Figure 7.** Maximum temperatures recorded in the 2nd, 3rd, and 4th layers for (a) three-layer specimens and (b) four-layer specimens.

Figure 7 presents the maximum temperature recorded in each layer. From this figure, it is evident that the use of a bituminous sub-tile without any additional thermal insulation provides moderate temperature resistance, reducing the temperature by approximately 73.5% from the second layer to the third layer (from 226.57 °C to 60.04 °C). For combinations of bituminous tile with insulation materials, the temperature in the third layer varied depending on the type of insulation used, but, in general, it was higher than in the specimen without insulation materials. The bituminous tile layer absorbs some heat but does not offer significant thermal insulation.

Rockwool shows high temperatures in the subsequent layers, with the second layer reaching 522.00 °C and the third layer 371.81 °C, indicating that while it can withstand fire, it does not effectively prevent heat transfer through the layers. This could be due to the limitations mentioned in the study about direct firebrand contact problems [21]. Furthermore, adding a sub-tile layer improves the performance of rockwool by providing an initial heat barrier. However, it can be observed that the temperature spikes in the third layer are due to the melting of the bottom layer of bituminous tile above the rockwool. This is analyzed in Section 4.2.

Cork shows a significant drop in temperature between the second layer (386.91 °C) and the third layer (73.96 °C), demonstrating better performance than rockwool. Additionally, the combination of bituminous tile and cork significantly reduces heat transfer. The high temperature in the third layer (222.24 °C) is substantially reduced to 37.12 °C by the fourth layer.

The XPS maintained lower temperatures (33.72 °C) in the third layer but loses its effectiveness at higher service temperatures. Furthermore, the combination of bituminous tile and XPS presented worse behaviour because the temperature increased significantly in the third layer due to the melting of the bituminous tile above it.

The impermeable membrane performs decently, managing to reduce the temperature from 128.07 °C in the third layer to 103.59 °C in the fourth layer. This was not expected, especially due to the small thickness of the specimen.

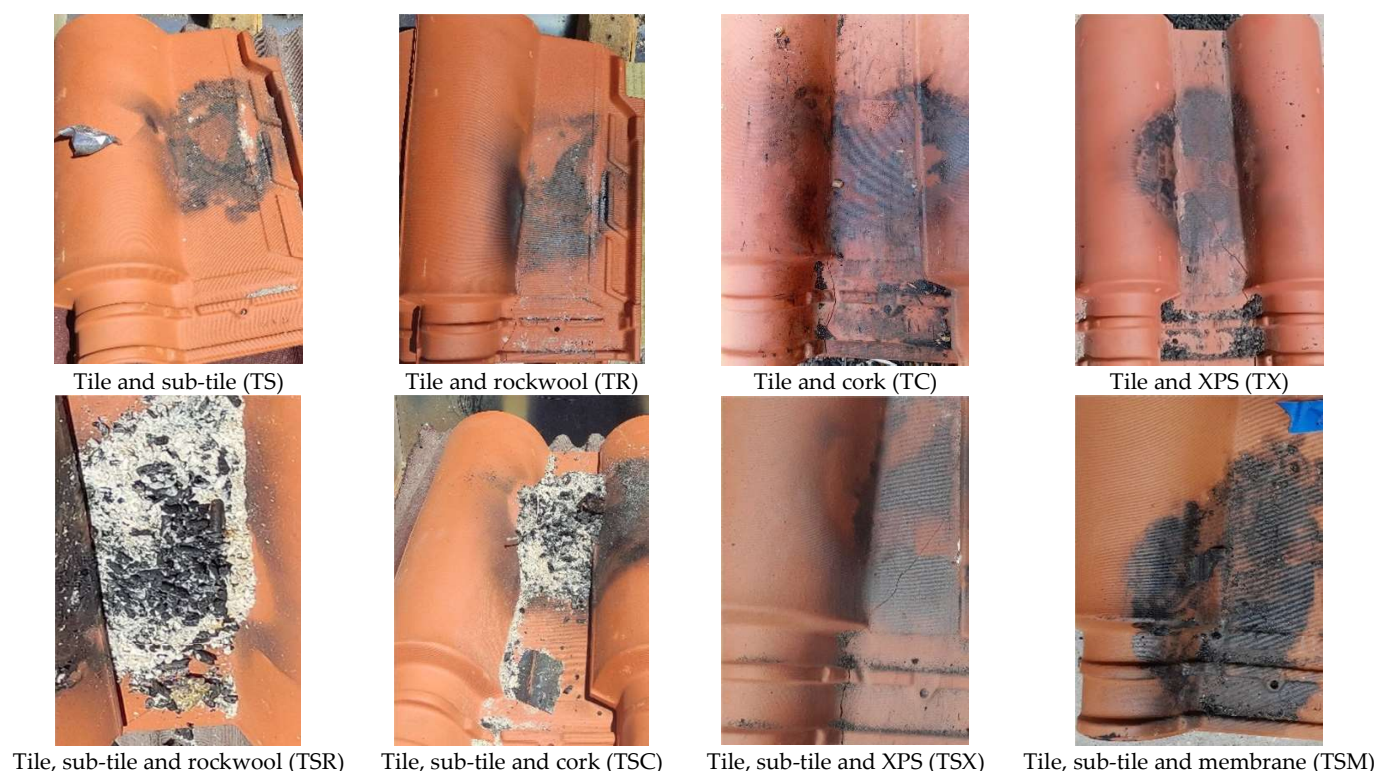
**Figure 8.** Tile condition of each specimen after exposure to firebrand accumulation test.

The behaviour of the roof specimen was monitored during and after the firebrand accumulation test, and numerous observations were recorded. Figure 8 portrays images of the tile in each roof specimen after testing. It is noted that the tile in some specimens, such as TS, TSC, and TSM, resisted the impact of firebrand accumulation during the test. However, in other specimens, including TR, TC, TX, TSR, and TSX, the tile showed cracking. This observation complements some findings reported in previous research [20,40,50–52]. Initially, it was believed that the use of ceramic tiles would prevent roof ignition in new dwellings due to firebrand wind transportation and later deposition during wildfires. Using the observations from these tests, it may be possible for a roof made of ceramic tile (on a new dwelling) to either suffer damage or start an ignition due to the combustion of the thermal insulation or extra layer of construction materials. This possibility can indeed

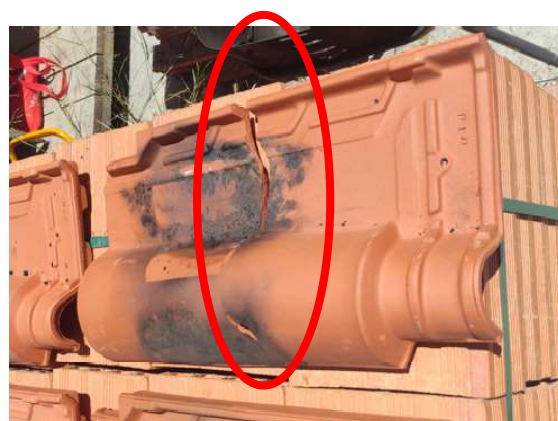
**Figure 9.** Extreme thermal event of firebrand accumulation that led to severe fracture in the ceramic tile.

happen in extreme events if the cracking is big enough, allowing firebrand penetration into the interior layers (Figure 9).

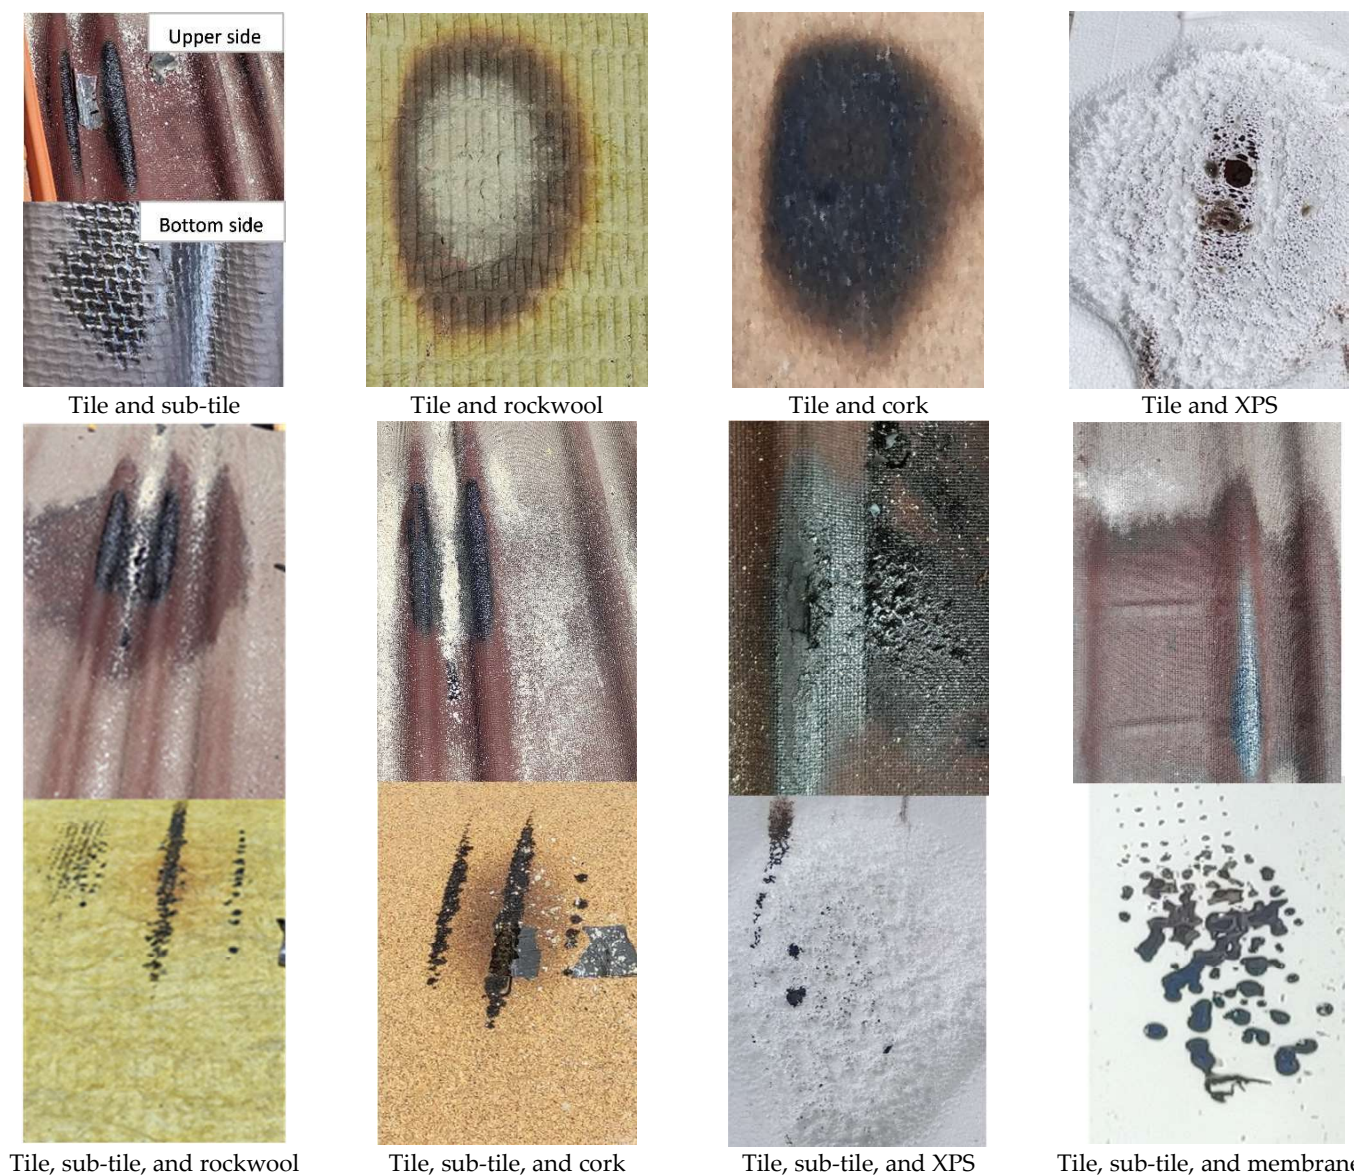
**Figure 10.** Impact of firebrand accumulation penetration in construction materials for each tasted specimen.

In all specimens, the bituminous tiles were ignited with the same intensity, with some smoke production and droplet production, which are visible in the TSM specimen, see Figure 10. The flow of these droplets could contribute to the temperature increase in the third layer, as can be well observed in the TSR and TSX specimen, as mentioned in Section 4.1. The rockwool and cork in the specimen without a sub-tile underwent smouldering ignition with significant smoke production. In contrast, the rockwool and cork in the specimen with a sub-tile exhibited low-intensity smouldering and minimal smoke production. The XPS reaction was not included in Table 3 because it melted and evaporated at low temperatures in both roof specimens, with and without a sub-tile. This makes tracking its performance difficult, and it can be concluded that it performs very poorly against firebrand accumulation. The impermeable membrane did not produce flame ignition, smoke, or droplets for firebrand accumulation. This later solution, just like in previous studies [21], presented a good solution for elevated temperatures due to firebrand accumulation.

The impact of firebrand accumulation on the studied specimens was assessed by analyzing heat penetration in each layer, as shown in Figure 10. It can be observed that

the impact of firebrand accumulation has reached the surface of the last material in all specimens tested, but creating different levels of damage. The firebrand accumulation caused damage to the sub-tile (bituminous tile) on the upper side with nearly the same severity in all specimens containing a sub-tile, and, on the bottom, the melting of the asphalt was clearly evident. Comparing specimens with and without a sub-tile, it can be observed that in the rockwool and cork specimens, the heat penetration was greater in specimens without sub-tile. Regarding XPS, a similar effect was observed in specimens with and without a sub-tile, except for the presence of small droplets resulting from the melting of the sub-tile. As for the impermeable membrane, categorized by fire reaction as  $B_{\text{roof}}$ , it had very little effect with the presence of bituminous tile melting drops. It is worth mentioning that specimens containing XPS allowed heat transfer on the last side, unlike specimens containing other materials, where the effect was only on the upper side. The insulation materials like cork and the impermeable membrane presented lower damage due to thermal firebrand penetration.
