## A DETAILED SAFETY AND RISK ASSESSMENT OF PEQUENOS LIBOMBOS DAM

### ABSTRACT

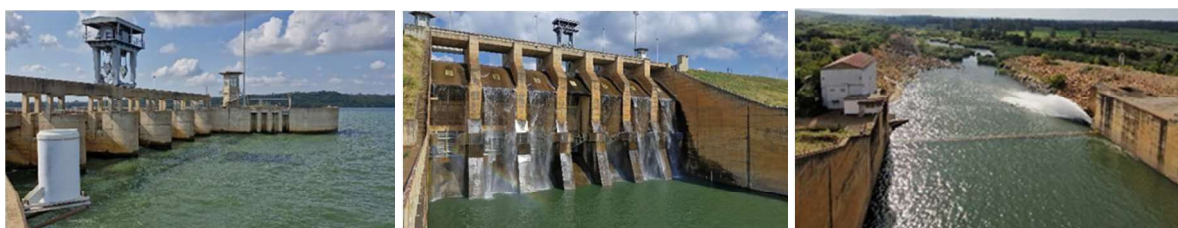
**Figure 1 – Appurtenant structures. Upstream and downstream views**

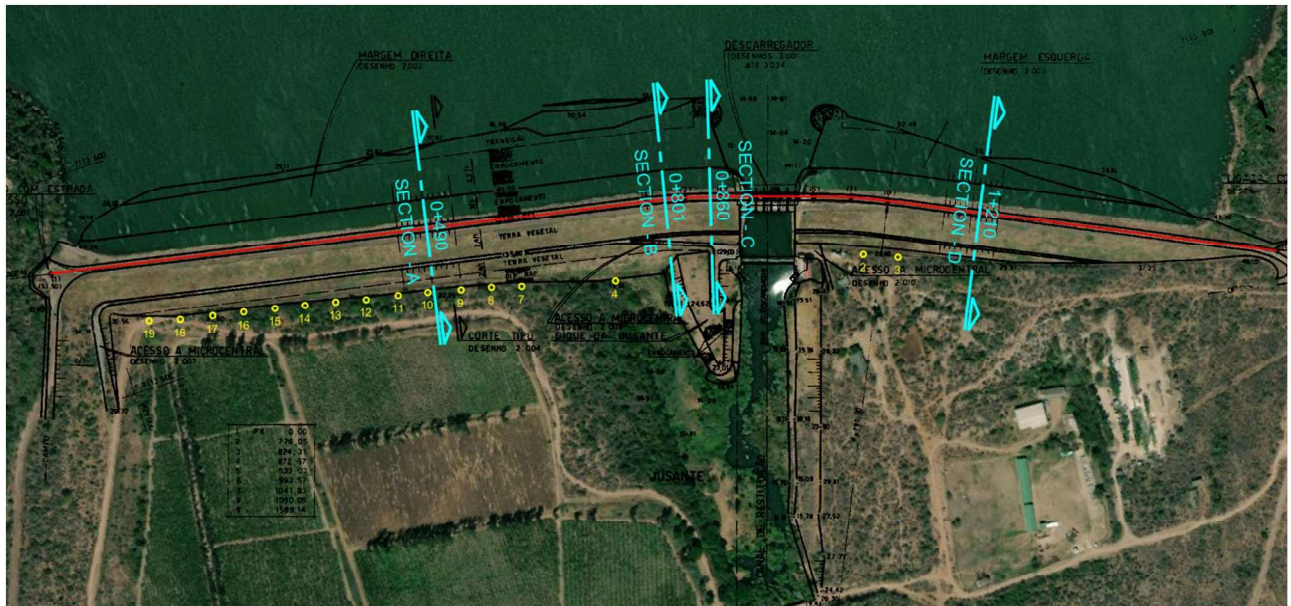
The hydraulic piezometers installed in the embankment body and its foundation generally show water levels consistent with the water level in the reservoir and their location. However, it is worth noting the limited number of piezometers installed and in operation. The water levels measured in the relief wells exhibit a similar behaviour (**Figure 8** and **Figure 9**).

**Figure 8 – Location plan of the monitoring cross-sections (A to D) and the relief wells situated downstream of the dam toe (yellow circles)**

A drone survey is recommended to obtain a quick assessment of the current elevations along the crest, allowing the reassessment of the dam's current freeboard. After this survey, it will be necessary to resume the readings of the superficial displacements of the dam.
