# MARCLAIMED

Progress Report Demo Sites

Deliverable D4.3

WP4: CoPs-Based Implementation and Validation at the Demo Sites

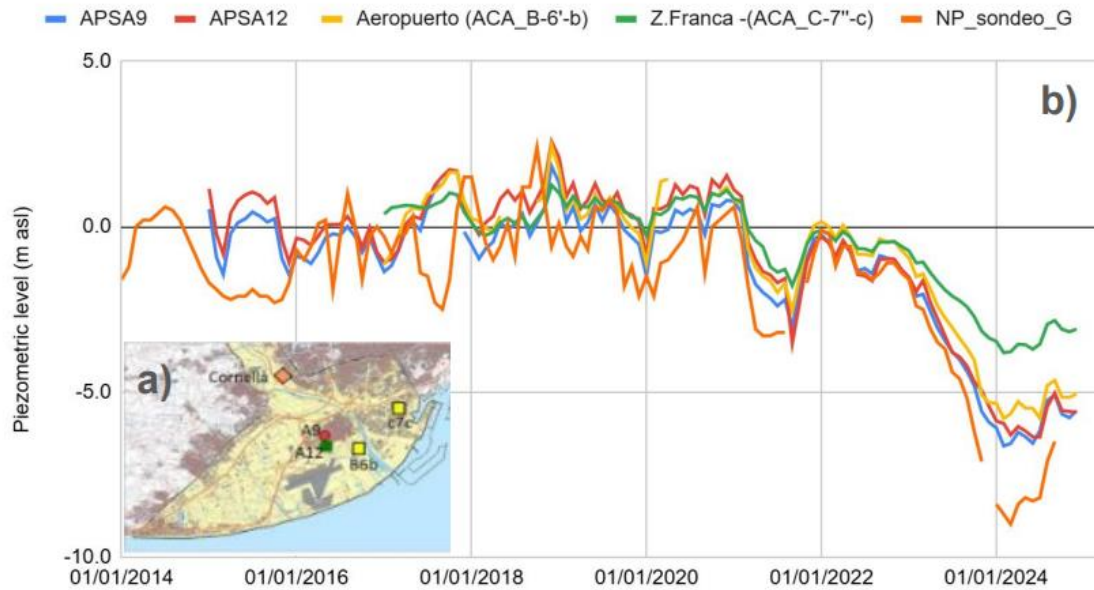
The combined effect of limited precipitation and historical overexploitation of the Baix Llobregat aquifer, has caused a concerning and sustained decrease in piezometric levels between 2022 and 2024 (Figure 1.1).

Figure 1.1 a) Piezometers located on the coastal aquifer of Baix Llobregat; b) Groundwater levels measured in the piezometers (m above sea level)

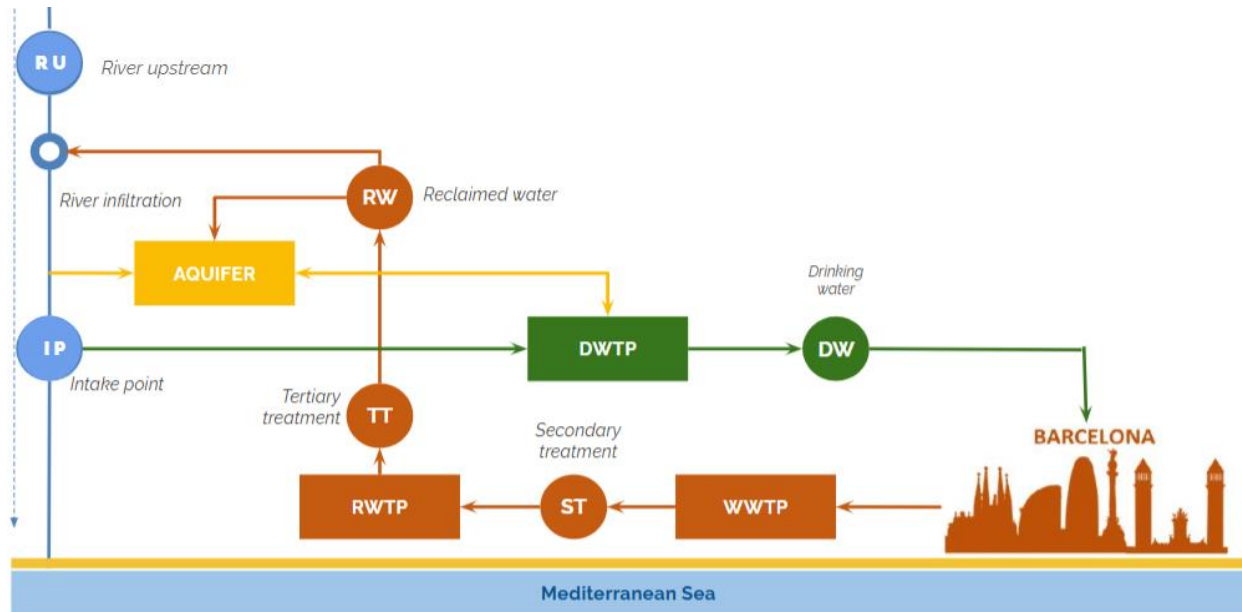
Figure 1.2 Scheme of Indirect Potable Reuse and MAR at Barcelona Metropolitan Area

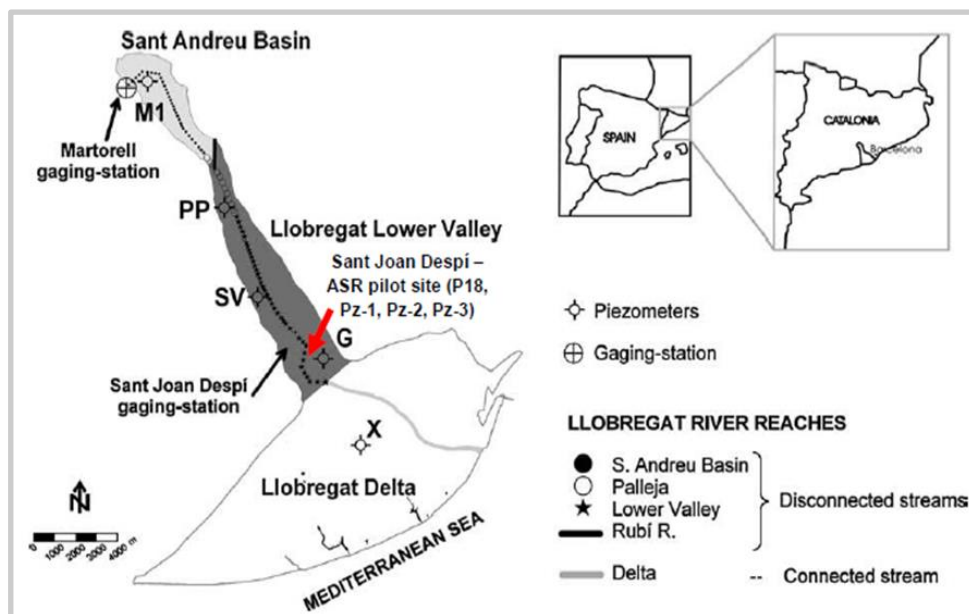
Figure 1.3 Lower Llobregat Valley and Delta; red arrow points to the Sant Joan Despí production plant involved in the Aquifer Storage and Recovery pilot system (Custodio 2007, modified)

The aquifers in the metropolitan area of Barcelona, located in the Lower Llobregat River Valley and delta of the Llobregat River (Figure 1.3), cover an area of approximately 100 km<sup>2</sup> (Custodio, 2007). These aquifers are mainly composed of gravels and sands and, in the Cornellà delta, they are divided into an upper aquifer (unconfined, with slightly finer grain size) and a lower aquifer (confined, more transmissive), separated by a wedge of silts and clays that act as an aquitard (Figure 1.4). The upper aquifer thickness varies between 6 and 20 m (Gámez Torrent, 2007), while the lower aquifer thickness, formed by sands and gravels, ranges from 40 m in the valley to 10 m near the coast.

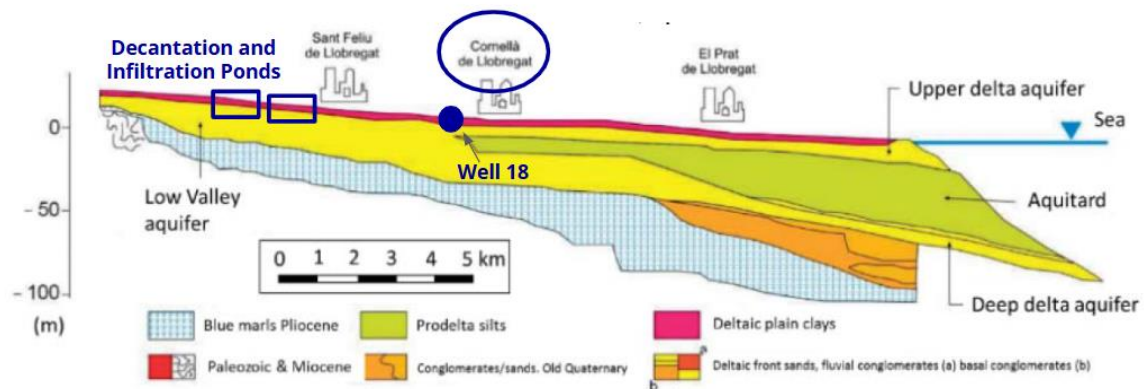
Figure 1.4 Cross-section of the Lower Valley and Delta aquifer of the Llobregat River (Queralt et al., 2020 modified). Infiltration ponds, and injection well (P18) locations are indicated

Decantation and infiltration ponds (Figure 1.4) are in the Lower Valley aquifer, at the municipality of Sant Vicenç dels Horts, northwest of Barcelona, a zone characterized by high transmissivity values.

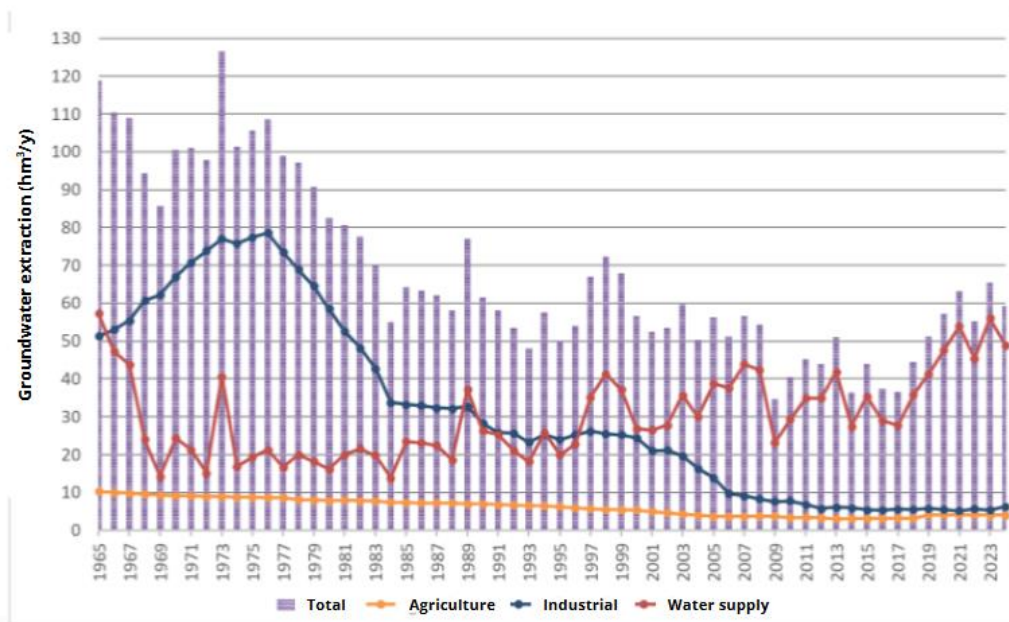
Figure 1.5 Evolution of groundwater extraction, Queralt *et al.*, 2020

The aquifer, monitored by CUADLL, has been historically overexploited, with maximum extractions reaching up to 110–120 hm<sup>3</sup>/year. Withdrawals from the main aquifer have decreased to around 60 hm<sup>3</sup>/year since the 80's (Figure 1.5). As for the superficial aquifer, extraction is estimated at approximately 10 hm<sup>3</sup>/year, mainly due to water supply wells and agricultural use (Queralt *et al.*, 2020).

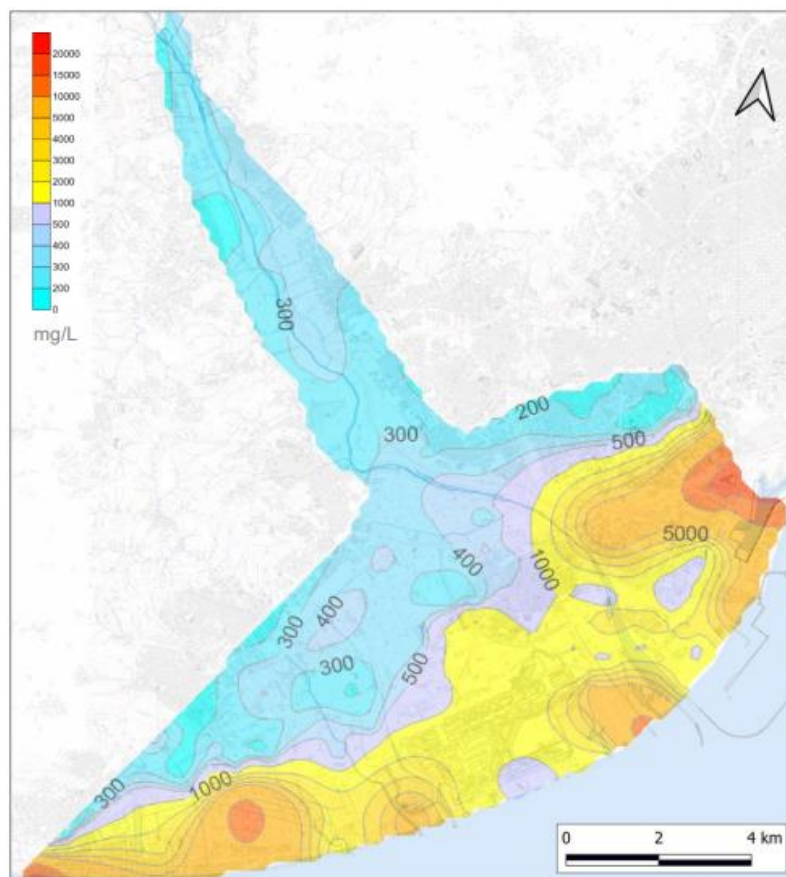
According to the River Basin District Management Plan of Catalonia ([PGDCFC](#)), the Lower Llobregat River Valley and Llobregat Delta face bad qualitative status, mainly due to salinization, but also to some other contaminants such as trichloroethylene (TCE) and tetrachloroethylene (PCE). Chloride concentrations over the aquifer are shown in Figure 1.6 (Queralt, 2025).

Figure 1.6 Chlorides distribution in Baix Llobregat aquifer

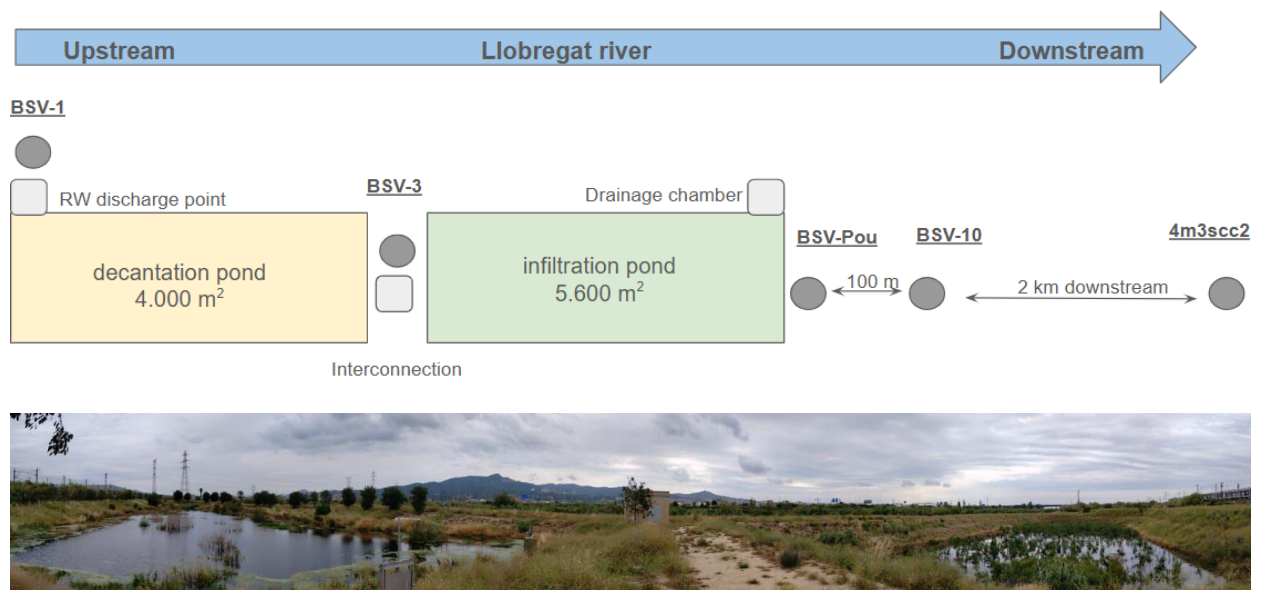
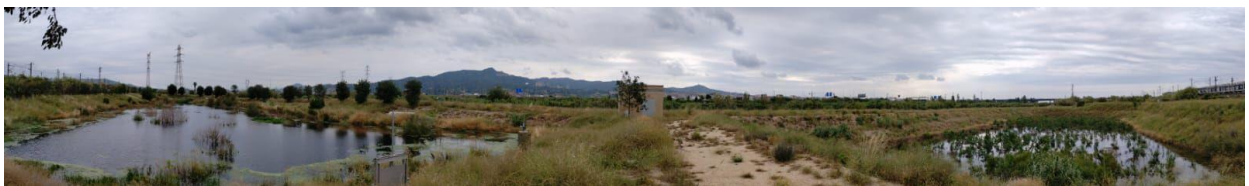
Reclaimed water (RW) reaches the decantation pond by a bulkhead operated manually by CUADLL. Reclaimed water, pumped from the reclamation facility first enters the 4.000 m<sup>2</sup> decantation pond and then flows through the channel into the 5.600 m<sup>2</sup> infiltration pond. The decantation and infiltration ponds are connected by a channel controlled also by a bulkhead. Finally, there is a drainage chamber at the end of the infiltration pond.

Figure 1.7 Sant Vicenç dels Horts infiltration ponds infrastructure scheme

Note: Picture shows, from left to right, the decantation pond, the interconnection and the infiltration pond. The interconnection between the ponds is 8–10 m. Wells BSV-1, BSV-3, and BSV-Pou are located just beside the ponds (less than 5 meters) as shown in the figure. Wells BSV-10 and 4m3scc2 are located 100 m and 2 km downstream, respectively, from the infiltration pond

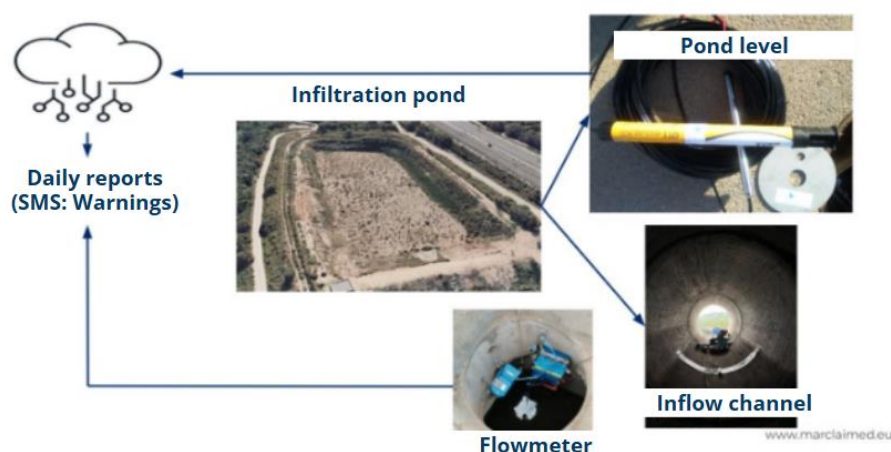
Figure 1.8 Devices installed to continuously measure flow and levels at the ponds

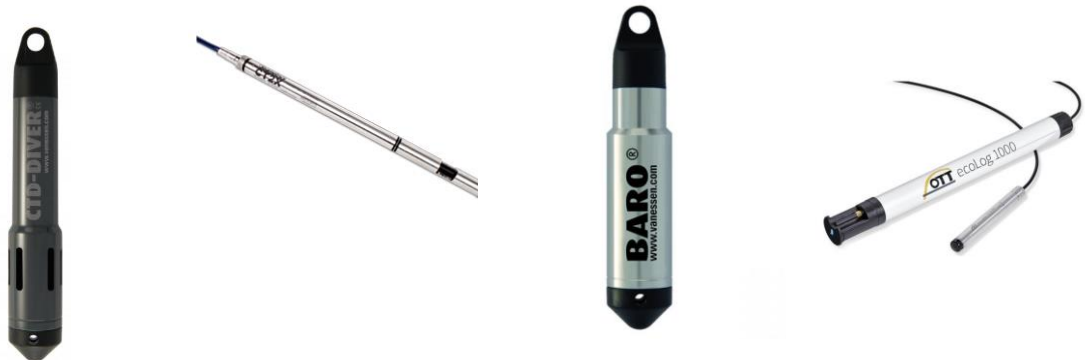
Figure 1.9 Devices installed, in order from left to right: CTD, CT2X, Barometer and the ecoLog 1000

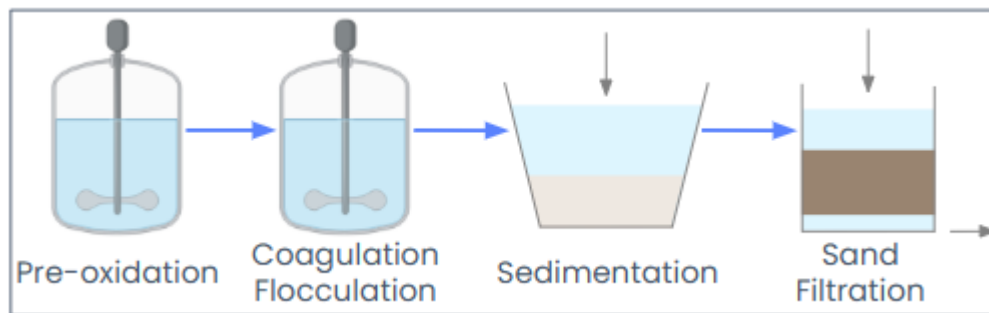
Figure 1.10 Treatment steps before water injection in Well 18

Deep aquifer injection is conducted at the Sant Joan Despí drinking water treatment plant, through the Well 18 (Pou 18). Before the injection, the water passes through several treatment steps: i) a pre-oxidation process with chlorine dioxide; ii) coagulation/flocculation process by polyaluminum chloride; iii) sedimentation/decantation pond and iv) rapid sand filtration (Figure 1.10).

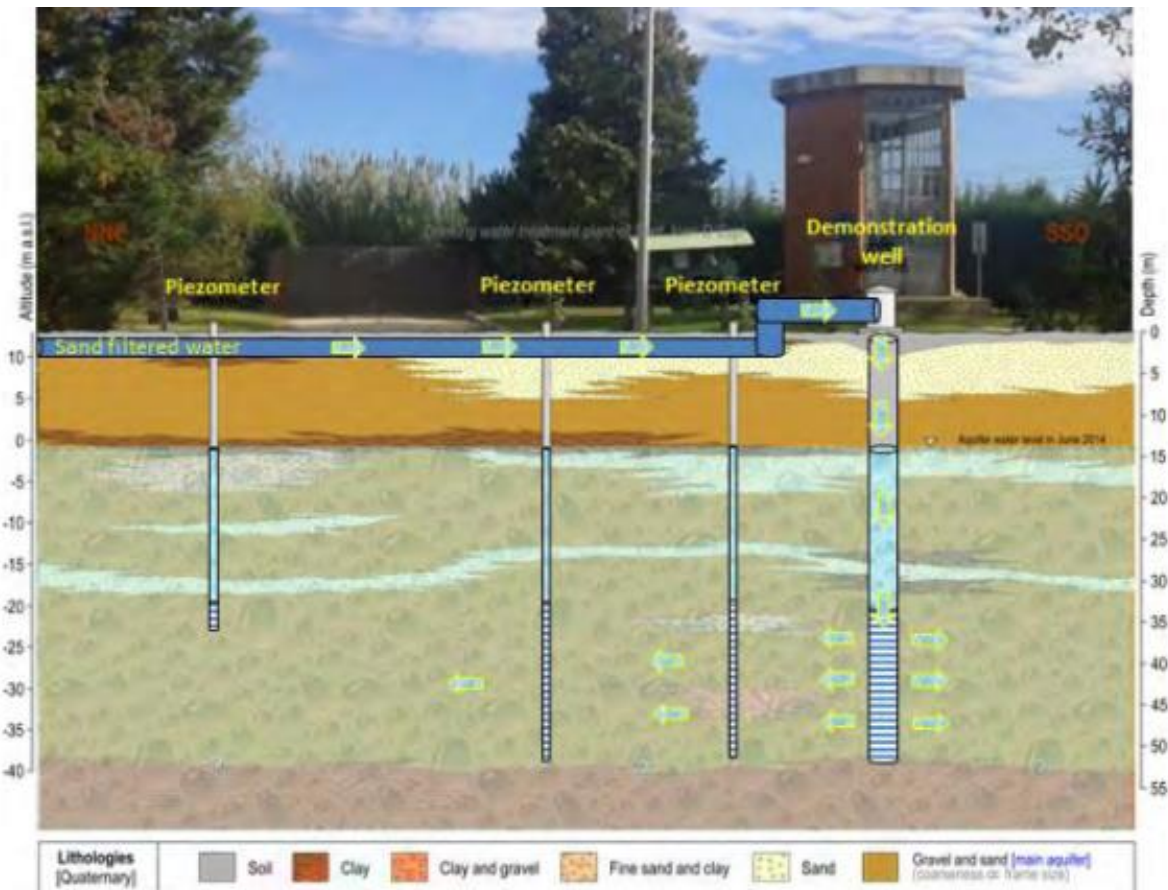
The configuration of the deep injection MAR systems is described as follows: three piezometers (PZ1, PZ2, and PZ3) are located at the distances of 4, 8 and 15 m from Well 18 (Aquifer Storage and Recover (ASR) well, P18 in Figure 1.11). Groundwater recharge Well 18 was equipped with these nearby piezometers as part of a previous research project ([DESSIN, 2015](#)). Nonetheless, due to diameter constraints, only PZ2 is included in the sampling campaigns within MARCLAIMED Project.

Figure 1.11 Geological cross-section of the Llobregat river, in the area of Sant Joan Despí - Cornellà, as well as the battery of wells located in that area (QUEEN final Deliverable, 2023)

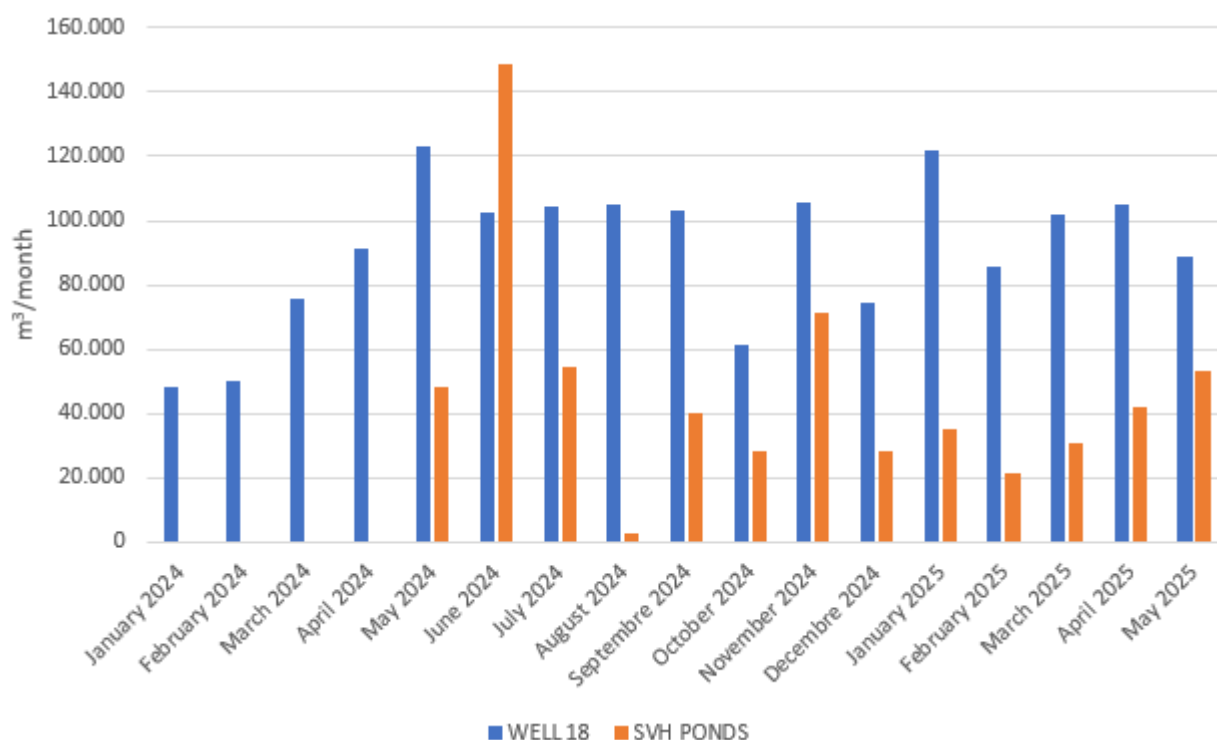
Total volumes recharged since the beginning of the project have reached **1.5 hm<sup>3</sup>** at Well 18 and **0.61 hm<sup>3</sup>** at Sant Vicenç dels Horts infiltration ponds (Figure 1.12).

Figure 1.12 Total volumes recharged at Well 18 and Sant Vicenç dels Horts Infiltration Pond

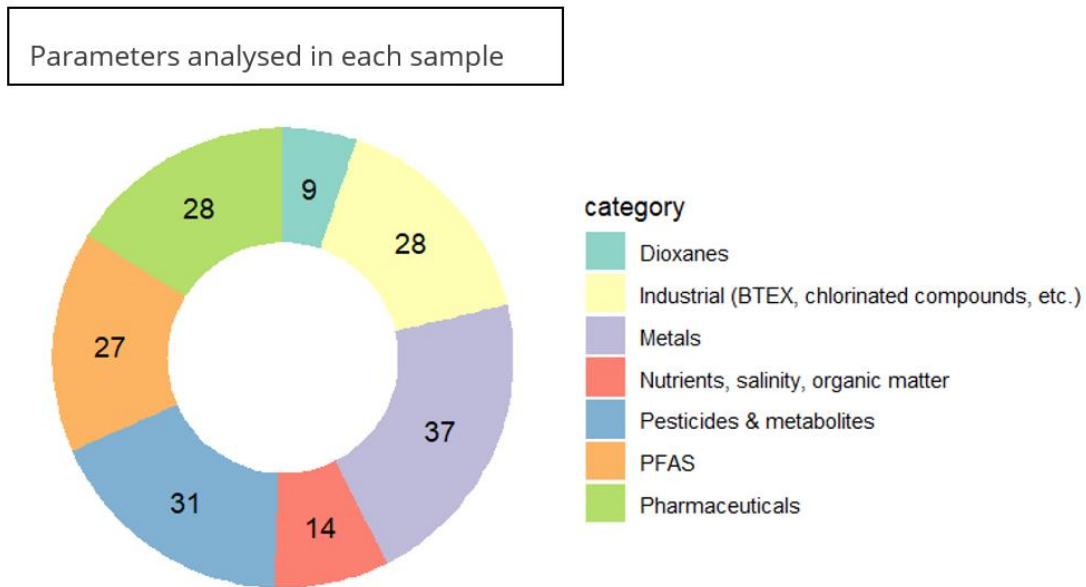
Regarding quality data, a thorough set of parameters (Figure 1.13) are analysed at each point (both at the infiltration ponds and at the deep injection well), in each sampling campaign, in order to be able to perform a thorough analysis as well as risk assessment exercise. The results will be further reported and discussed.

Figure 1.13 Analysed parameters at the infiltration pond and at the deep injection well

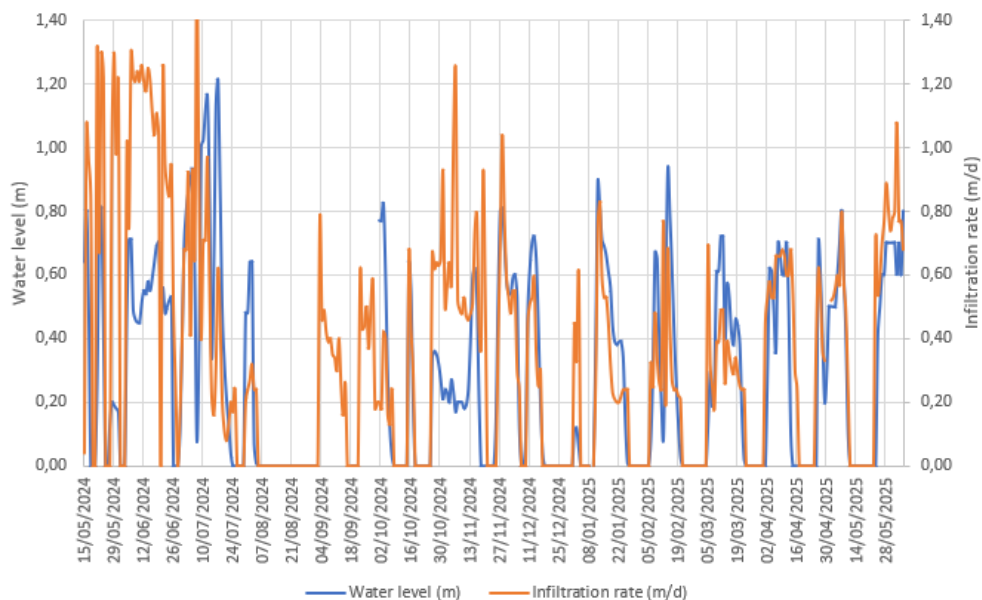
The evolution of the infiltration rate as well as the water level at the infiltration pond are shown in Figure 1.14.

Figure 1.14 Infiltration rate water level at Sant Vicenç dels Horts infiltration ponds

After the first months of operation, a limit was established by ACA in order not to surpass 1 m of water level at the infiltration pond avoiding deep clogging. In fact, when values exceed 0,8 m, ponds management personnel automatically receive an SMS notification on their cell phones.

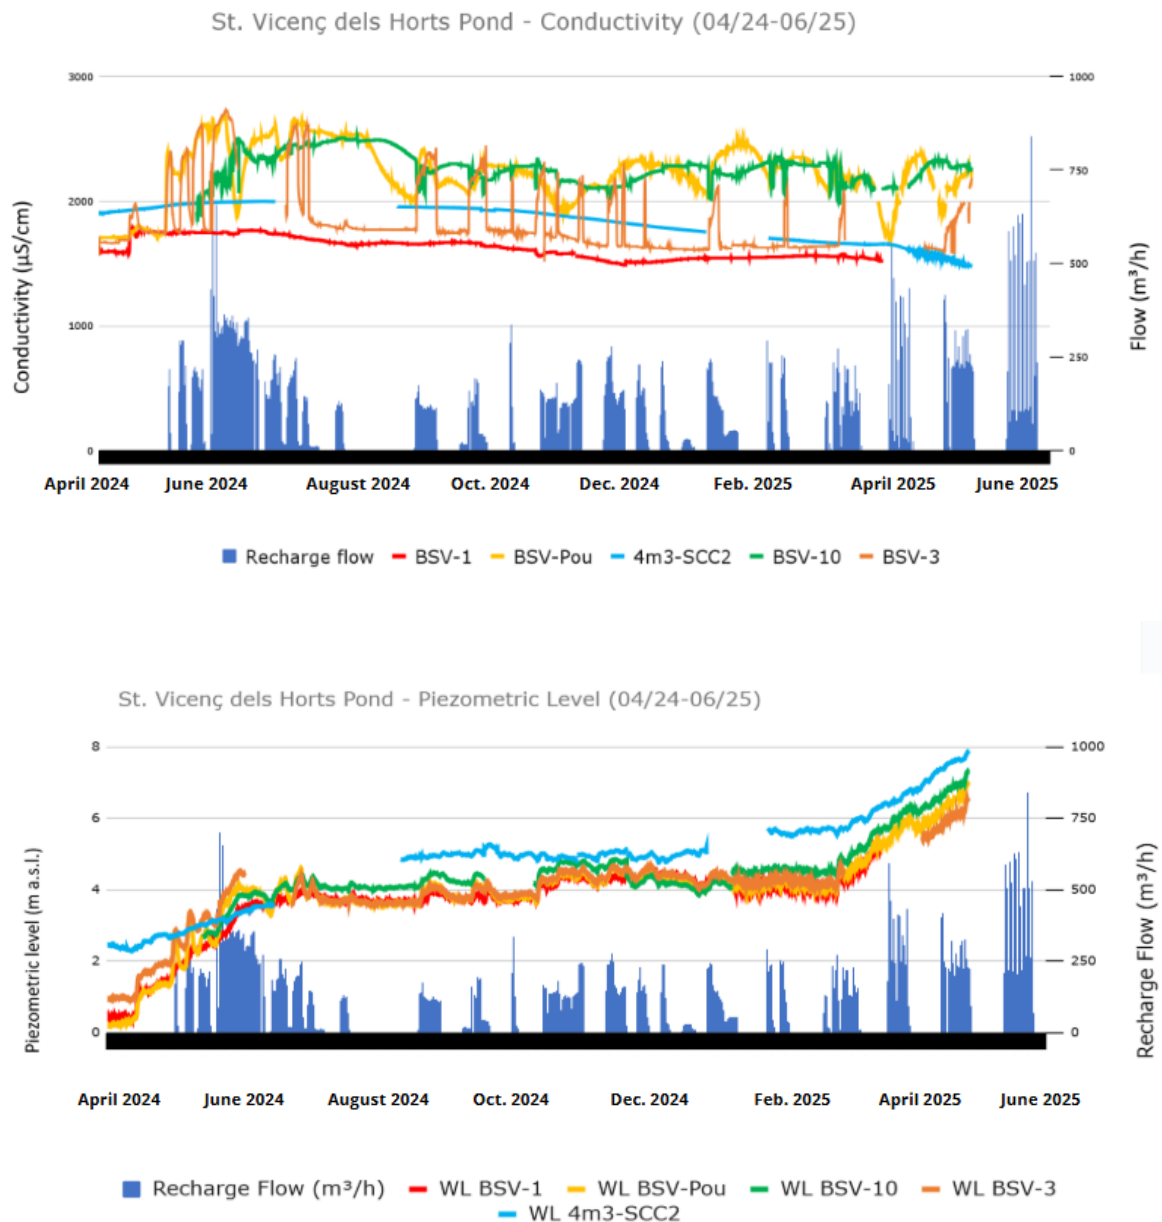
Results gathered from CTD installed at the different observation points are shown in Figure 1.15.

Figure 1.15 Conductivity and piezometric level evolution at monitored piezometers, compared with the recharge flow

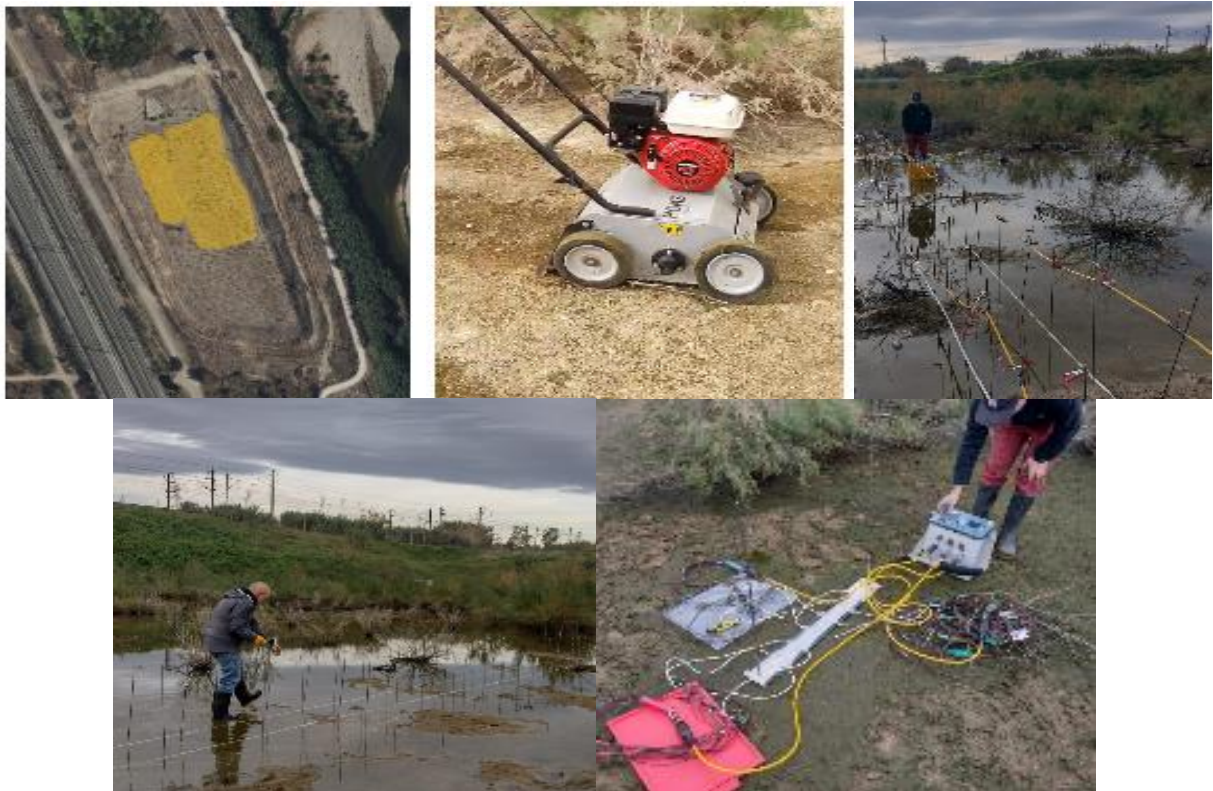
- Two scarification procedures, being the last one in January 2025. Nonetheless, they have had very little effect on improving the infiltration rate.
- Several ground geophysical surveys as well as grain size analysis have also been performed and lead to the conclusion that no important changes have been seen at a depth of 1.5 m (same grain size characteristics as at the beginning of the recharge). Indeed, the most impermeable part is in an intermediate layer at approximately 0,5 m depth, which means that scarification of the first 5-10 cm is not helpful.

*Figure 1.16 Field works: scarified area, scarifying machine and geophysical surveys*

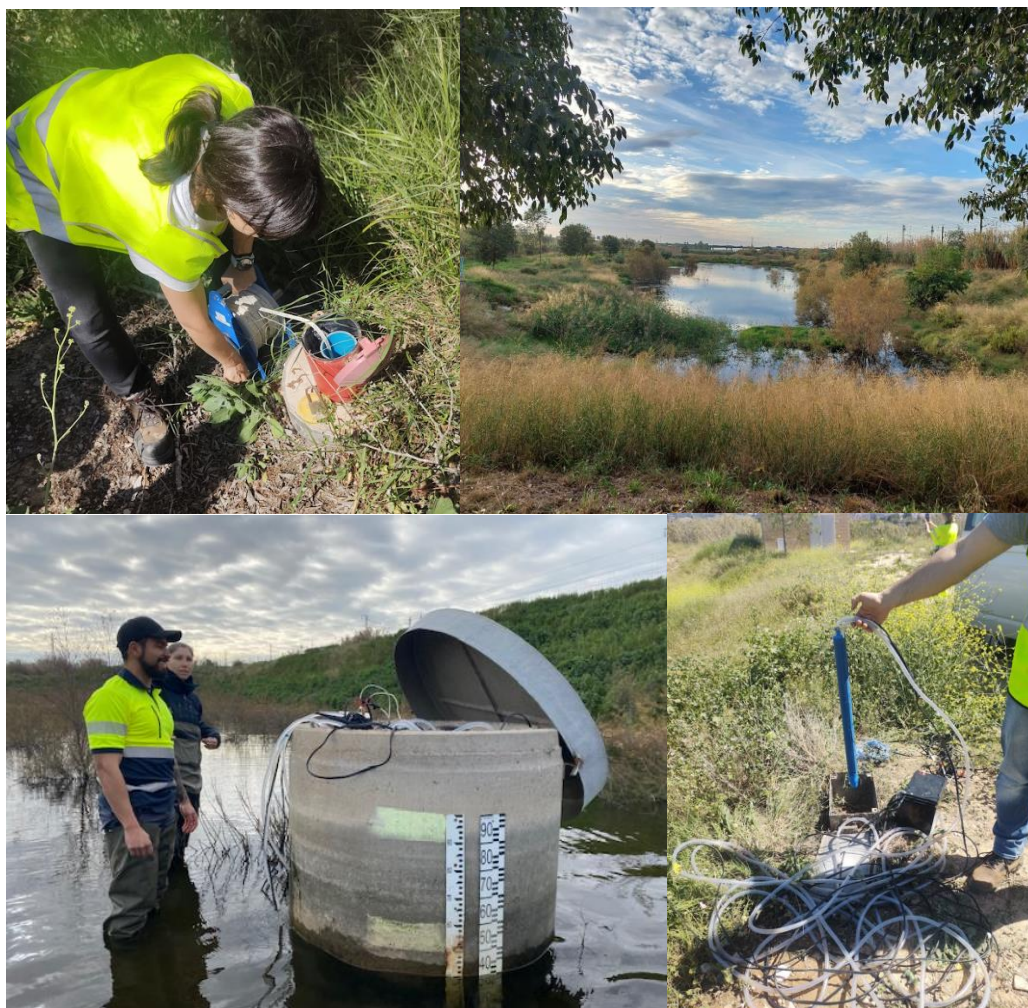
Figure 1.17 Sampling operations at the infiltration pond

A total of six sampling campaigns have been conducted since the recharge began, scheduled every 6 to 8 weeks depending on the recharging periods and the volumes of reclaimed water recharged (Figure 1.17).

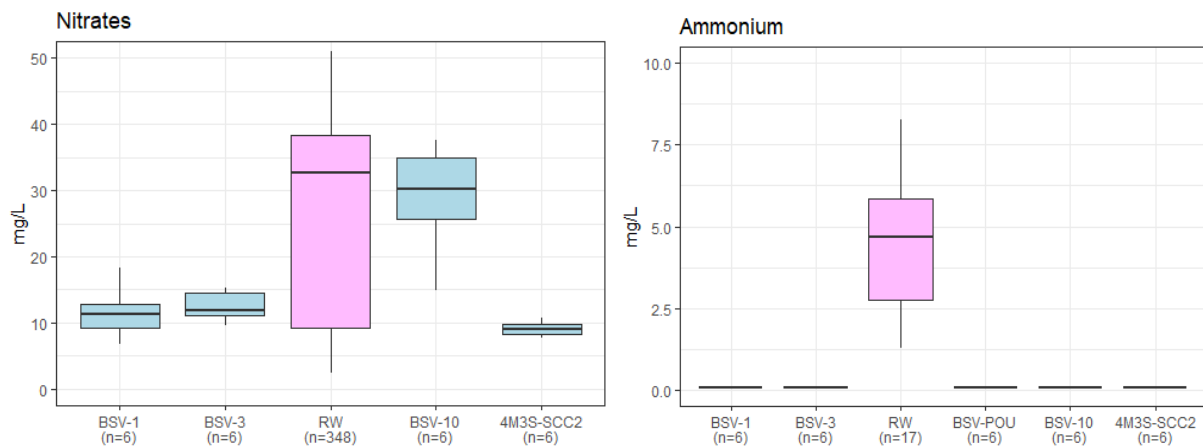
- Values have been kept within limits for Total suspended solids (TSS).
- Values have slightly exceeded Total Nitrogen as well as Nitrates (Figure 1.18). Regarding this, there are two things to be considered: as has previously been explained, this same RW has been widely used during 2024 for IPR, therefore sending it to the river upstream of the main DWTP catchment. For this purpose (drinking water production) ammonium was a stronger constraint, whilst nitrates were not (the parametric value for drinking water according to RD3/2023 is 50 mg NO<sub>3</sub><sup>-</sup>/L). That is why, for most of the recharging period, ammonium was preferred rather than nitrates. Moreover, big improvements have been made at the biological treatment in the WWTP (aeration process improvement), so now both nitrates and total nitrogen have significantly decreased since beginning 2025 (Figure 1.19).

Figure 1.18 Nitrates and ammonium at SVH infiltration ponds

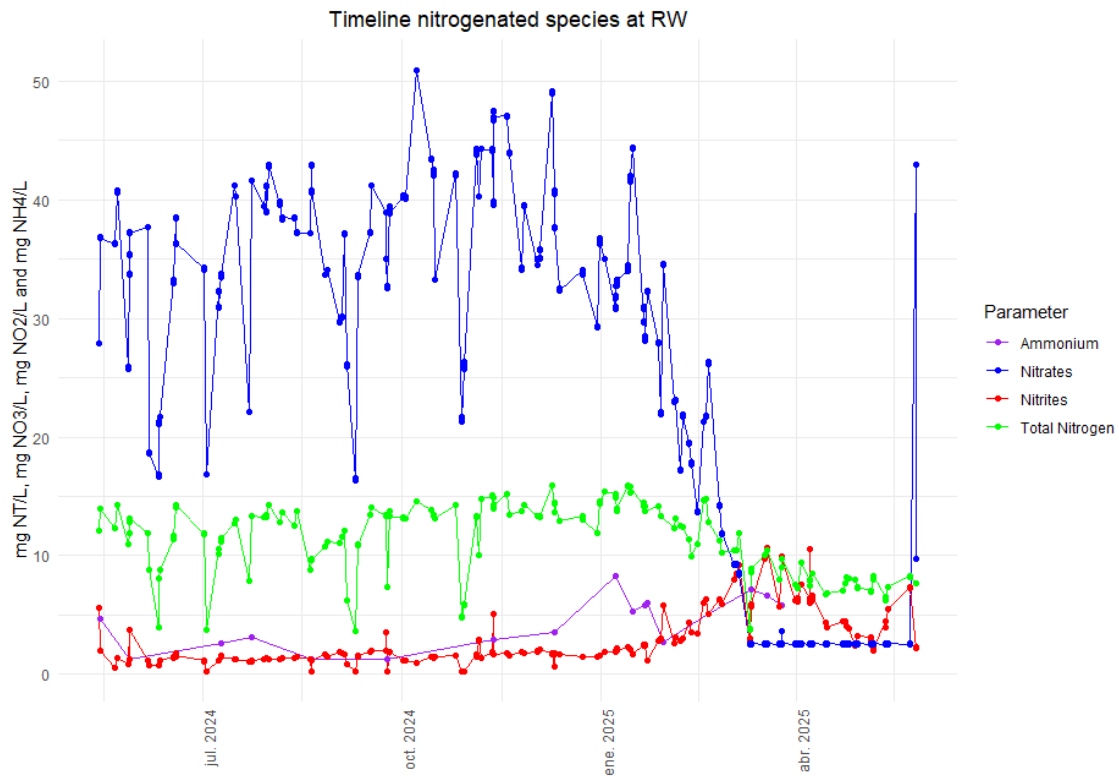
Figure 1.19 Nitrogenated species evolution over time

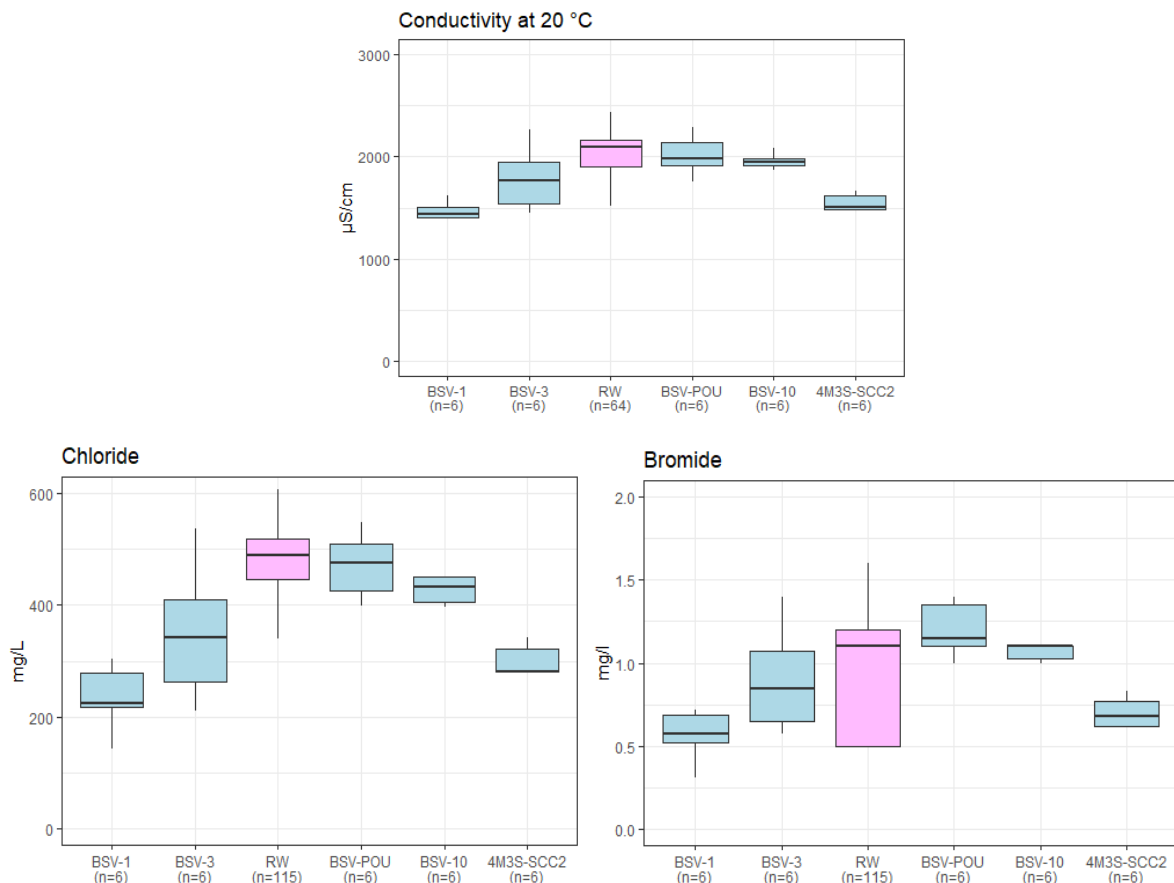
Figure 1.20 Salinity evolution during the recharge process

The industries located at the delta region take groundwater for their production processes, and the rejection from the reverse osmosis processes goes to the WWTP, therefore increasing RW conductivity (Figure 1.20). Besides this, big efforts are being made to divert these brackish waters before getting into the WWTP. Once this goal is achieved, conductivity values at the RW are expected to have a decrease of about 400-500  $\mu\text{S}/\text{cm}$ .

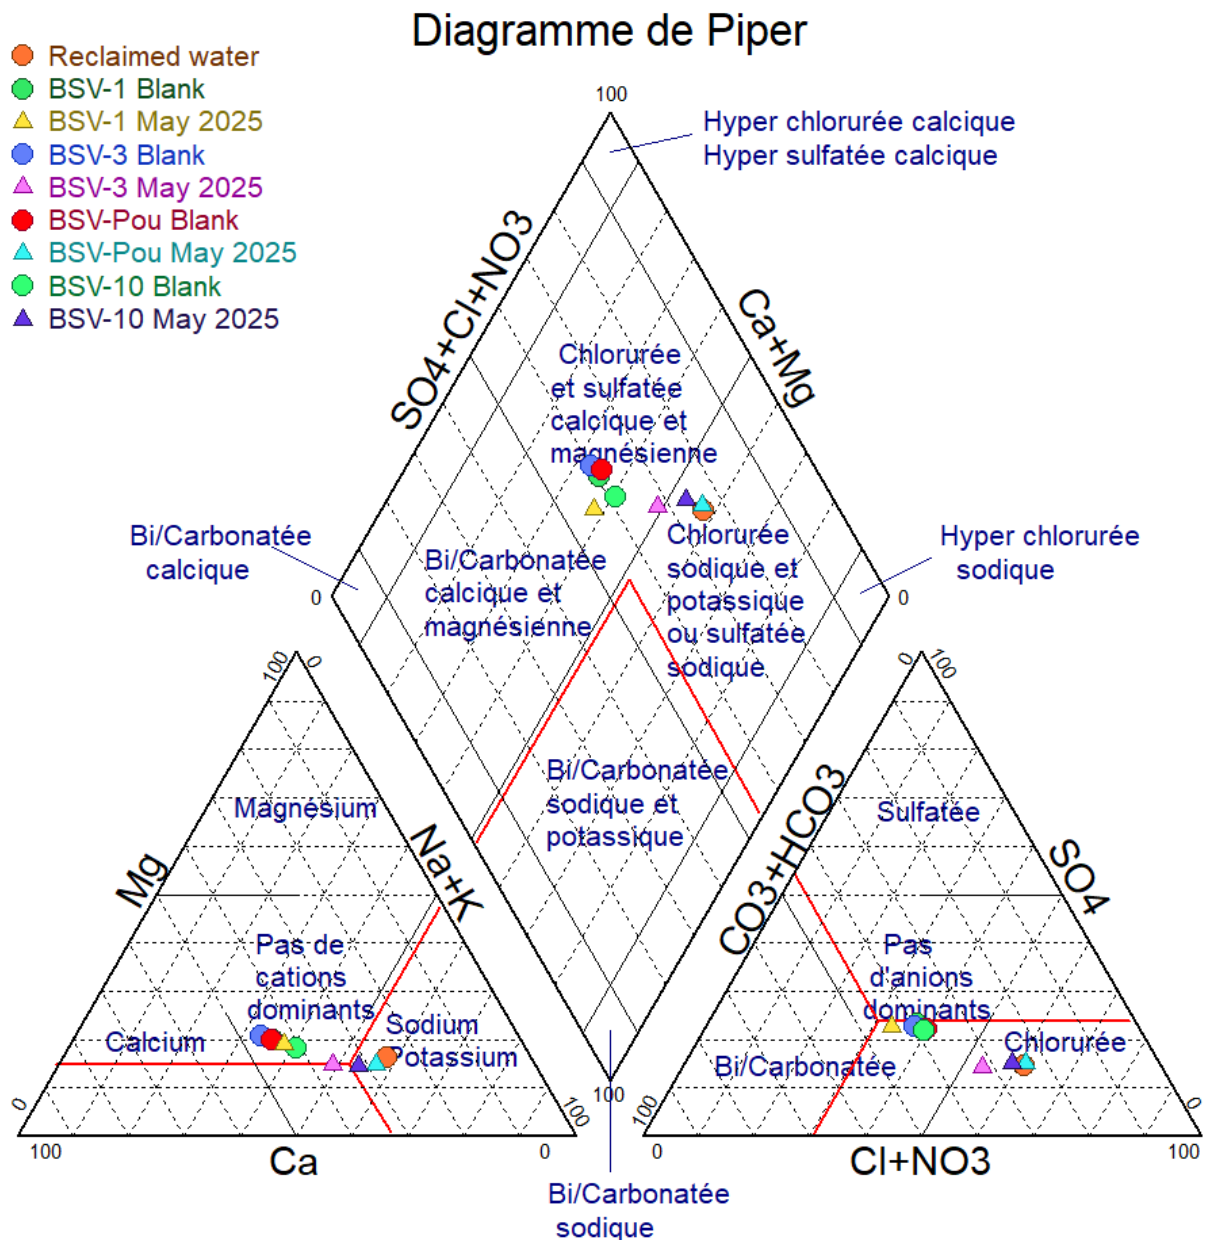
The relative proportion of major cations and anions, for the different observation points, before and after the recharge is shown on a Piper diagram (Figure 1.21). As it can be seen, there is a difference between the blank samples and the latest sampling campaign towards more chlorides and more sodium/potassium, especially at BSV-Pou and BSV-10 and, to a lesser extent, at BSV-3. On the contrary, BSV-1 is barely altered.

Figure 1.21 Piper diagram representing reclaimed water and main groundwater observation points both before and after recharge

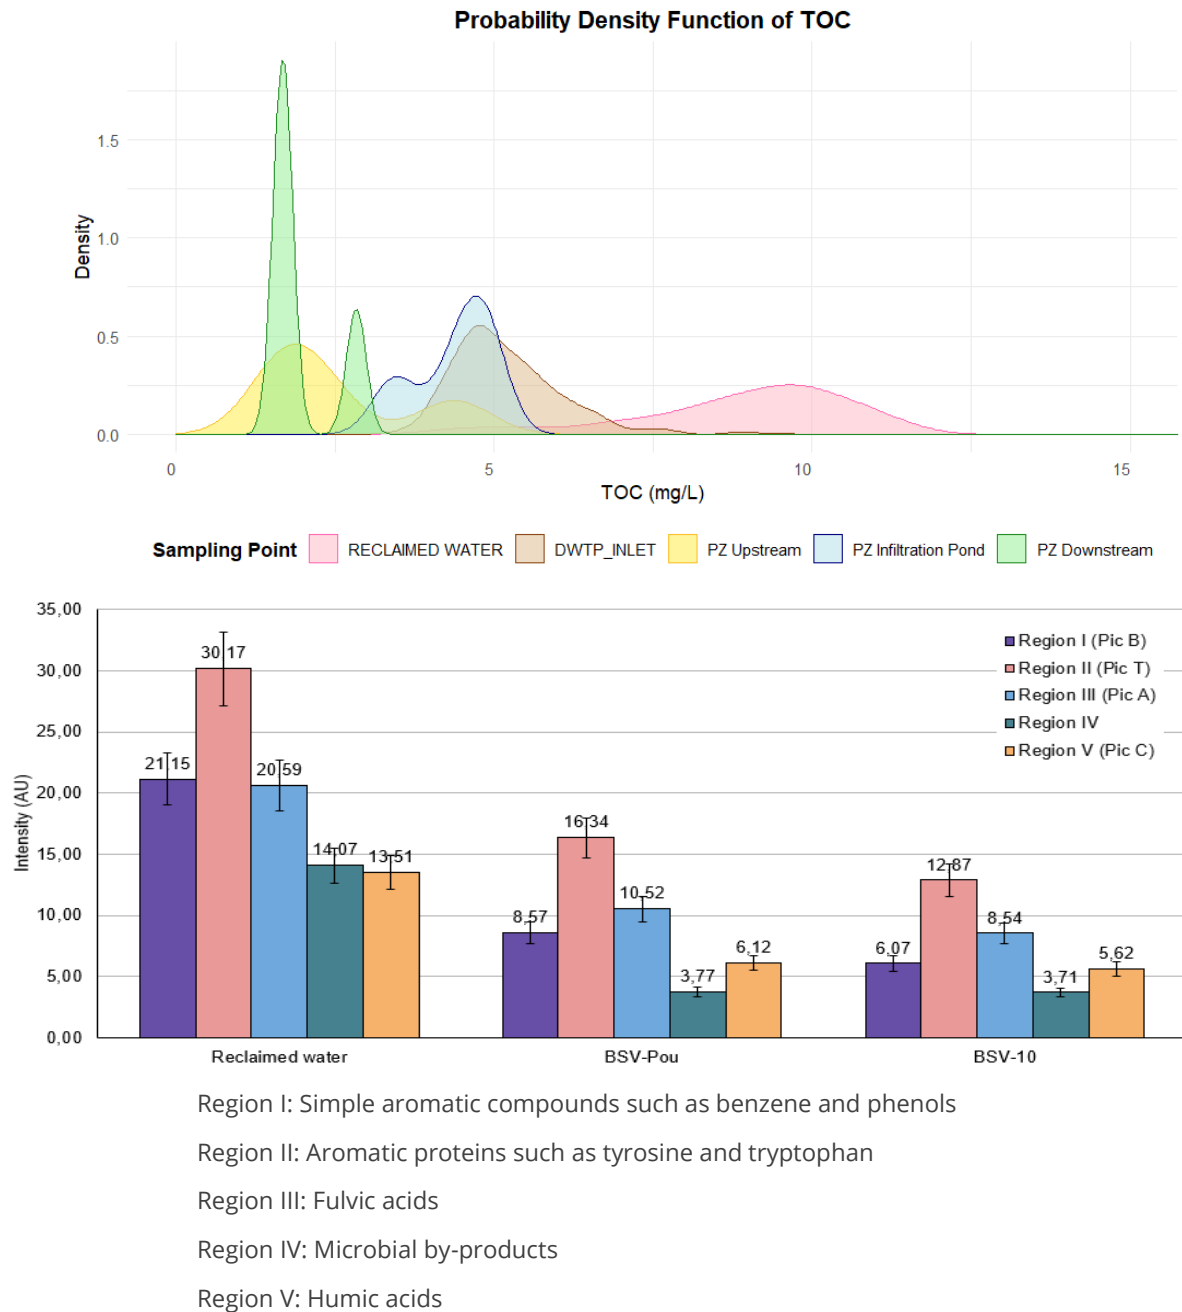
On the contrary, a key-point related to the recharge of reclaimed water is its organic matter (Figure 1.22). Indeed, organic matter poses a challenge at the DWTP because it is the main precursor, from surface water, for certain disinfection by-products formation (mainly trihalomethanes). If this reclaimed water with high organic matter content is recharged at the infiltration ponds, TOC values are reduced already by half at the first observation point downstream (BSV-POU). In one of the campaigns, also a fluorimetry analysis was performed

in order to see the main regions of the organic matter. Indeed, the intensity of all regions suffers a decrease around half of the former value when water is recharged (Figure 1.22).

Figure 1.22 Organic matter evolution during recharge

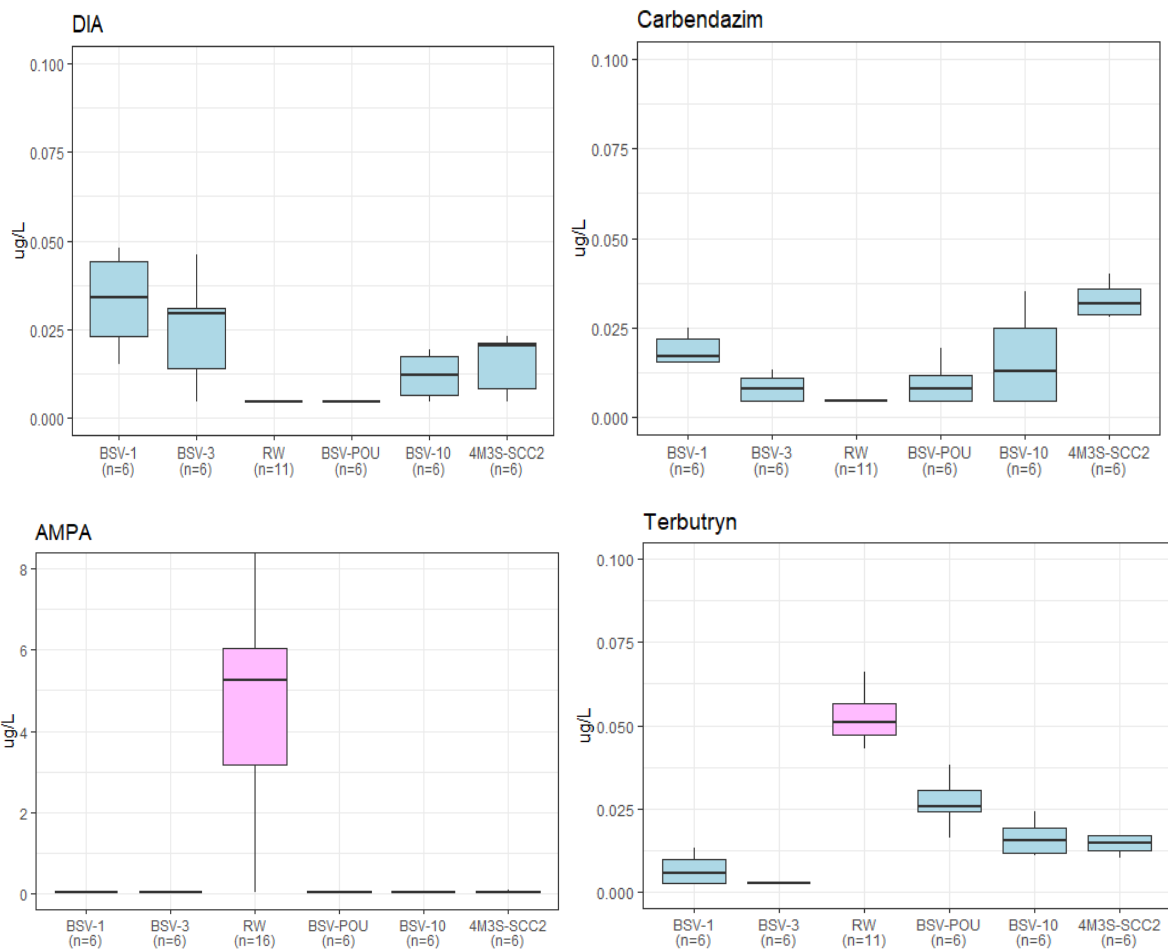
- Some pesticides are not detected in RW whilst they are known to be detected in groundwater at Vall Baixa aquifer. This means that a dilution is observed in the area of recharge or that there are contributions from other sources. This is the case for Carbendazim and Desisopropylatrazine (DIA).
- Some other pesticides are completely removed during the recharge process. This is the case for AMPA, which is detected at very high concentrations in RW (normally between 3 and 6 µg/L), and it has never been detected in groundwater samples, not even at BSV-POU.
- Some other pesticides present in RW are much more persistent. That is the case for diuron, imidacloprid, and terbutryn.

Plots for the different behaviours of pesticides are summarized in Figure 1.23.

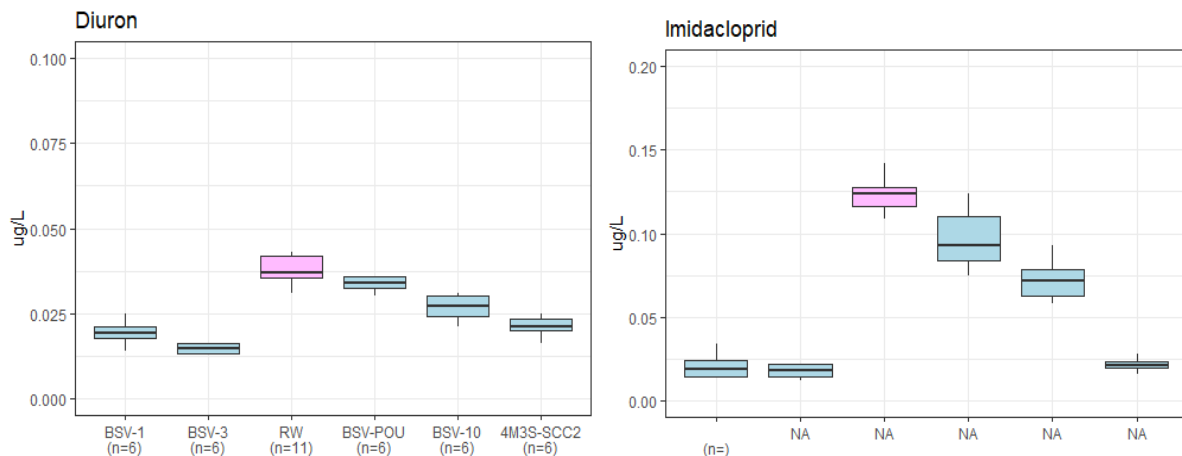
Figure 1.23 Behaviour of pesticides during recharge process
