# MARCLAIMED

Progress Report Demo Sites

Deliverable D4.3

WP4: CoPs-Based Implementation and Validation at the Demo Sites

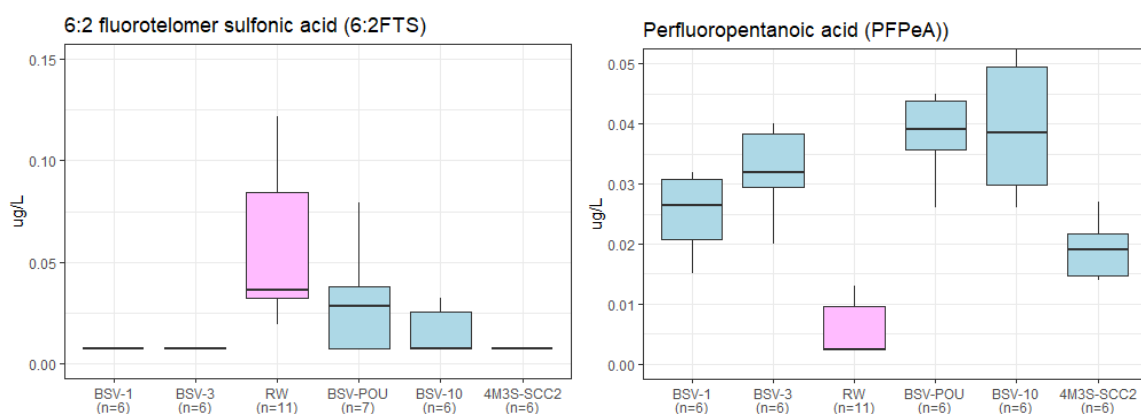
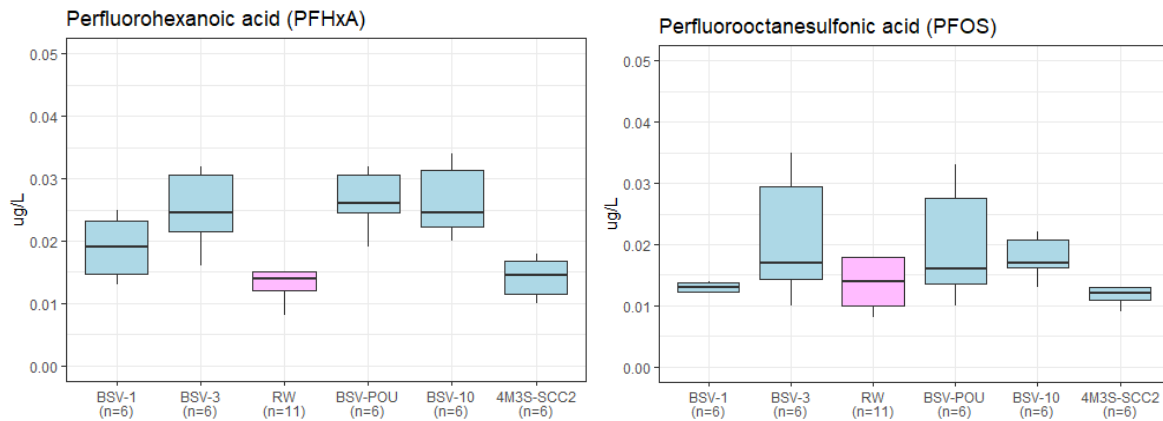
What has been seen so far is that 6:2 FTS, which is among the ones at highest concentration in RW, decreases while crossing the non-saturated zone, whilst short chain PFAS (PFBA, PFHxA, PFPeA, etc.) increase (Figure 1.24). With all, the sum of PFAS gets not altered with water recharged at the infiltration ponds, with values around 0,1 µg/l, so just at the limit of the parametric value for drinking water according to RD 3/2023.

Figure 1.24 PFAS evolution during the recharge process

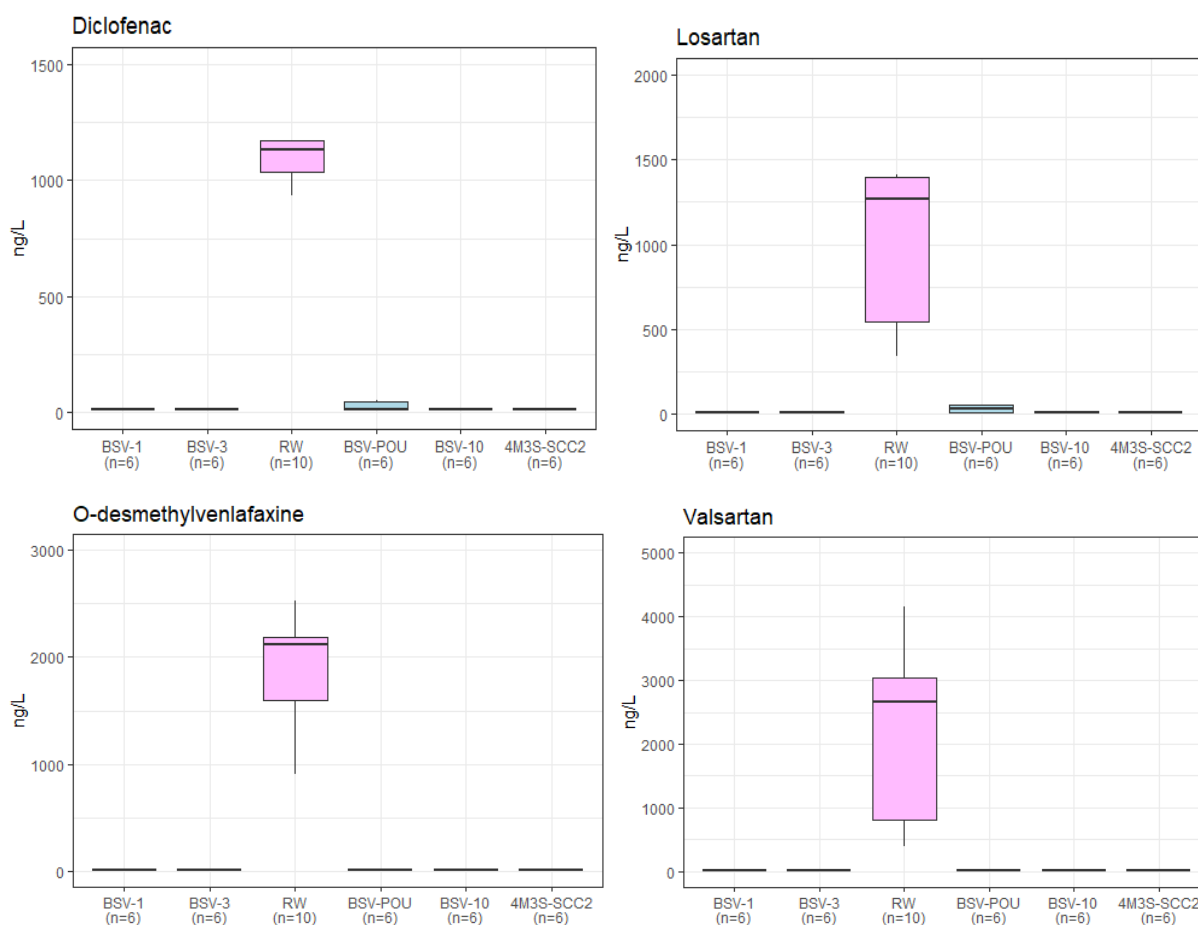
Figure 1.25 shows, some PhCs that are completely removed while they cross the vadose zone. That is the case for Diclofenac, Losartan, O-Desmethylenlafaxine, and Valsartan. In fact, they are usually found in RW at concentrations that exceed 1.000 ng/L, but they are not detected neither at BSV-POU (located right at the end of the infiltration pond) nor in the piezometers downstream.

Figure 1.25 Pharmaceutical compounds completely removed at the non-saturated zone (I)

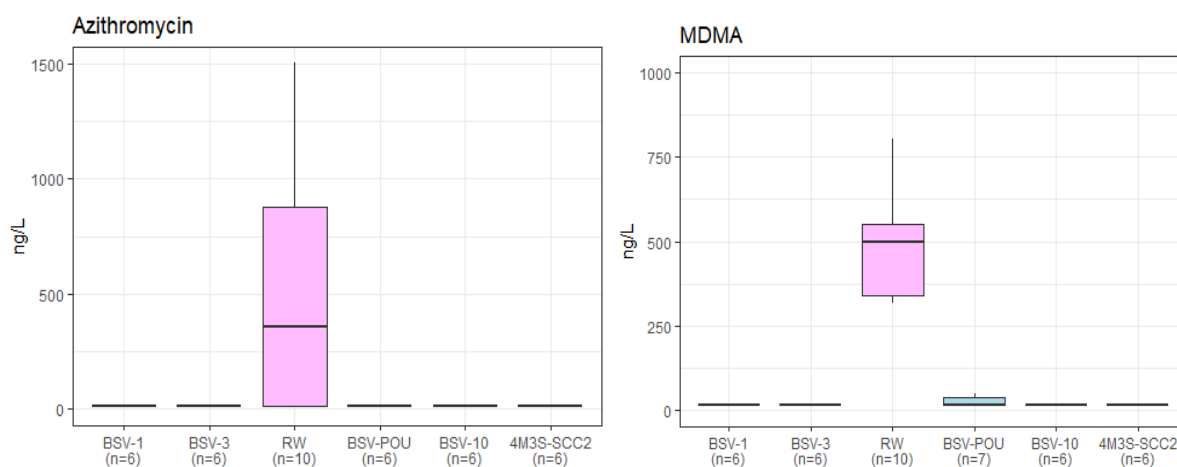
Figure 1.26 Pharmaceutical compounds completely removed at the non-saturated zone (II)

With the same behaviour, but slightly lower concentrations at RW, many other pharmaceuticals could be mentioned (e.g., Azithromycin, MDMA, Ciprofloxacin, Doxycycline, Methamphetamine, Ofloxacin, Venlafaxine). Some of them are summarized in Figure 1.26.

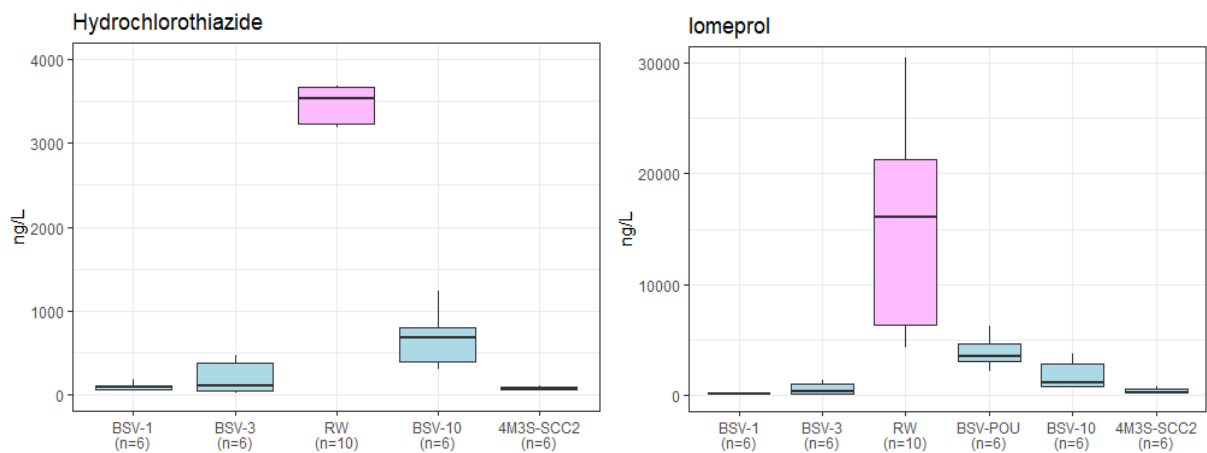
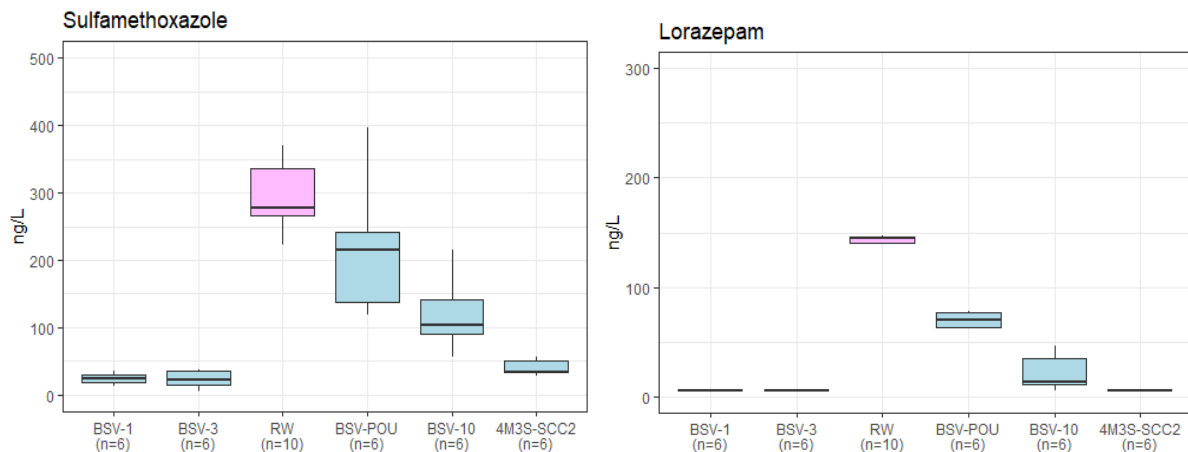
On the contrary, in some others, the concentrations decrease despite they are not completely removed at BSV-POU (e.g., Hydrochlorothiazide, lomeprol, Sulfamethoxazole, Lorazepam, Bisoprolol, Amantadine). Nonetheless, once this water travels further away, the correspondent concentrations go back to expected native groundwater values (either dilution or degradation) (Figure 1.27).

Figure 1.27 Pharmaceutical compounds partially removed at the non-saturated zone (III)

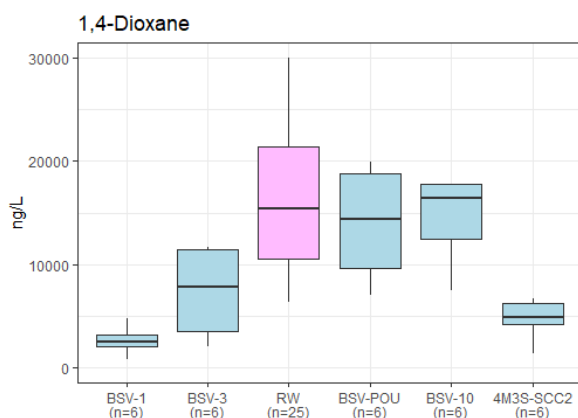
Big efforts were made at that point to detect its origin and force industries towards a decrease in the released concentrations.

Thanks to that, since recharge at the infiltration ponds began in May 2024, 1,4-dioxane concentrations in RW have been kept below the recommended value by the WHO (Figure 1.28).

From the very first moment that reclaimed water from El Prat de Llobregat reclamation facility was intended for indirect potable reuse, a clear issue arose with 1,4-dioxane, which was reaching values far above the guidance limit established by the World Health Organization (50.000 ng/L).

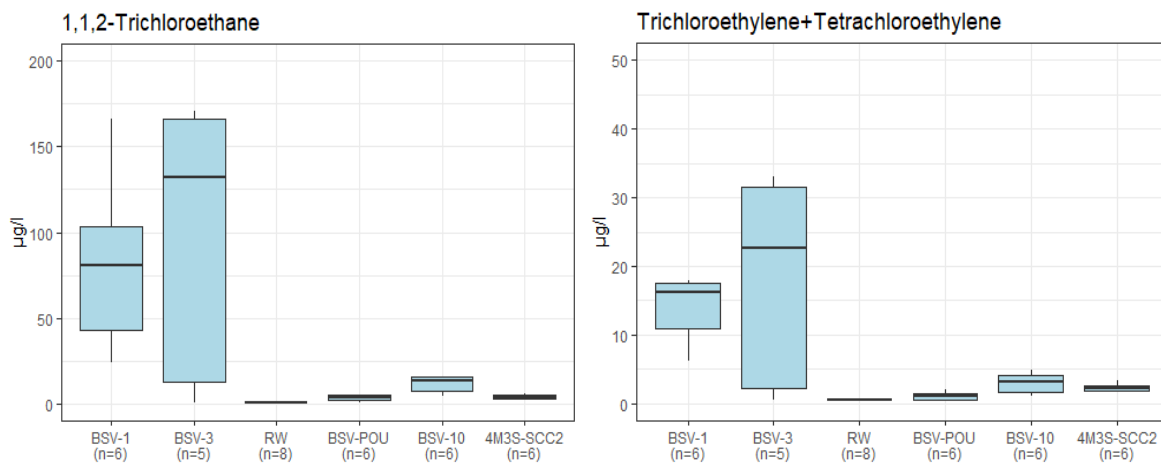
Another already known contamination in the Lower Llobregat River Valley aquifer is that of organochlorinated compounds (1,1,2-trichloroethane, trichloroethylene and tetrachloroethylene). This contamination comes from ancient industries in the area, which carried out extraction of aggregates and filled them up with contaminated deposits. As in can be seen in Figure 1.29, concentration of 1,1,2-trichloroethane and trichloroethylene + tetrachloroethylene are sensitively higher at BSV-1 and BSV-3 (before infiltration pond) than in BSV-POU, BSV-10 and 4m3SCC2 (after reclaimed water is infiltrated, without this compounds).

Figure 1.29 Organochlorinated compounds in the recharge observation points

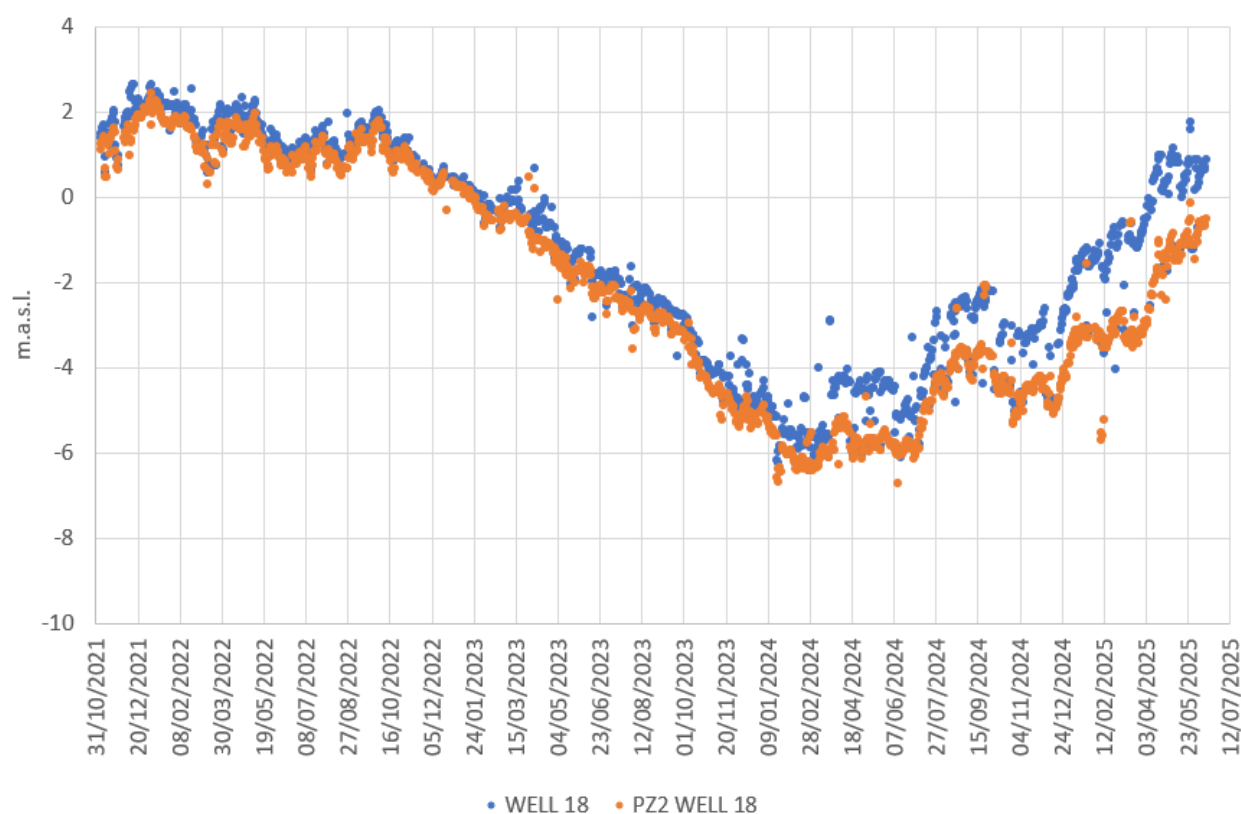
Figure 1.30 Water table evolution at Well 18 and PZ2 WELL 18

Since the recharge at Well 18, as stated before, began in October 2021, water table evolution is shown since then. Levels at Well 18 and PZ2 WELL 18 showed a very close evolution while a recharge of 30 L/s was performed. Nonetheless, since recharge was increased up to 50 L/s in spring 2024, levels at WELL 18 have become slightly higher (Figure 1.30).

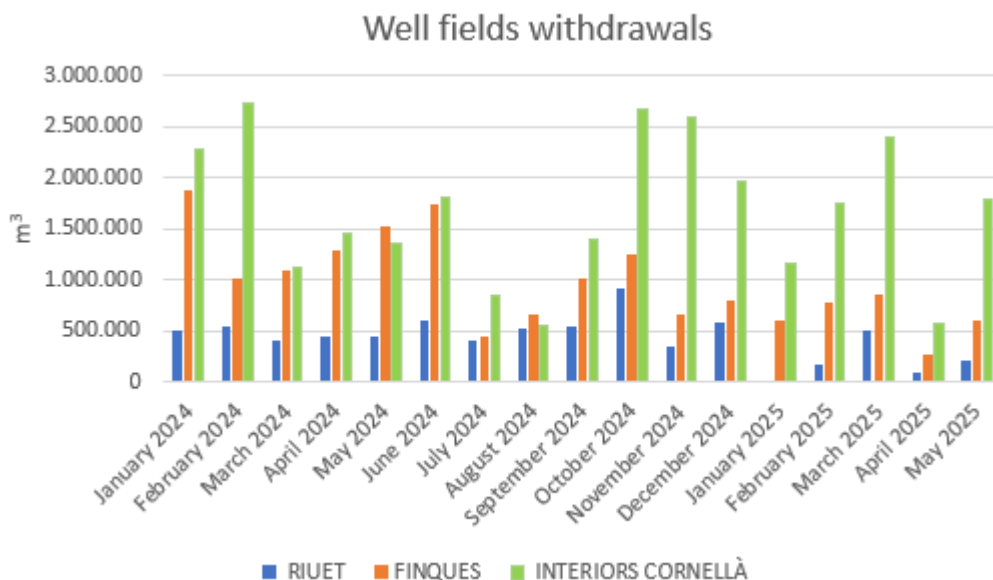
Figure 1.31 Well fields withdrawals

Despite the continuous recharge done at Well 18, the withdrawals in the area (Figure 1.31) create an important cone of depression, which means that the natural water flow (blue arrow in Figure 1.32) is significantly modified towards Interiors Cornellà (red arrow). The resultant vector of main water flux is depicted (green arrow). Therefore, despite the natural regional flow towards the sea discharge, during the analysed period groundwater flow dynamics were mainly characterized by groundwater flux from Well 18 to Well 13.

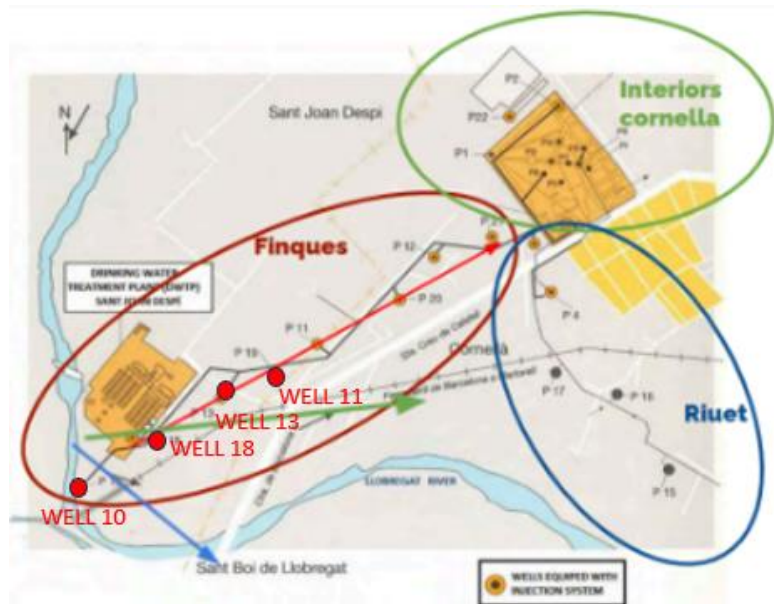
Figure 1.32 Natural water flow

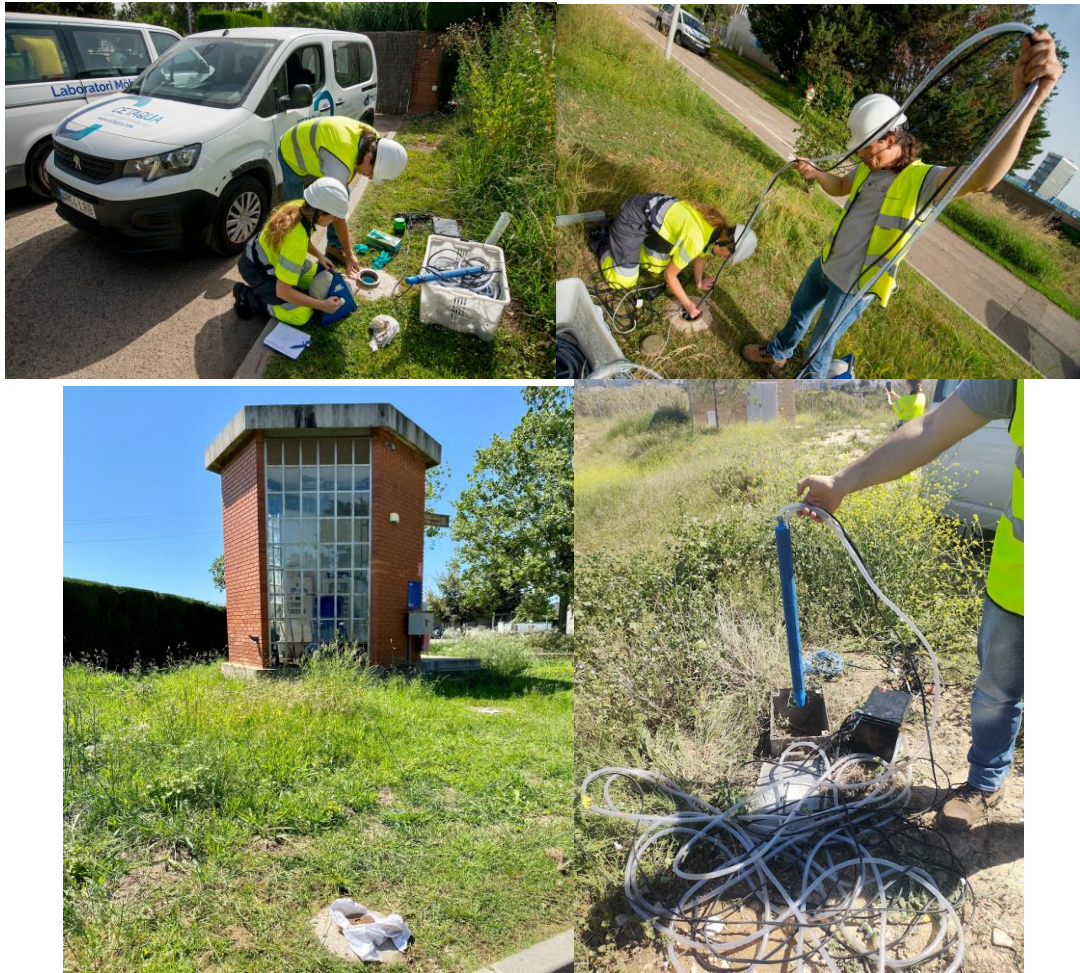
*Figure 1.33 Sampling campaigns at Well 18 and nearby piezometers*

Sampling campaigns (Figure 1.33) have been conducted every three months since the recharge began. Despite the MARCLAIMED Project officially started in 2024, results presented here date back to January 2023, when, due to IPR implementation, reclaimed water mixed with surface Llobregat River water became the source for recharge.

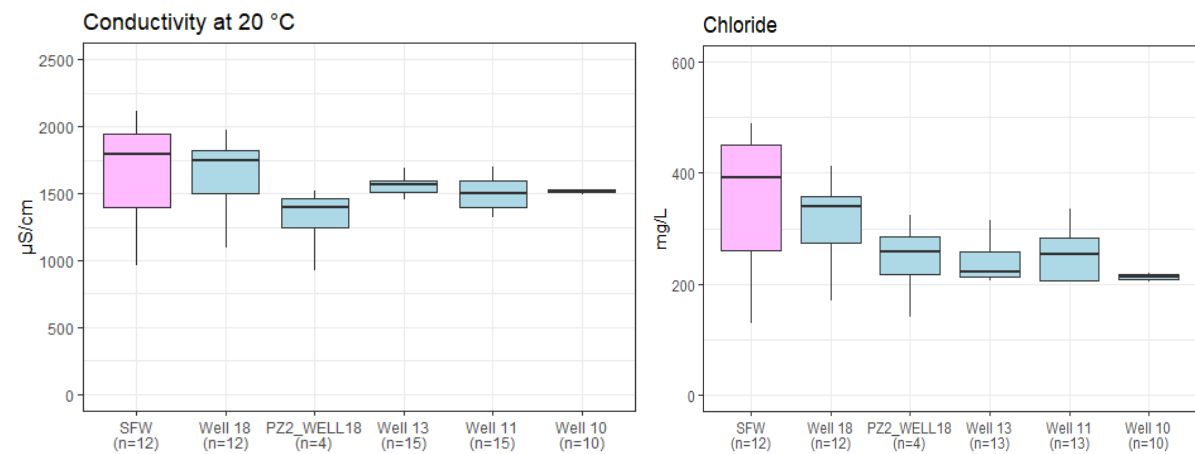
Figure 1.34 Salinity in the recharge Well 18 and observation wells

With the IPR scheme, there was a change in the Llobregat river water and, therefore, a change in the water used for MAR. The main concern, as previously stated, is the salinity of reclaimed water. Despite this, salinity values come down to normal groundwater levels, even in the area not that far away from the recharge well (Figure 1.34).

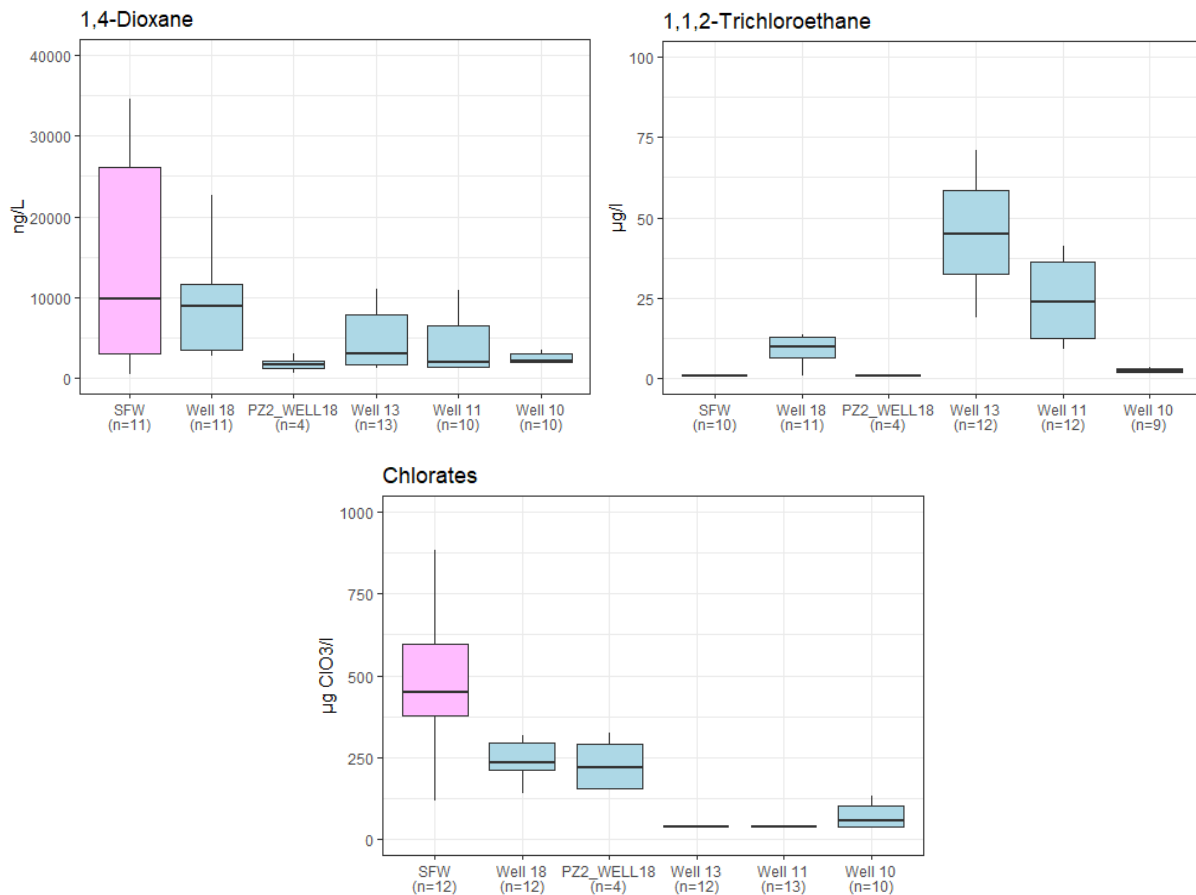
Figure 1.35 Concentration of tracer compounds in SFW, Well 18 and observation wells

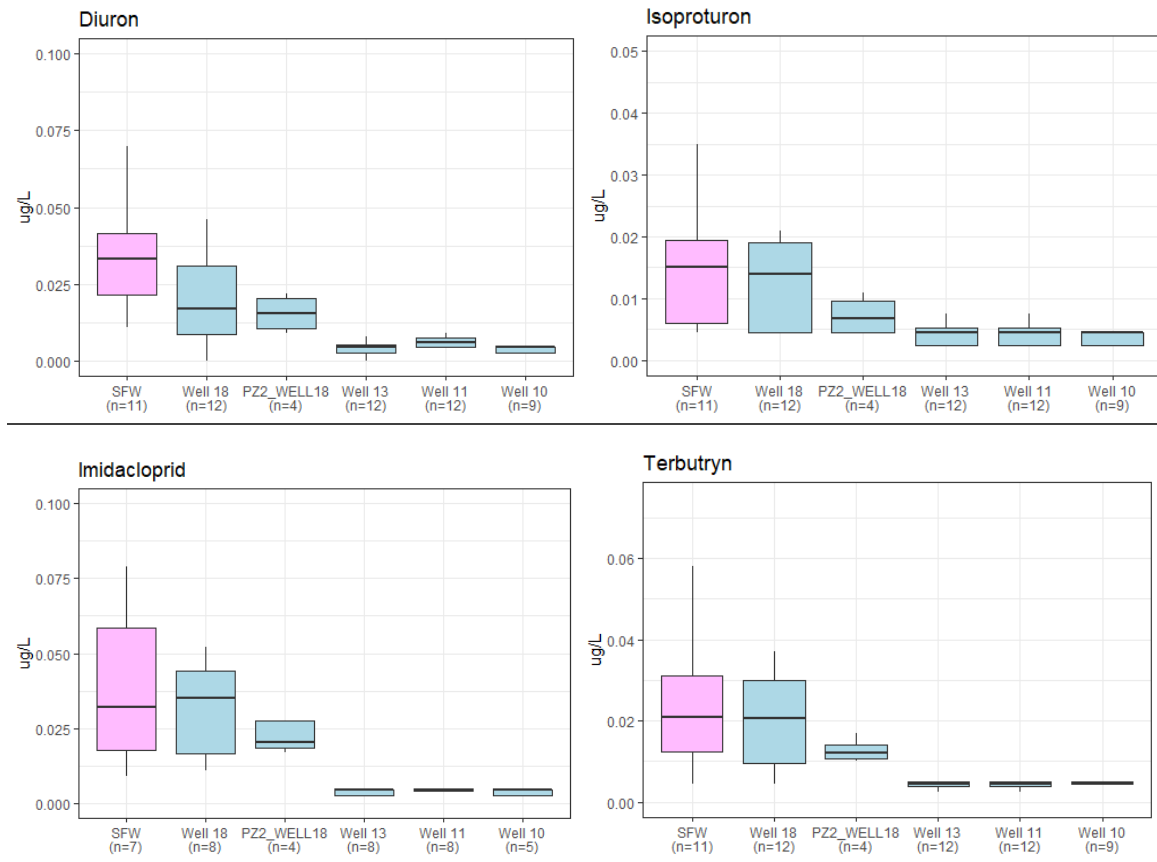
Figure 1.36 Concentration of pesticides in SFW, Well 18 and observation wells

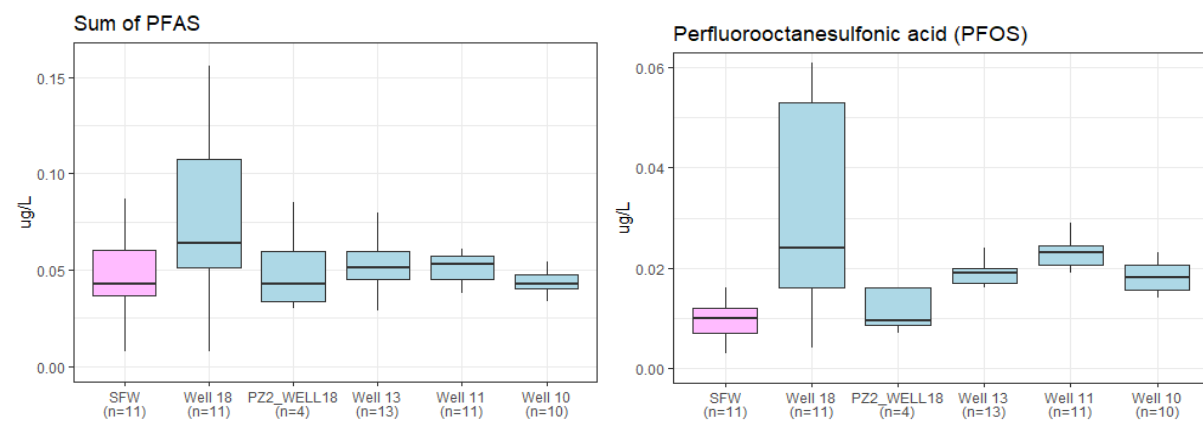
Figure 1.37 Concentration of Sum of PFAS and PFOS in SFW, Well 18 and observation wells

The sum of PFAS as well as the individual PFAS do not show significant differences between recharged water and groundwater (Figure 1.37), meaning that recharge with AWR at this point has no negative effect on groundwater regarding PFAS.

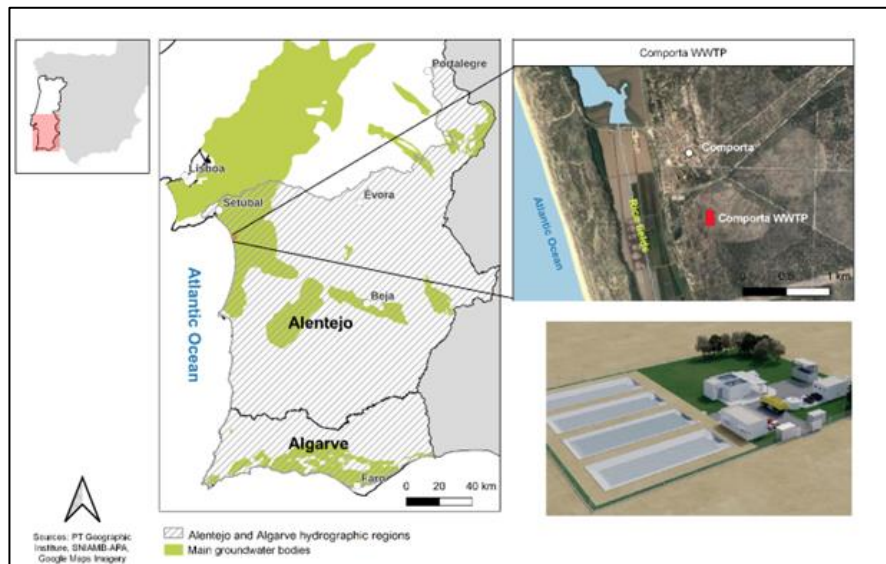
Figure 2.1 Location and general layout of Comporta WWTP\_SAT-MAR system

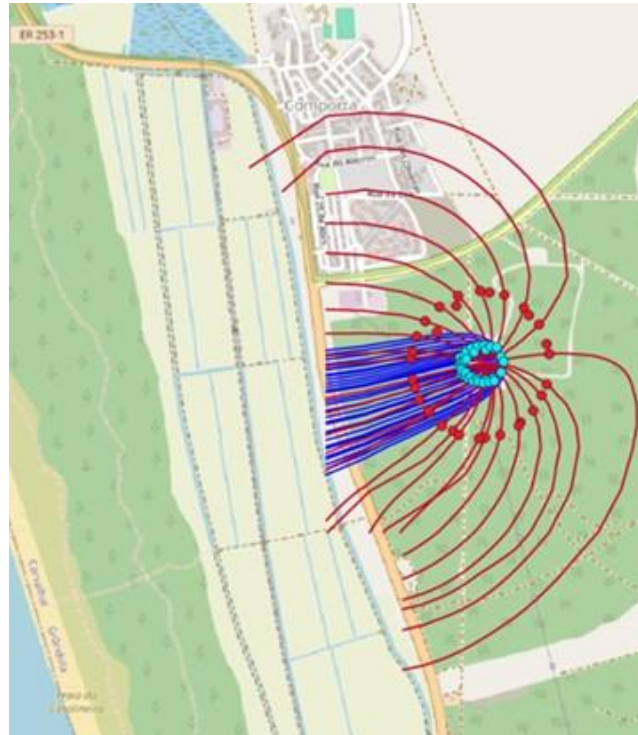
Figure 2.2 Pathlines originating in the infiltration basins towards Vala Real and particles for 1 year travel time (blues = current average infiltration rate, reds = maximum infiltration rate) (Leitão et al., 2024)

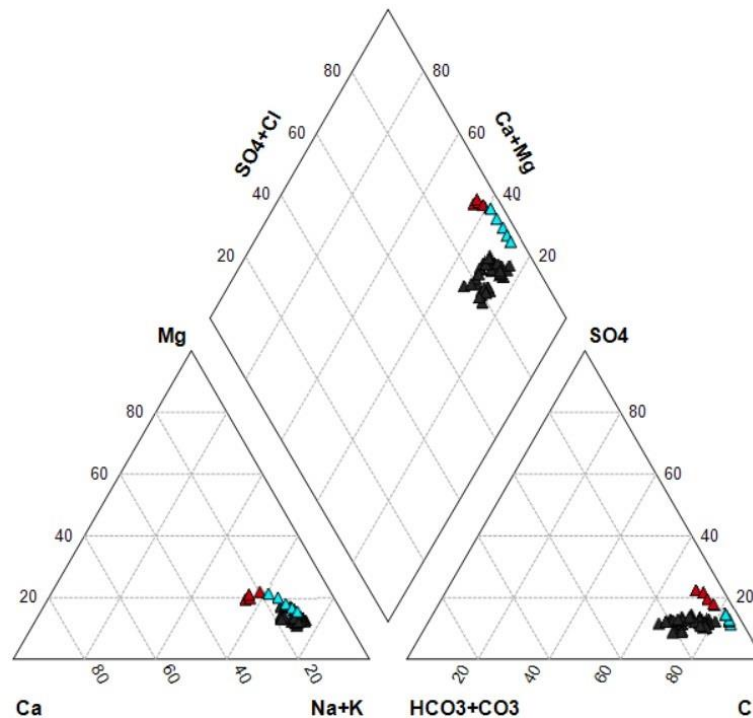
Figure 2.3 Piper diagram showing in red the projected values until December 2021, in blue the transition period, and in black the more recent values

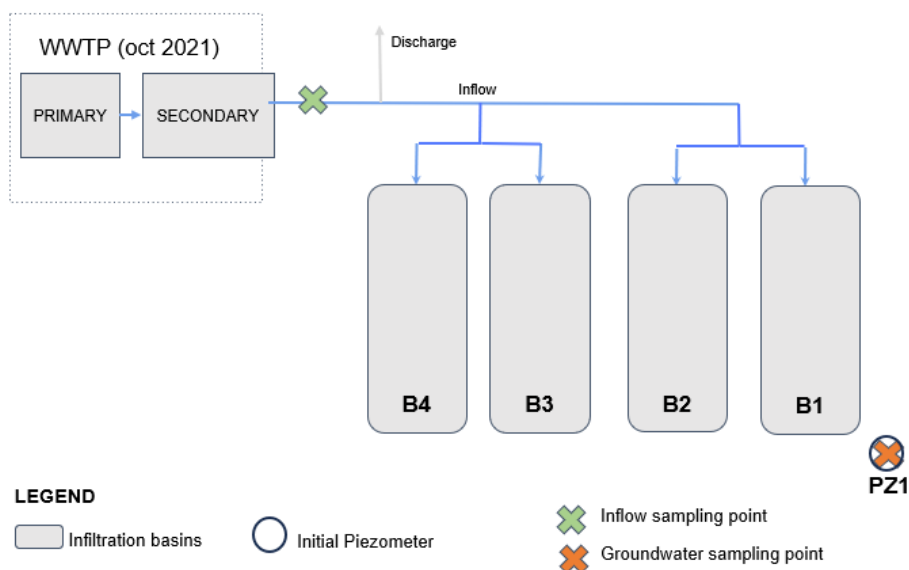
Figure 2.4 Comporta WWTP\_SAT-MAR system initial schema and sampling points

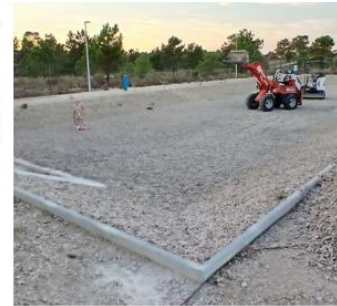
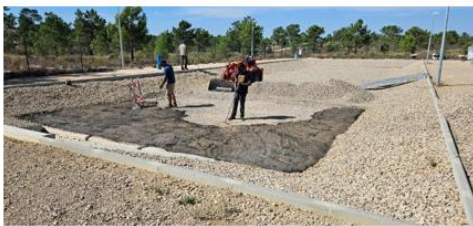
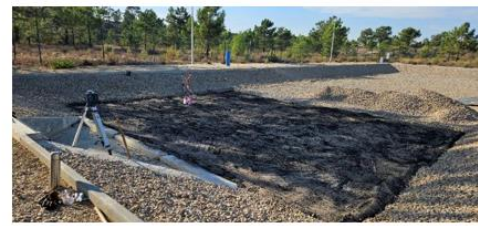
Figure 2.5 Aspects of the placement of the two reactive organic layers in Basins 1 and 2, at Comporta WWTP\_SAT-MAR

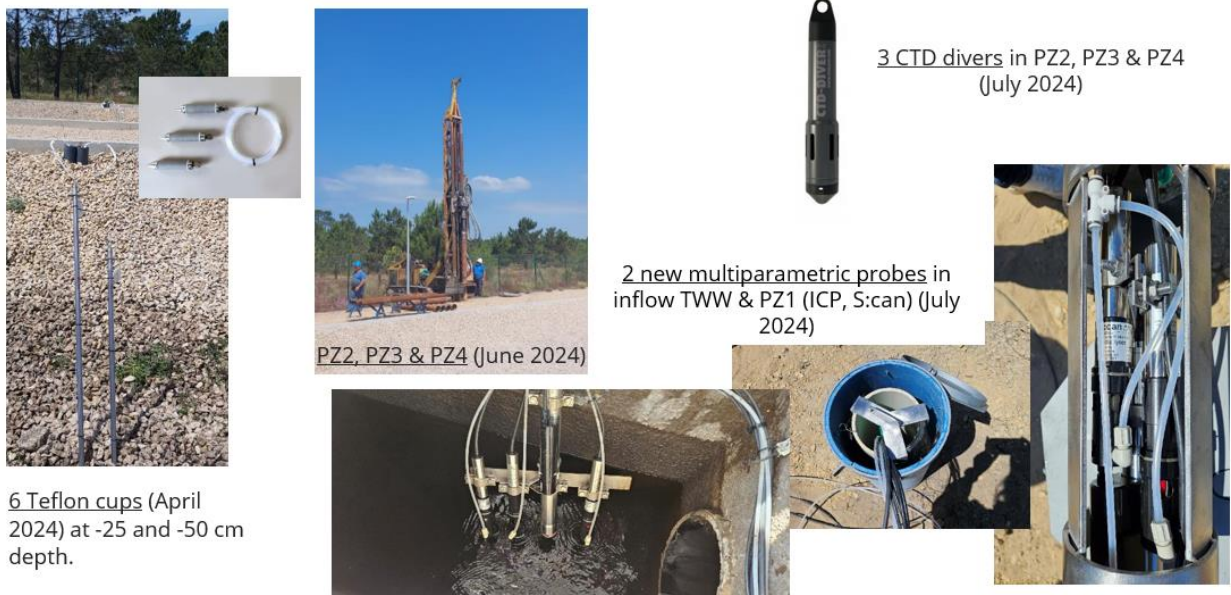
Figure 2.6 Monitoring and sampling equipment installed under MARCLAIMED at Comporta WWTP\_SAT-MAR

To evaluate the system's performance, and to understand the risk of groundwater contamination resulting from SAT-MAR, the following set of infrastructures were installed (Figure 2.6 and Figure 2.7):

- Vadose zone: in April 2024, two Teflon cups were installed at depths of -25 cm and -50 cm in each of the B1, B2, and B4 basins, totalling six cups overall.
- Groundwater: in June 2024, AgdA has provided budget for the installation of three new piezometers (PZ2, PZ3 & PZ4, the latter being the reference situation), drilling up to 12 m depth, with PVC casing until 10 m. The piezometers have been isolated from the surface until about 4 m depth.

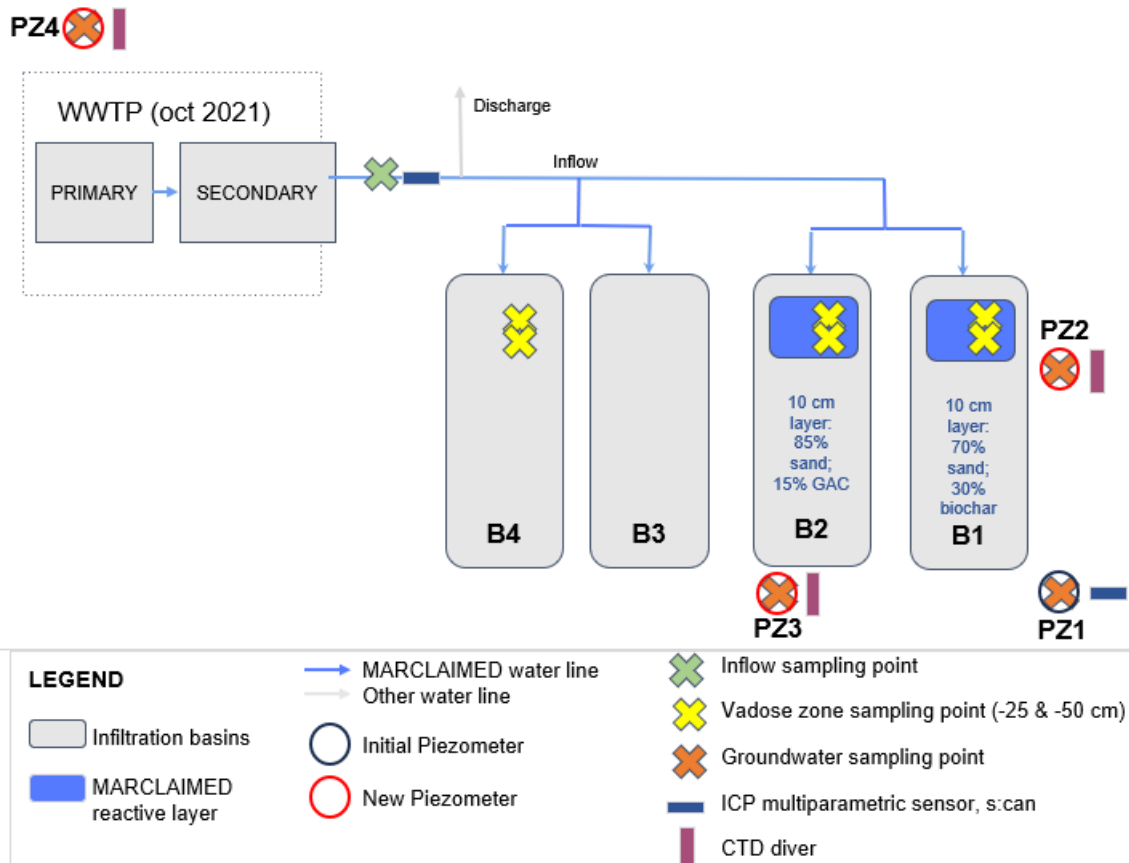
Figure 2.7 Comporta WWTP\_SAT-MAR schema and current infrastructures installed under MARCLAIMED

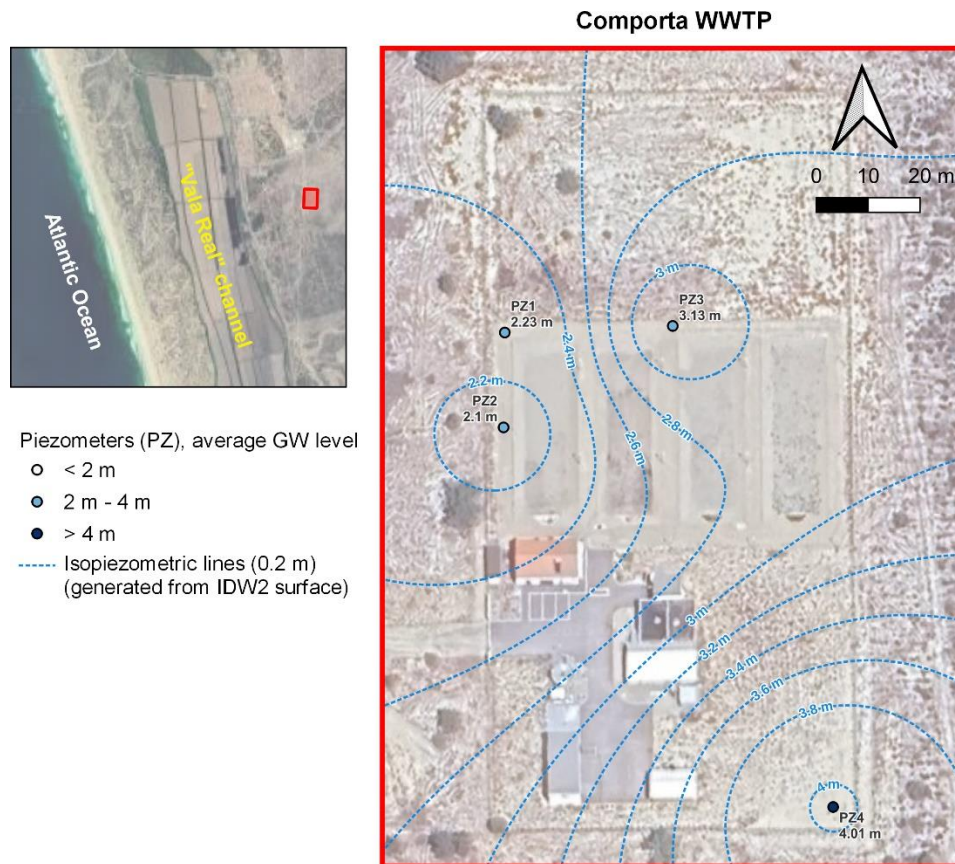
Figure 2.8 Average groundwater level distribution at the Comporta WWTP site, interpolated with IDW2

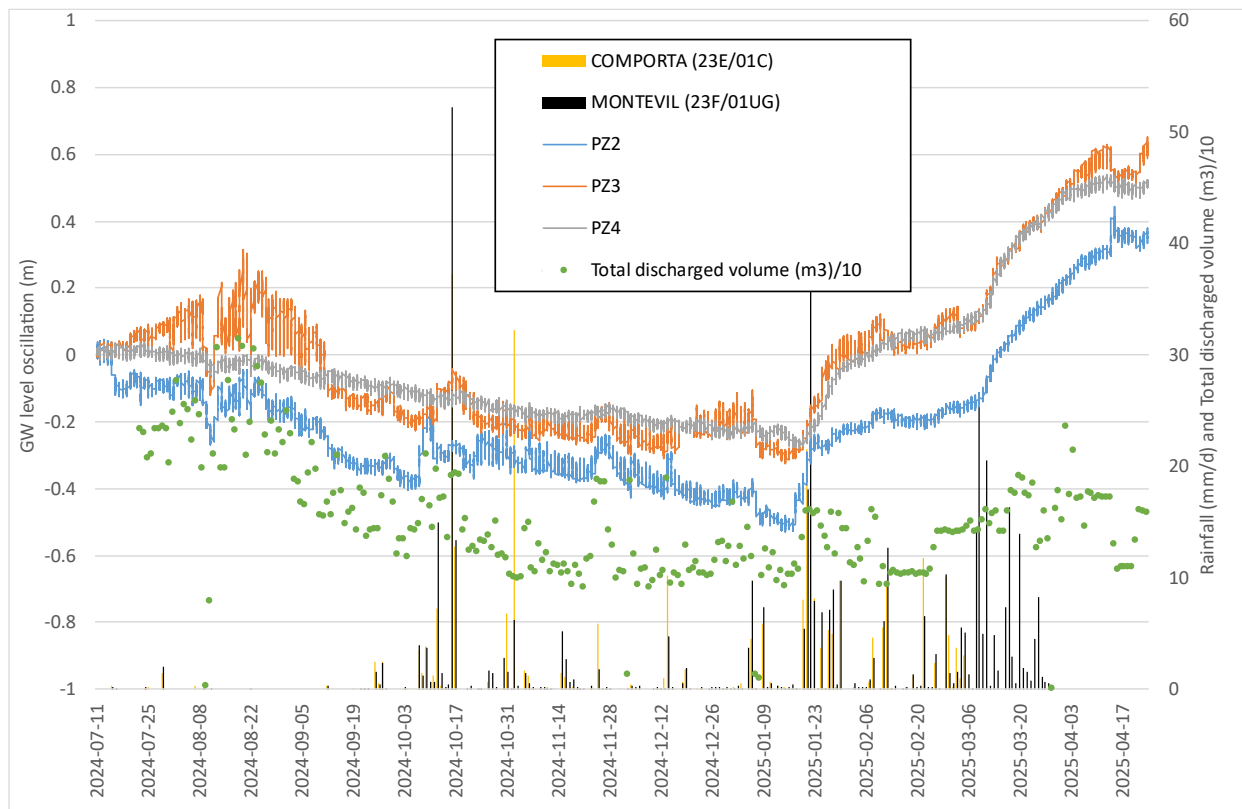
Figure 2.9 GW level oscillation (CDT divers), Rainfall (SNIRH, 2025) & TWW discharges (SCADA sensors)

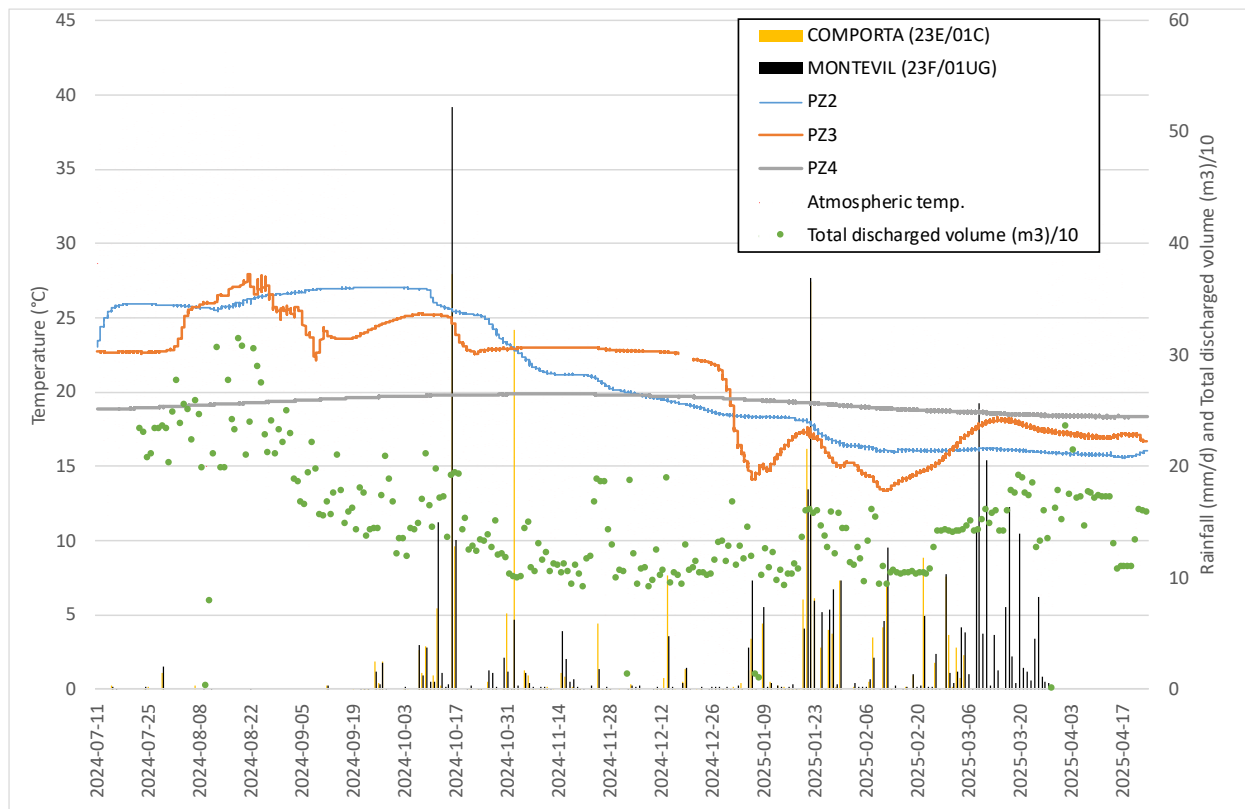
Figure 2.10 Temporal variation of groundwater temperature (CDT divers), rainfall (SNIRH, 2025), and TWW discharge (SCADA sensors)

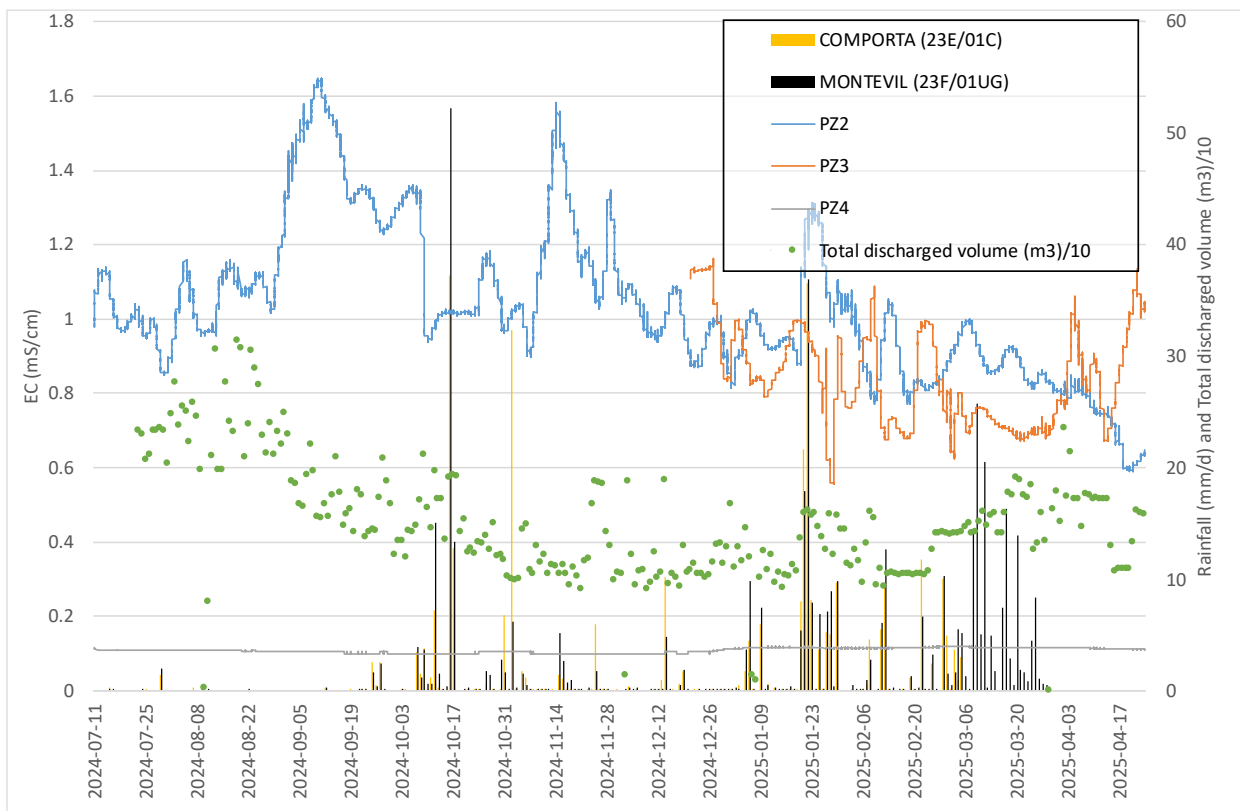
Figure 2.11 Temporal variation of groundwater electrical conductivity (EC) (CDT divers), rainfall (SNIRH, 2025), and TWW discharge (SCADA sensors) highlighting recharge-related dilution events

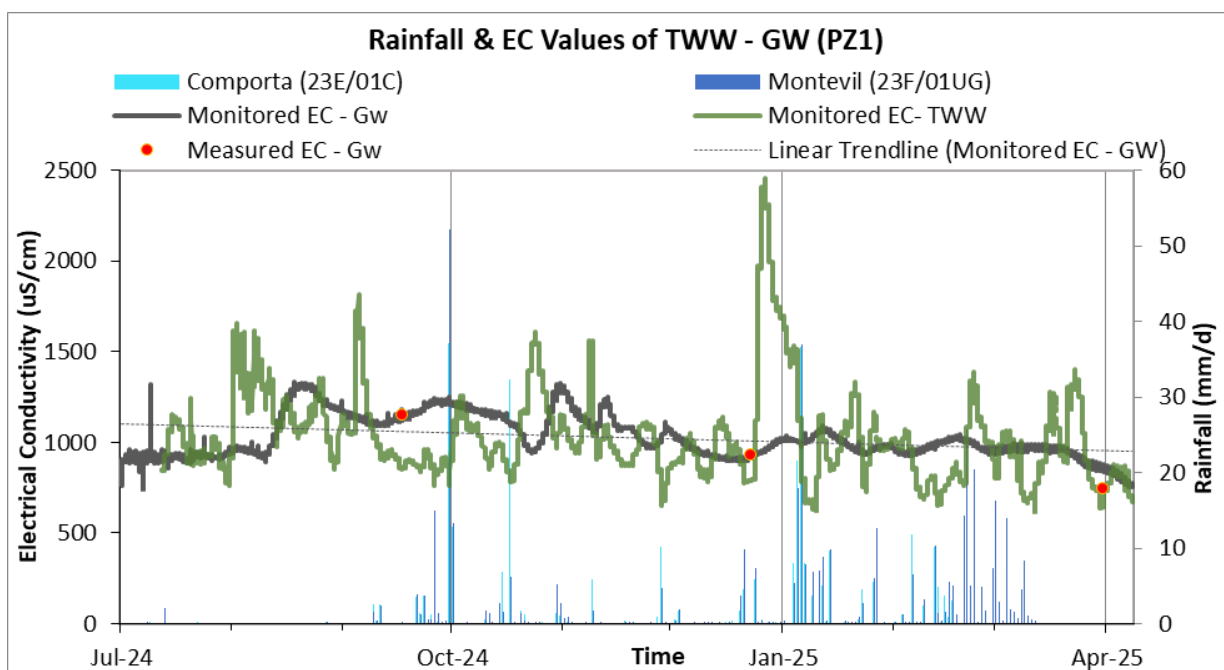
Figure 2.12 Rainfall & EC in TWW and GW (PZ1) continuously monitored using the S::can probe at Comporta WWTP. Manually measured values from previous sampling campaigns included

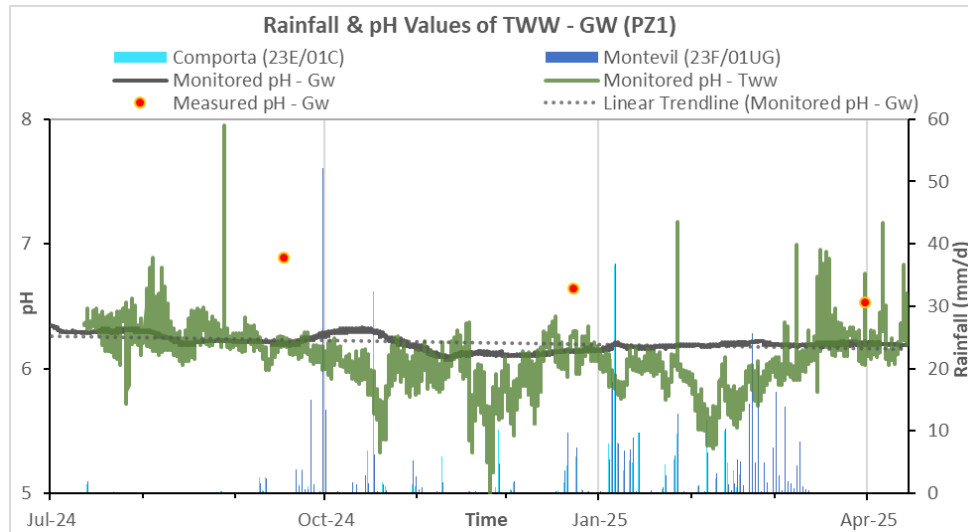
Figure 2.13 Rainfall & pH in TWW and GW (PZ1) continuously monitored using the S::can probe at Comporta WWTP. Manually measured values from previous sampling campaigns included

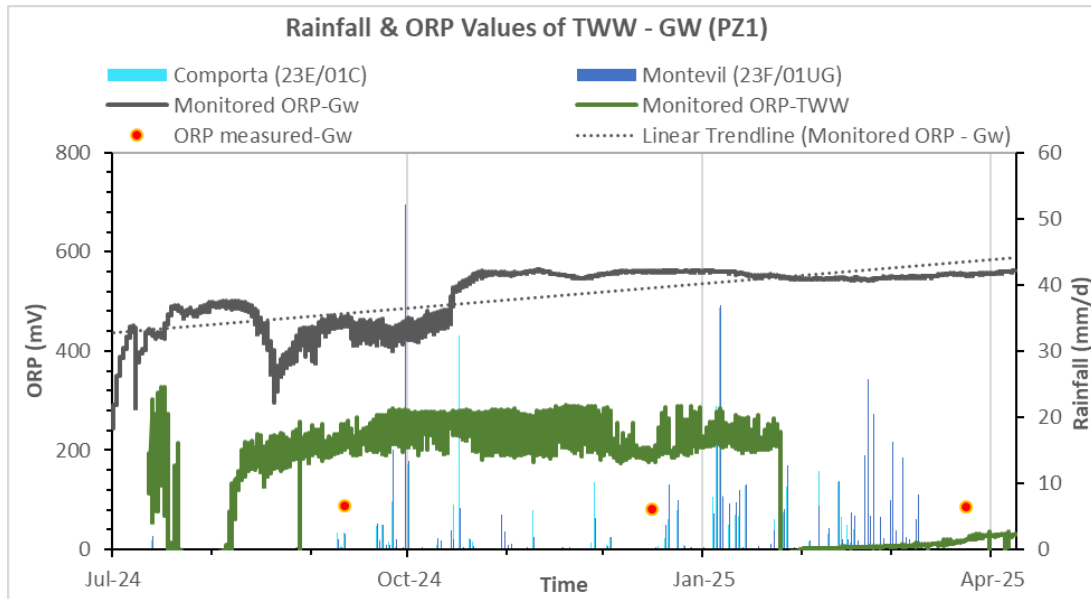
Figure 2.14 Rainfall & ORP in TWW and GW (PZ1) continuously monitored using the S::can probe at Comporta WWTP. Manually measured values from previous sampling campaigns included
