# MARCLAIMED

Progress Report Demo Sites

Deliverable D4.3

WP4: CoPs-Based Implementation and Validation at the Demo Sites

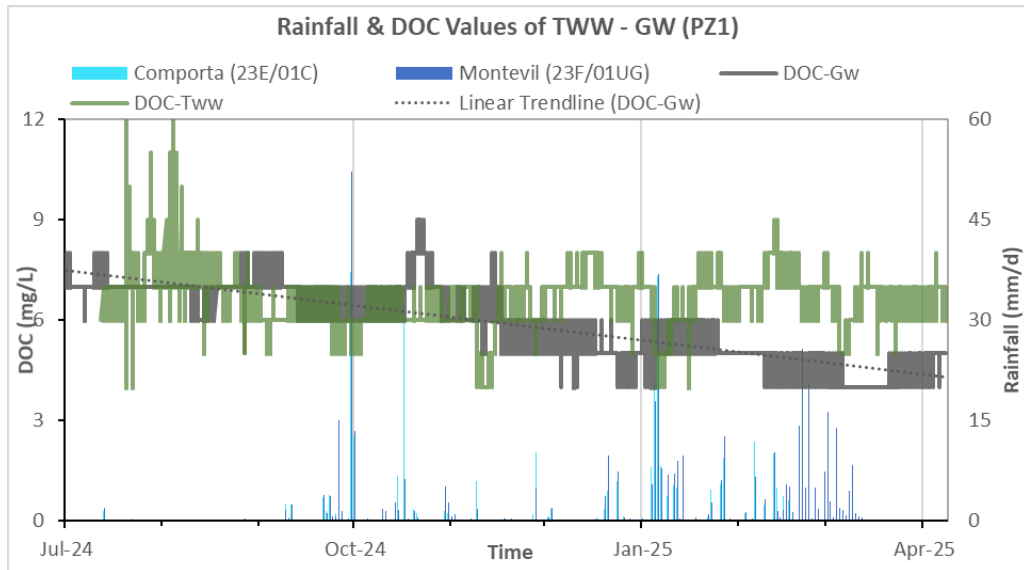
Figure 2.15 Rainfall & DOC in TWW and GW (PZ1) continuously monitored using the S::can probe at Comporta WWTP

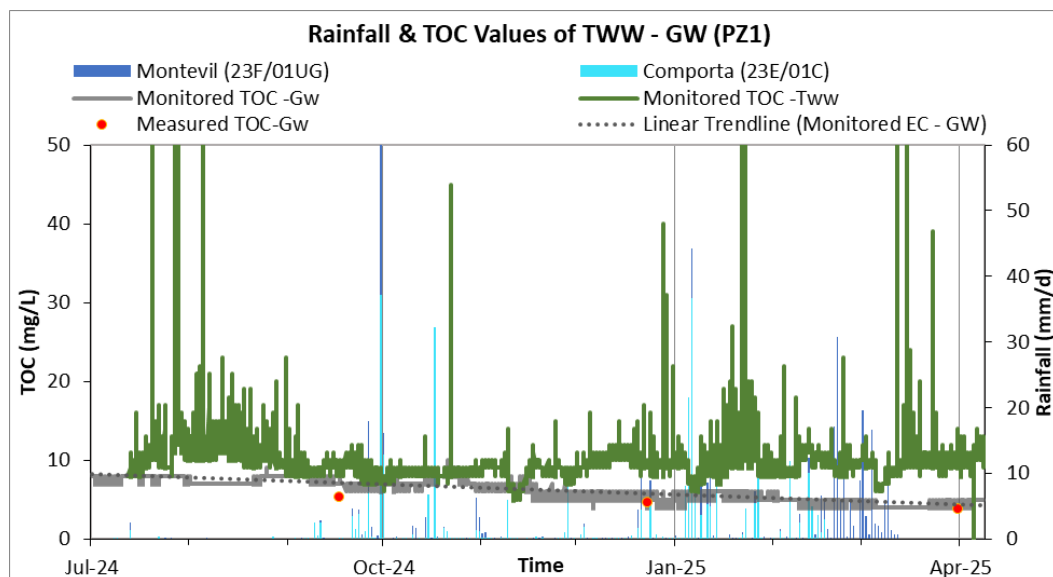
Figure 2.16 Rainfall & TOC in TWW and GW (PZ1) continuously monitored using the S::can probe at Comporta WWTP. Additionally, manually measured values included for each sampling campaign at Comporta WWTP

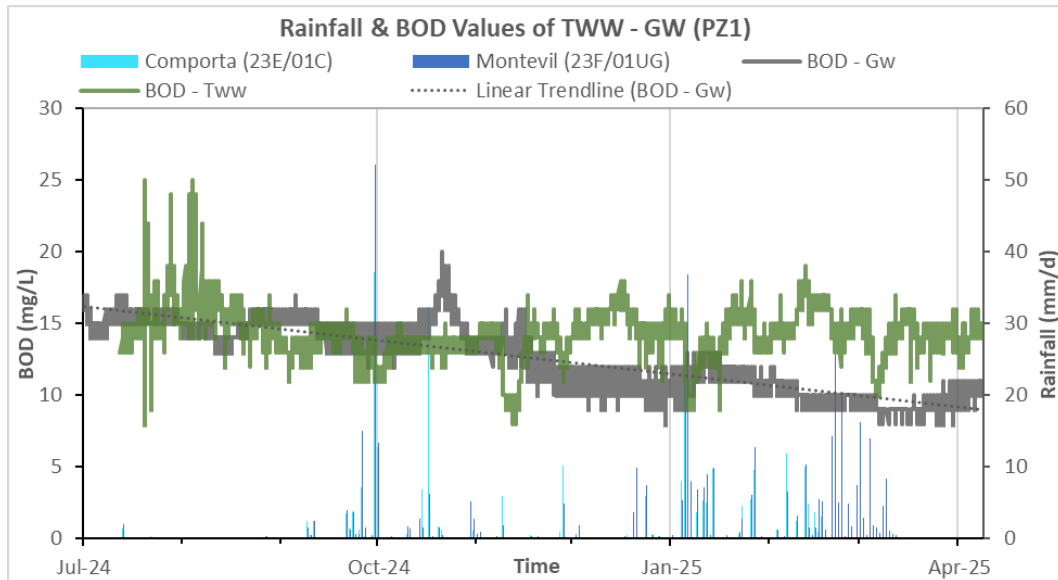
Figure 2.17 Rainfall & BOD<sub>5</sub> in TWW and GW (PZ1) continuously monitored using the S::can probe at Comporta WWTP

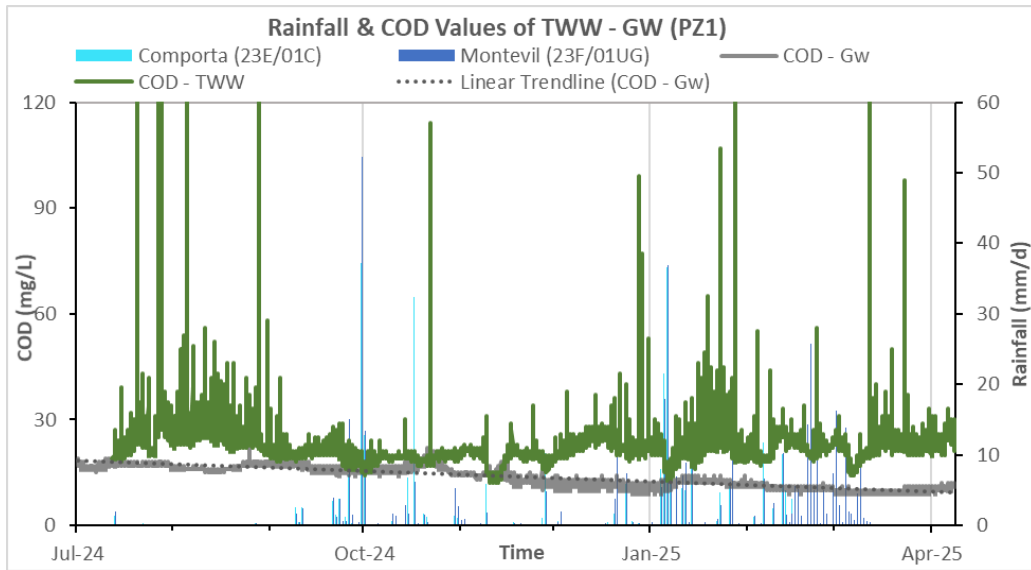
Figure 2.18 Rainfall & COD in TWW and GW (PZ1) continuously monitored using the S::can probe at Comporta WWTP

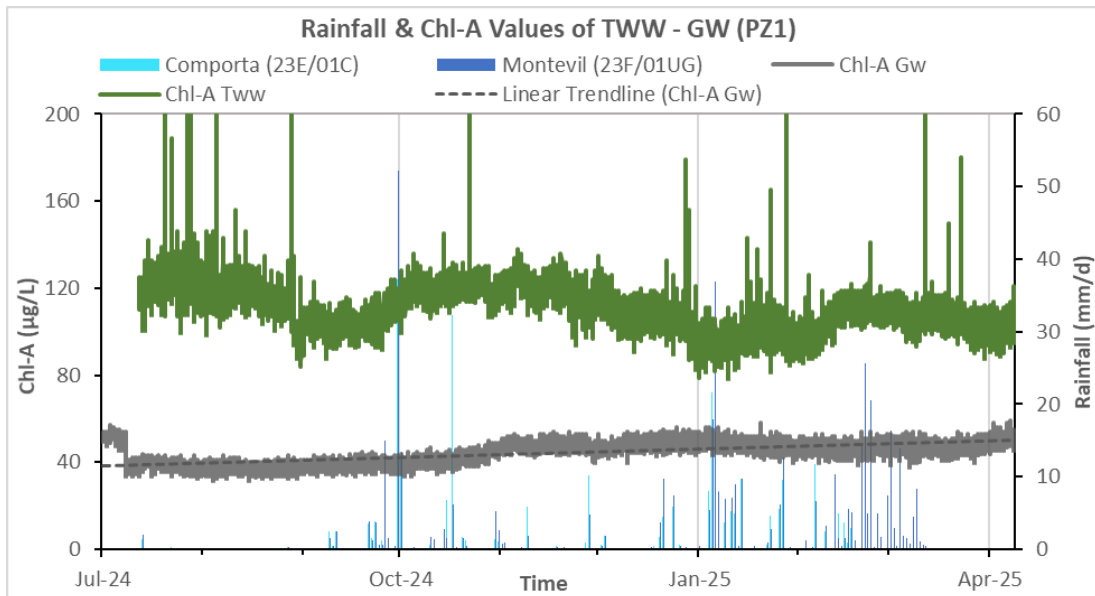
Figure 2.19 Rainfall & Chl-A in TWW and GW (PZ1) continuously monitored using the S::can probe at Comporta WWTP

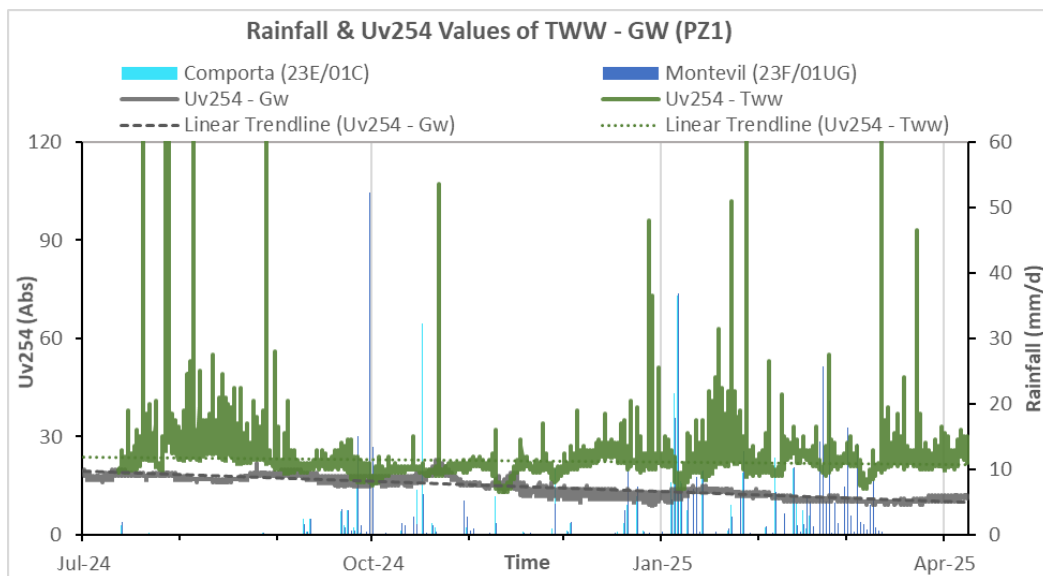
Figure 2.20 Rainfall & Uv254 in TWW and GW (PZ1) continuously monitored using the S::can probe at Comporta WWTP

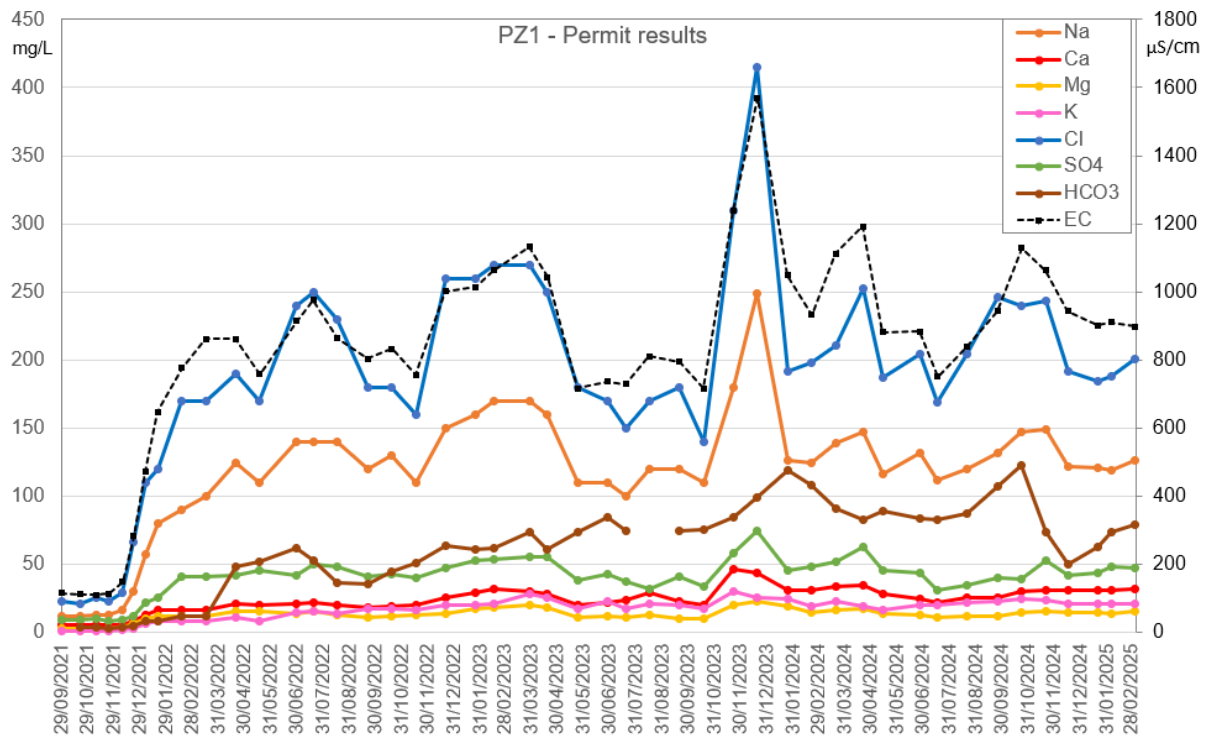
Figure 2.21 Major ions concentrations and EC values in PZ1

Consistently with what was referred in section 2.3, a clear shift could be seen in the groundwater facies of PZ1<sup>1</sup> after a couple of months of the WWTP working, mainly as a result of the contribution of  $\text{Cl}^-$ ,  $\text{Na}^+$ , and  $\text{HCO}_3^-$  (Figure 2.21). The EC values in the groundwater reflect mainly  $\text{Cl}^-$  and  $\text{Na}^+$  concentrations, having also contributions from all other ion's concentrations.

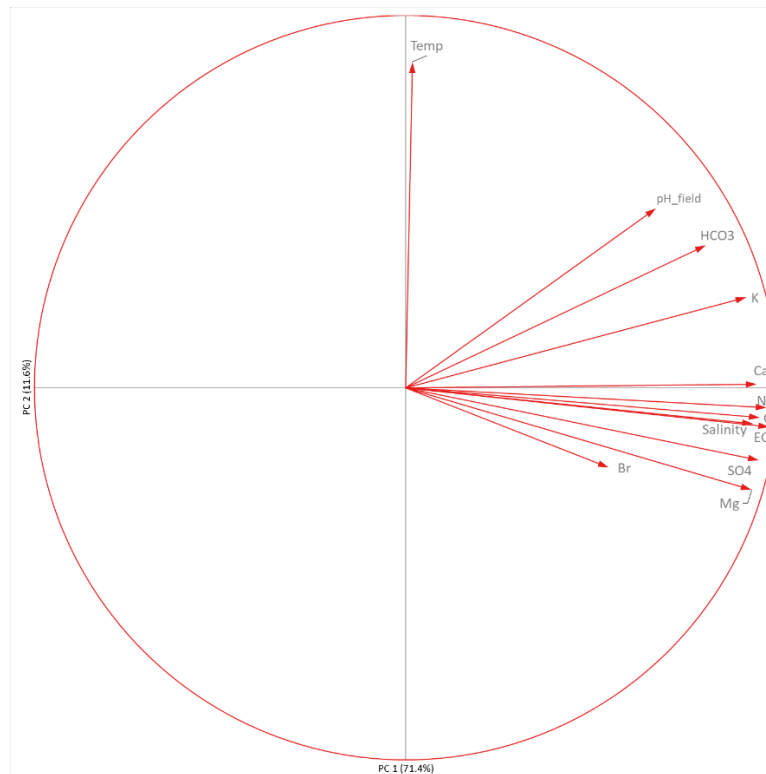
Figure 2.22 PCA analysis with the main groundwater quality characteristics at PZ1

A Principal Components Analysis (PCA) was run to help visualizing possible relations (in a monoplots) between variables, reducing the dimensionality of the data. The results are shown in Figure 2.21.

One can see that the 1<sup>st</sup> PC explains the majority (71.4%) of the total variance of the dataset, and the second category of water samples contributing 85.7% of the variance cumulatively. The elements belonging to the same PC, with close component quadrant vectors, suggest that the variables are correlated and derive from a common origin (TWW). All variables but Br have a good representation (cf. high extension of the arrow).

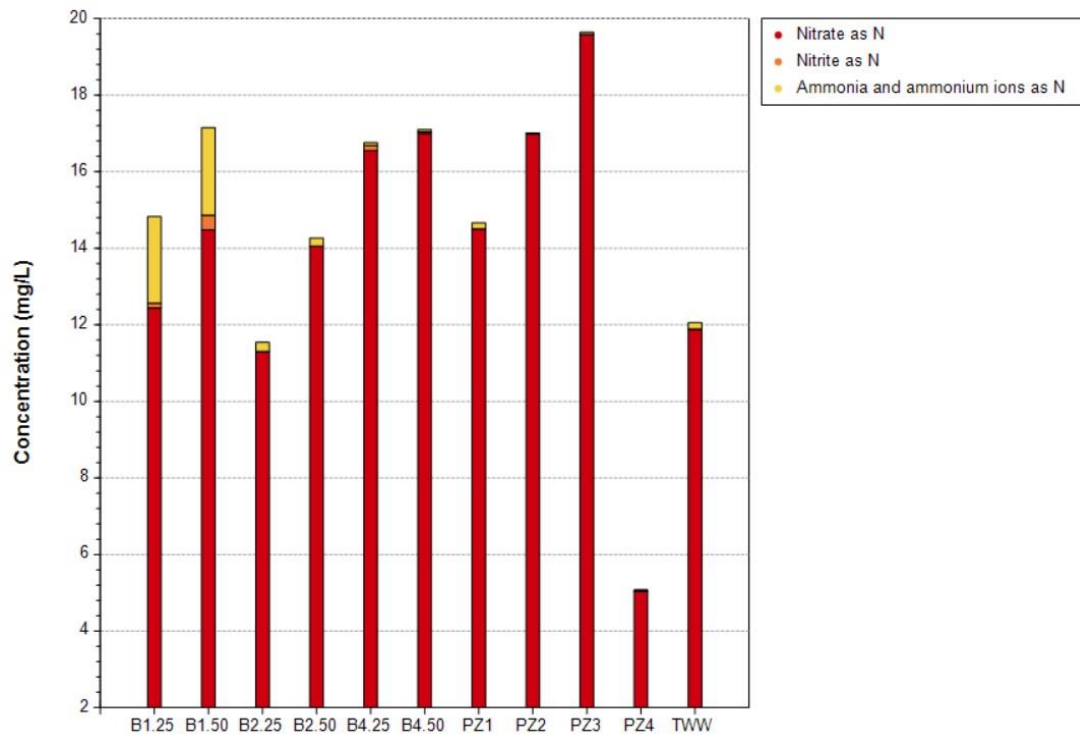
Figure 2.23 Sum of N species in the water samples at Comporta WWTP\_SAT-MAR

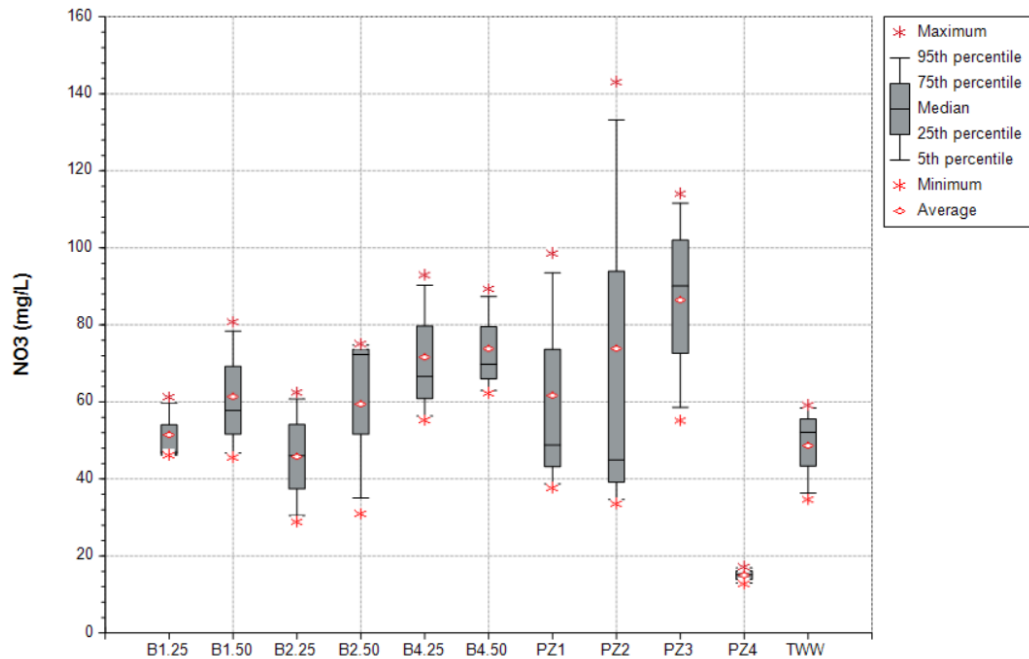
Figure 2.24 Box-plot diagram of the nitrate's concentration in the water samples at Comporta WWTP\_SAT-MAR

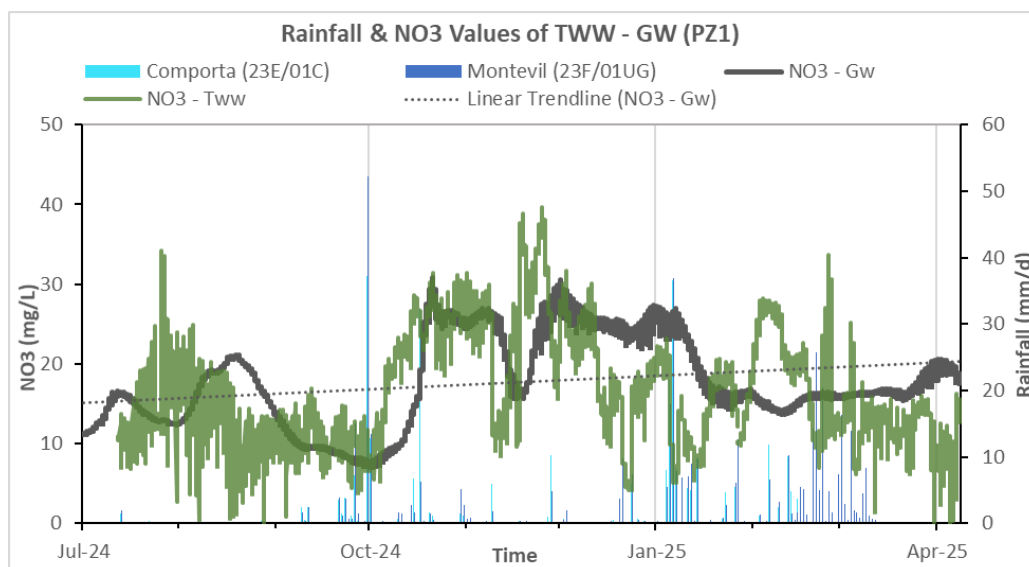
Figure 2.25 Concentration of NO<sub>3</sub><sup>-</sup> (as N) in PZ1 measured in the S::can probe at PZ1

The concentrations of N are very high in the TWW, with values of  $\text{NO}_3^-$  surpassing 50 mg/L (threshold values for groundwater) (Figure 2.24 and Figure 2.25). Furthermore, it is likely that the secondary treated wastewater still contains some dissolved and particulate organic nitrogen. These are not measured as nitrate or ammonium initially but, during infiltration, microbes in the unsaturated zone can mineralize these forms to ammonium, which is then rapidly nitrified to nitrate under aerobic conditions. As a result, the infiltrating water can even gain mobile nitrate during passage through the basins.

Figure 2.25 presents the continuous measurement of nitrates (as N) in TWW and PZ1, which shows clear variations through time. This might reflect periods with some problems in the WWTP.

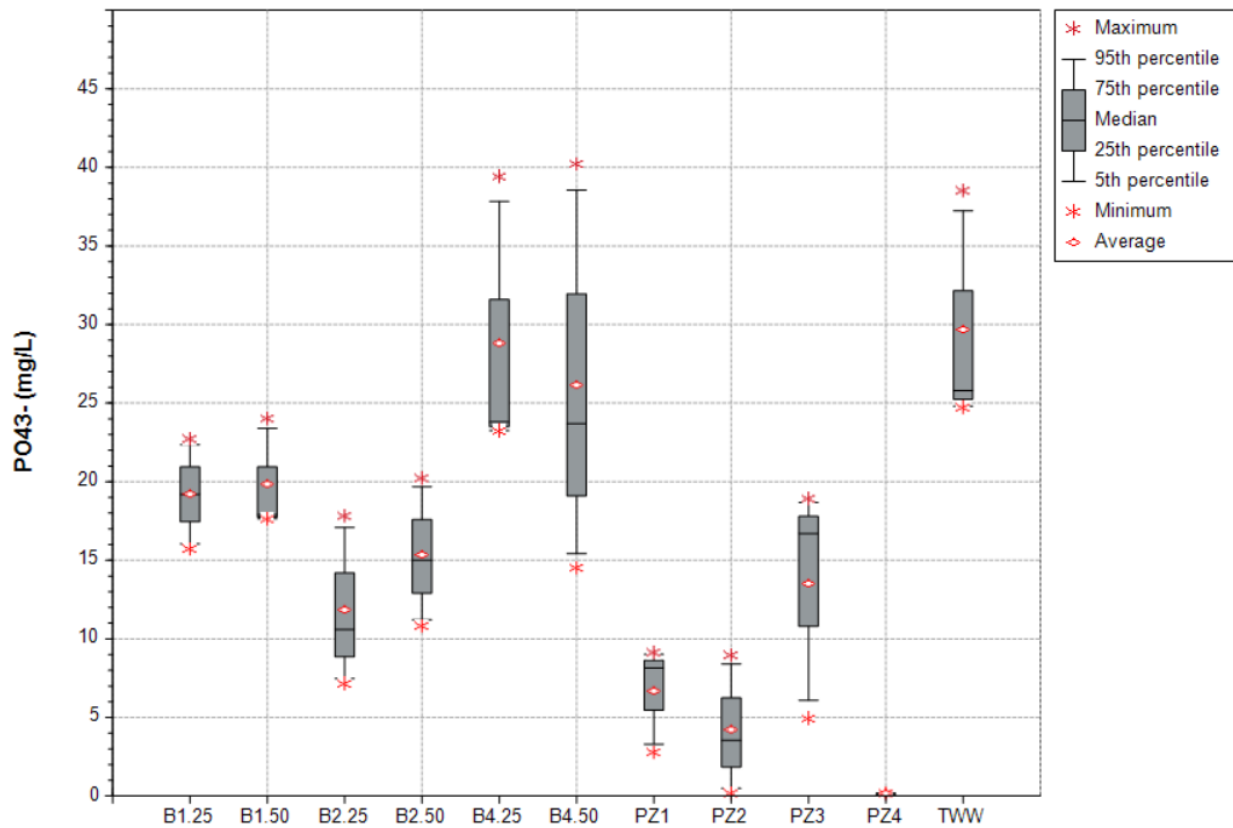
Figure 2.26 Box-plot diagram of the phosphate's concentration in the water samples at Comporta WWTP\_SAT-MAR

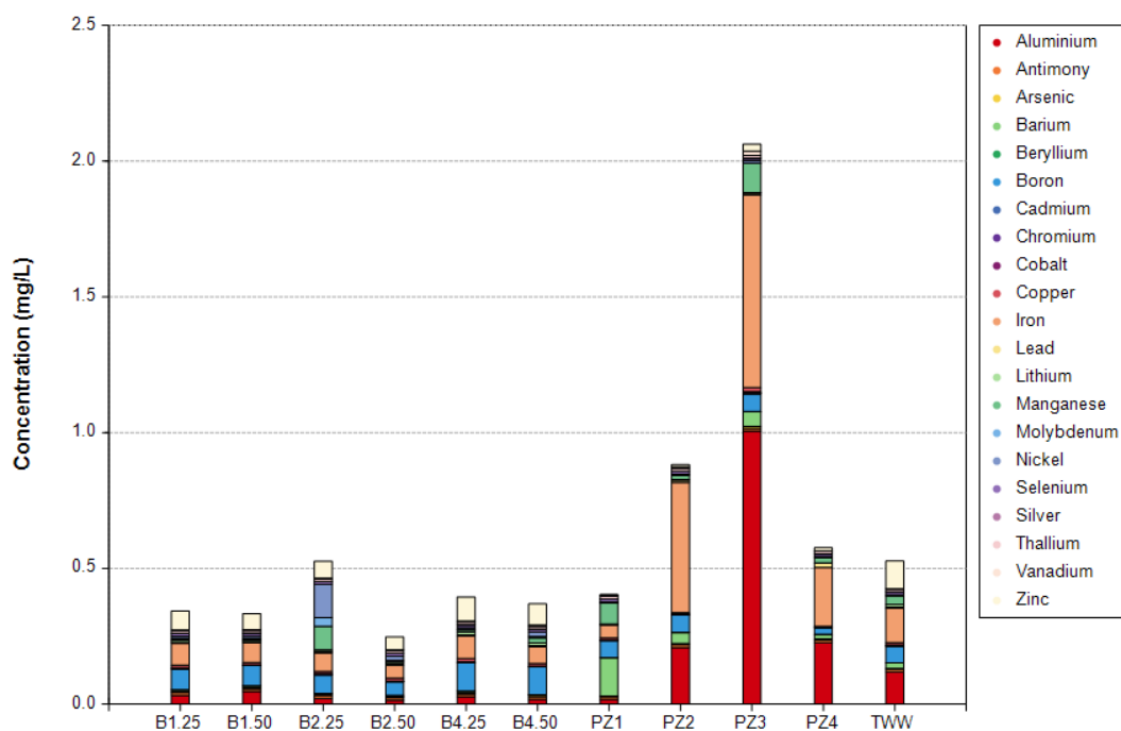
Figure 2.27 Sum of metals and metalloids in the water samples at Comporta WWTP\_SAT-MAR

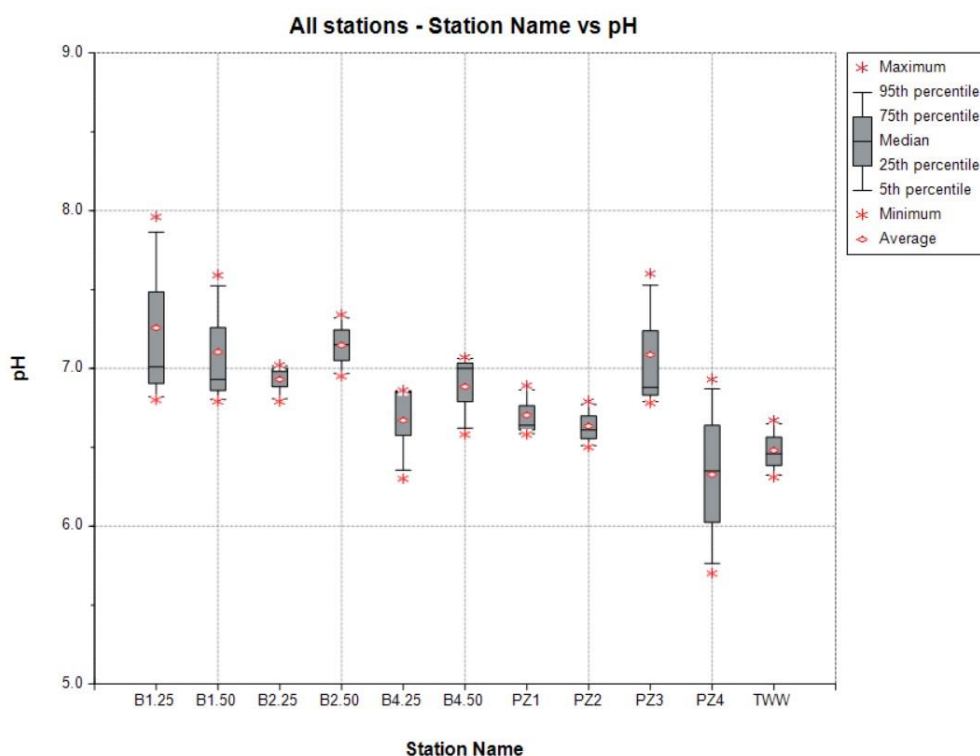
Figure 2.28 Box-plot diagram of the pH values (left) and Redox values (right) in the water samples at Comporta WWTP\_SAT-MAR

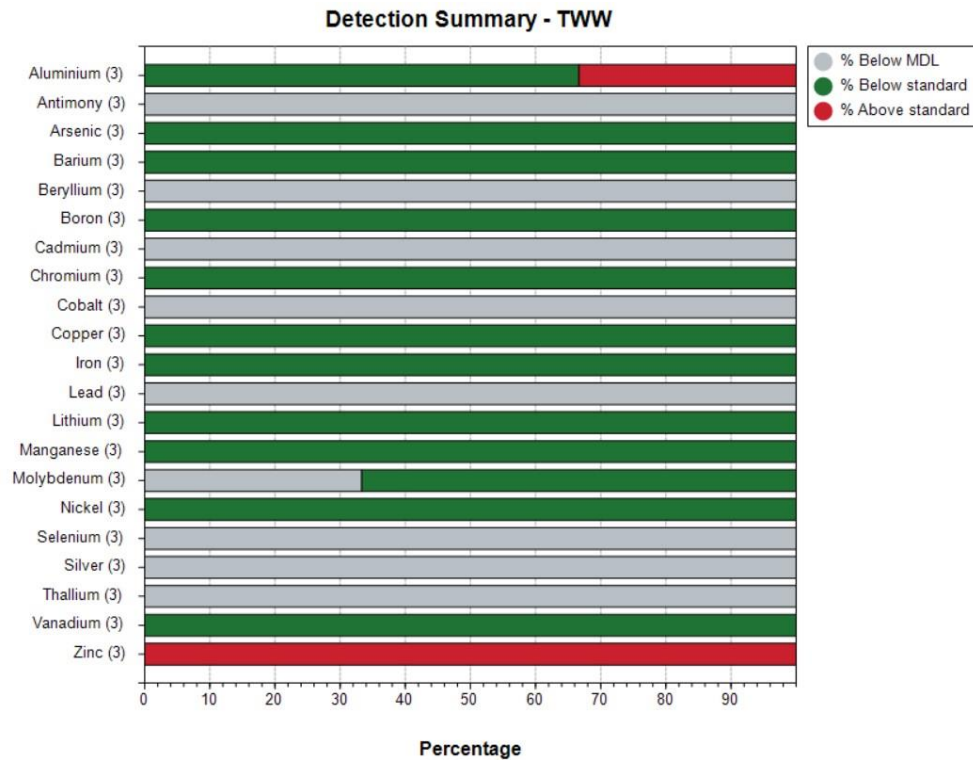
Figure 2.29 Detection summary of the metals and metalloids in the TWW samples analysed at Comporta WWTP\_SAT-MAR

Figure 2.29 presents a detection summary of the metals and metalloids with concentrations in the TWW. From the 21 parameters analysed, eight had concentrations below the Maximum Detection Limit (MDL, also referred in this report as Limit of Detection, LoD), and two had concentrations above the standard. Of the two, only zinc concentrations exceed the standards in the vadose zone, while in the groundwater, it is aluminium that exceeds the standards (Figure 2.30).

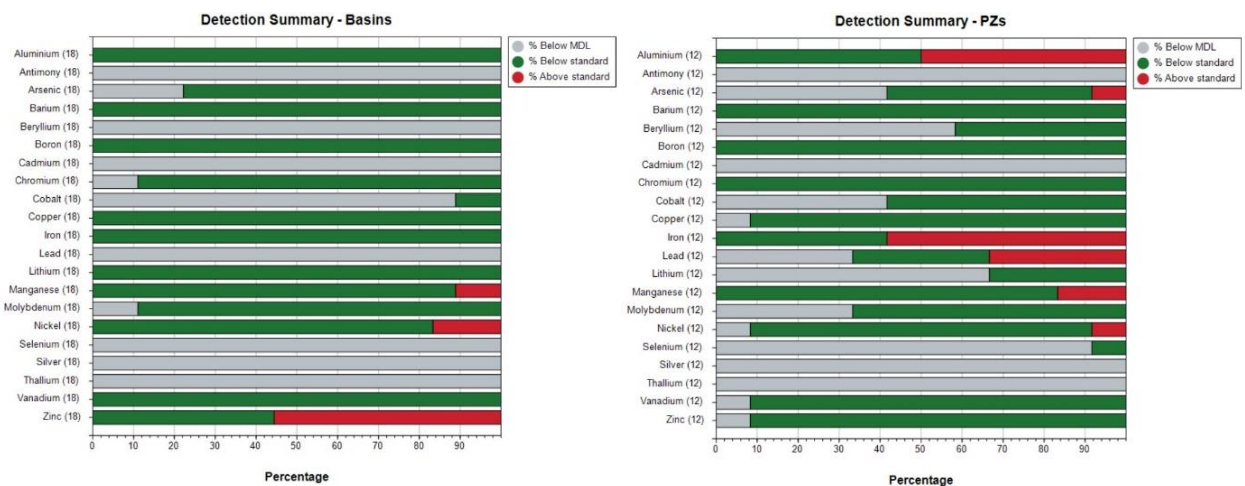
Figure 2.30 Detection summary of the metals and metalloids in the vadose zone (left) and groundwater (right) samples analysed at Comporta WWTP\_SAT-MAR

While the presence of zinc in vadose zone water samples appears to be clearly influenced by the TWW (Figure 2.31), the presence of aluminium and iron in the groundwater (Figure

2.32) is likely due to water percolation and the longer residence time in the sandy aquifer, which contains some clay. Similar graphics could be seen for lead (not presented here).

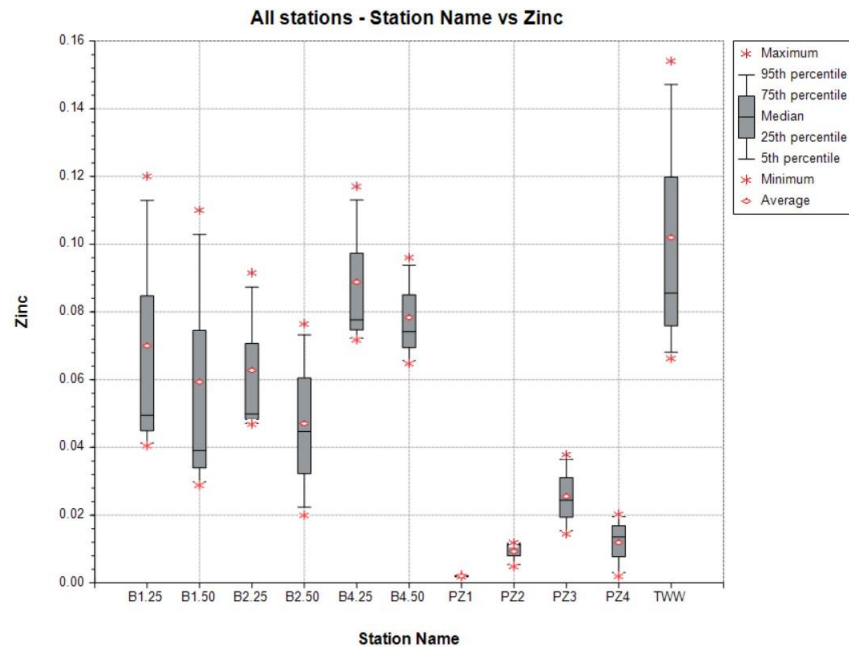
Figure 2.31 Box-plot diagram of the zinc concentrations in the water samples at Comporta WWTP\_SAT-MAR

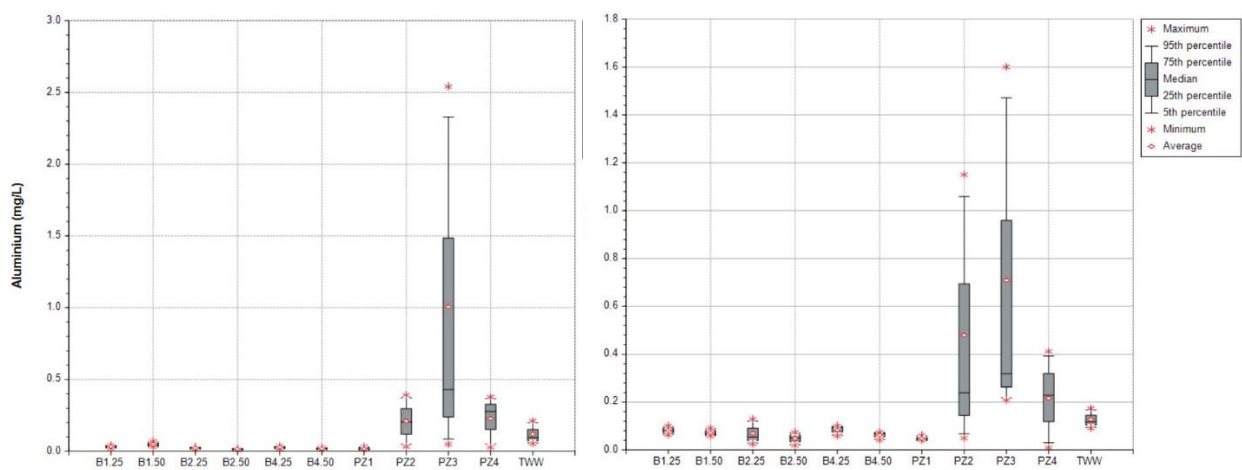
Figure 2.32 Box-plot diagram of the aluminium (left) and iron (right) concentrations in the water samples at Comporta WWTP\_SAT-MAR

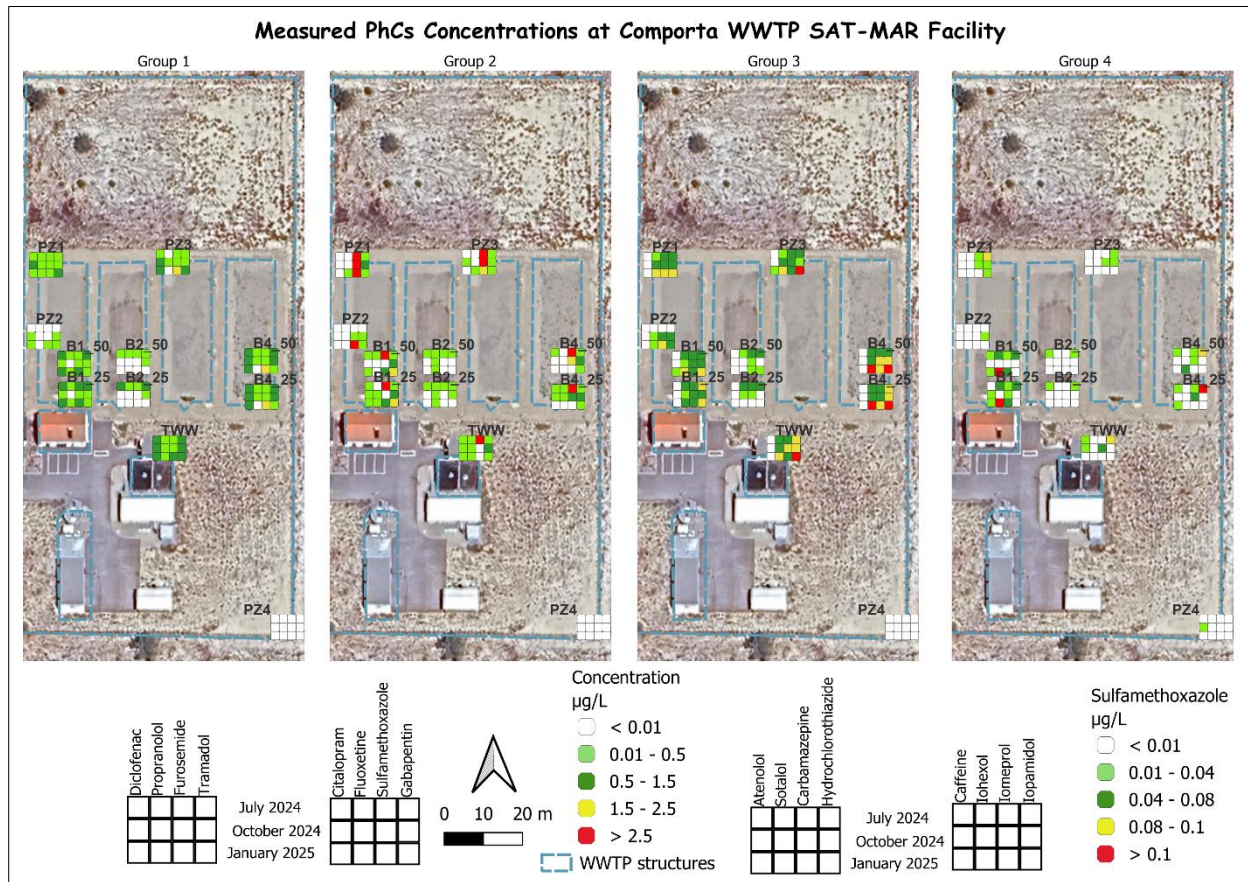
Figure 2.33 Measured Pharmaceutical Compounds (PhCs) concentrations in each sampling point for 3 Different Sampling Campaigns at Comporta WWTP SAT-MAR Facility

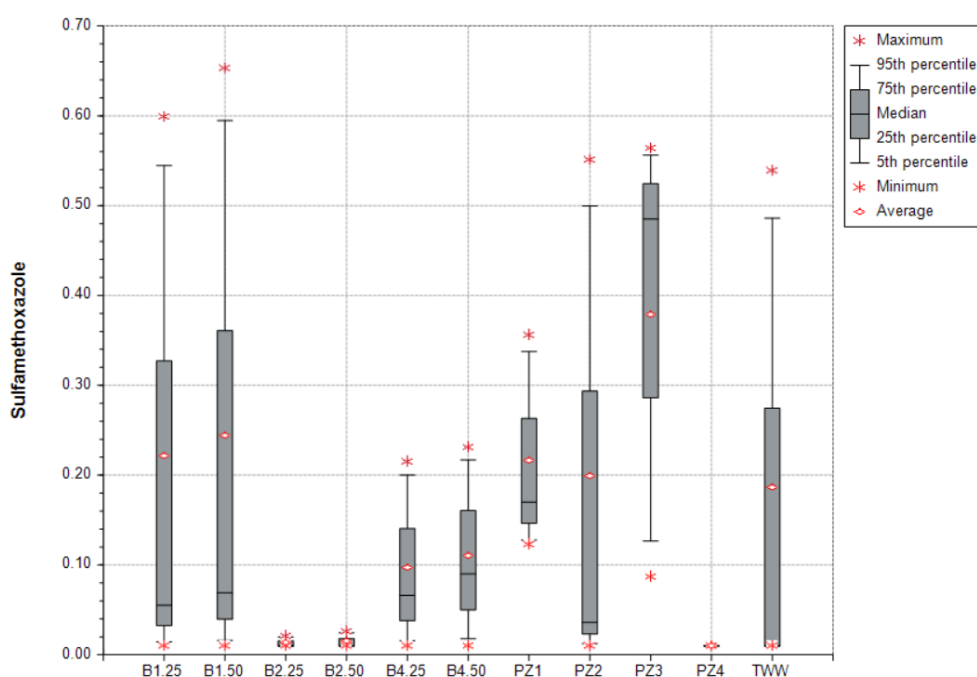
Figure 2.34 Box-plot diagram of the Sulfamethoxazole concentrations in the water samples at Comporta WWTP\_SAT-MAR

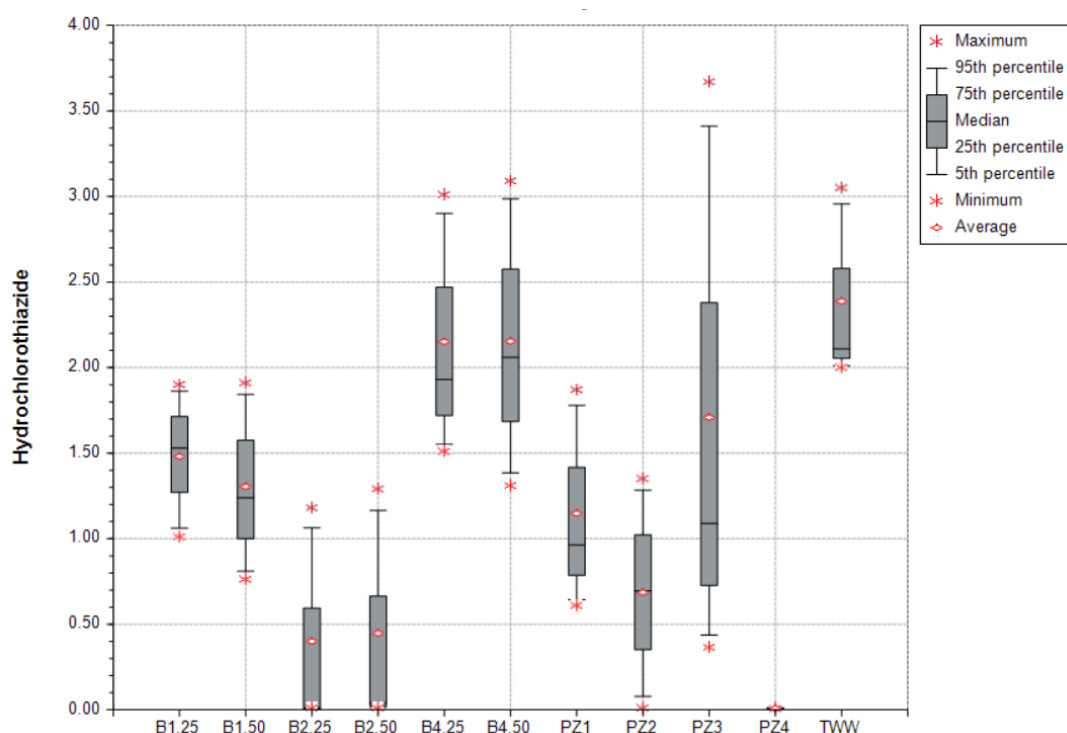
Figure 2.35 Box-plot diagram of the Hydrochlorothiazide concentrations in the water samples at Comporta WWTP\_SAT-MAR

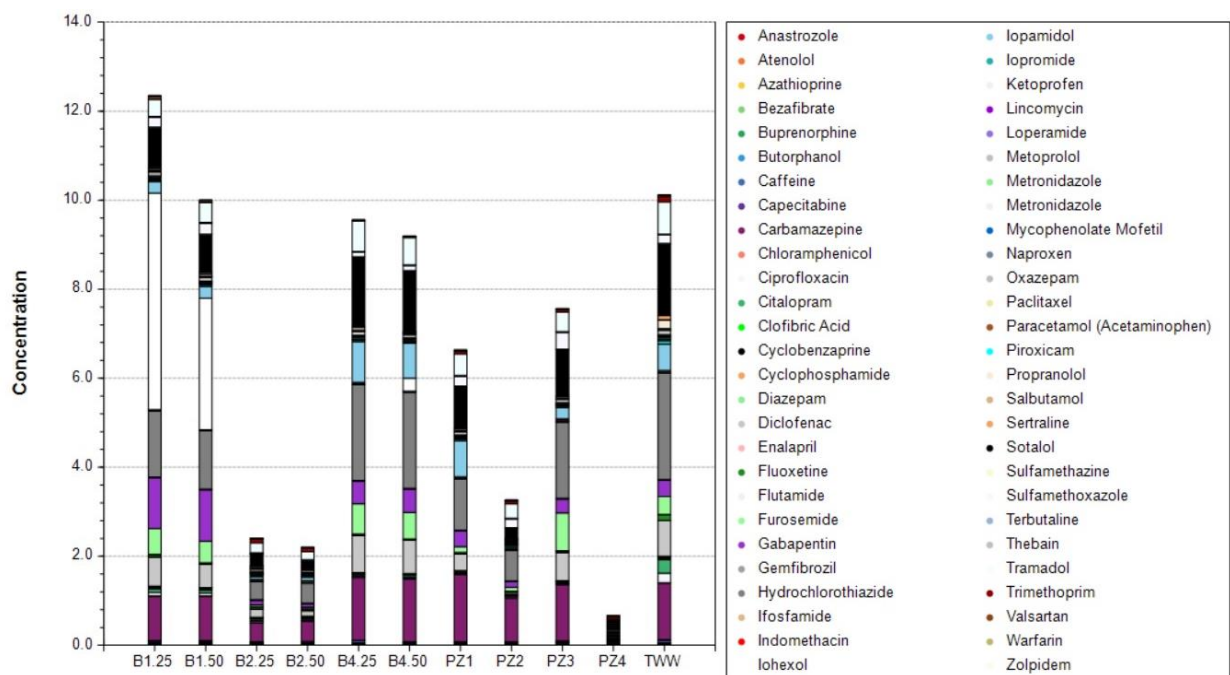
Figure 2.36 Sum of the average concentration of PhCs compounds (µg/L) in the water samples at Comporta WWTP\_SAT-MAR

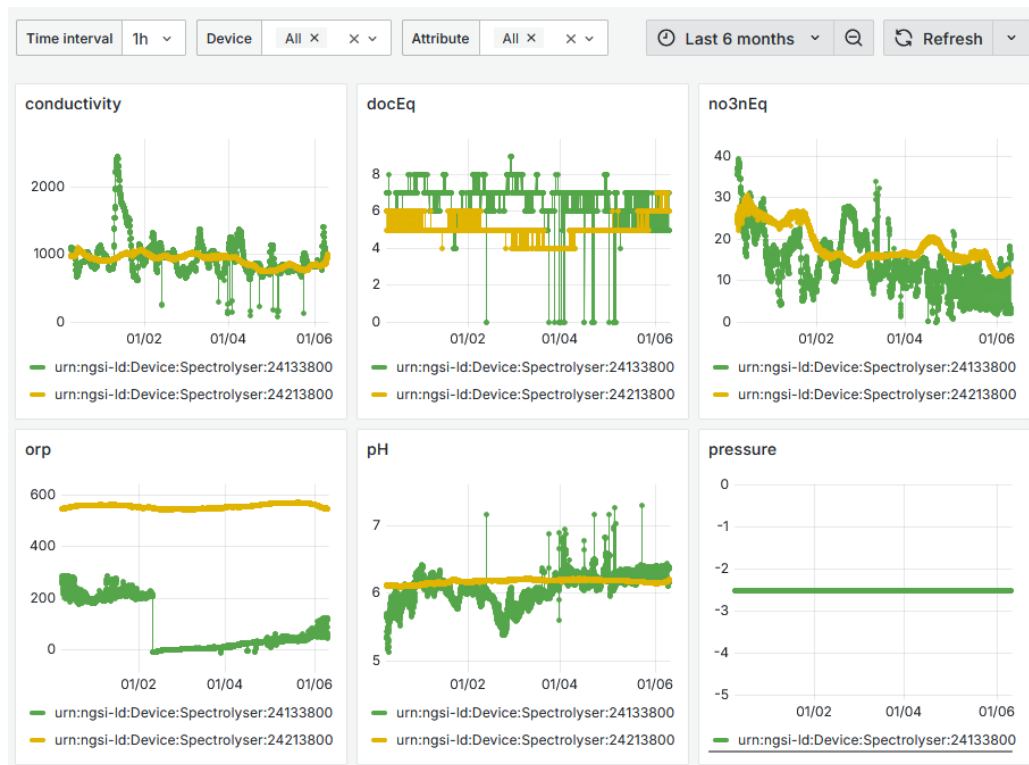
Figure 2.37 Basic dashboard for s::can sensors online analysis

Some simple dashboards were developed and provided for the project's partners to be able to visualize the retrieved data (cf. Figure 2.37 and Figure 2.38). It also includes a dynamic schema of the DS2 infrastructure, which shows the latest measurement of the chosen variable at each of the sensors' / sampling points' locations (cf. Figure 2.39).

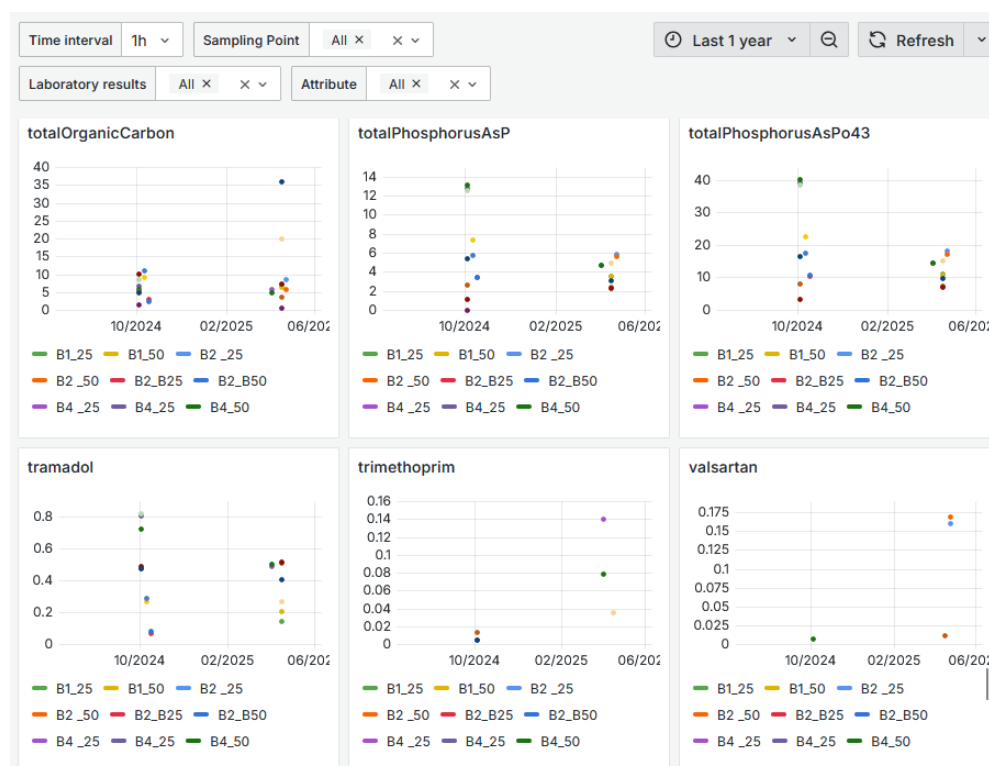
Figure 2.38 Basic dashboard for laboratory results analysis

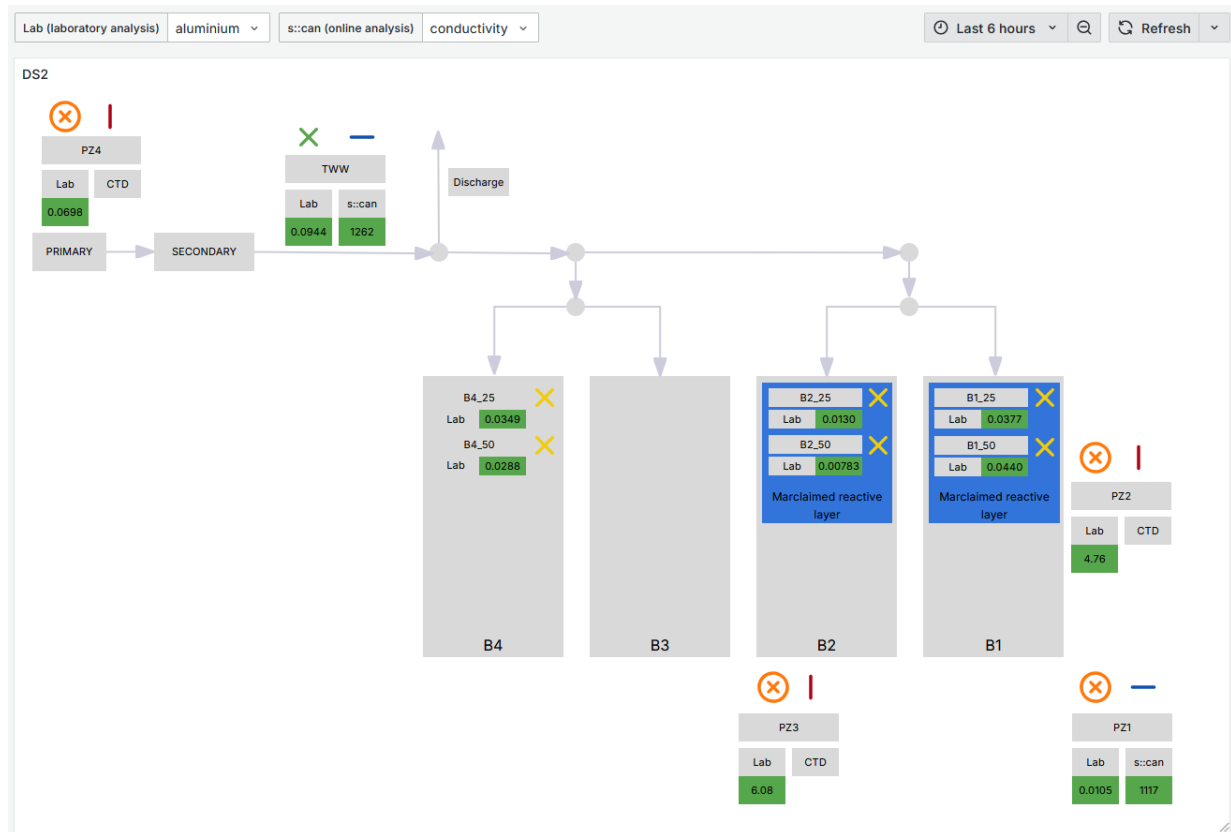
Figure 2.39 Dynamic schema of the DS2 infrastructure with example of the results

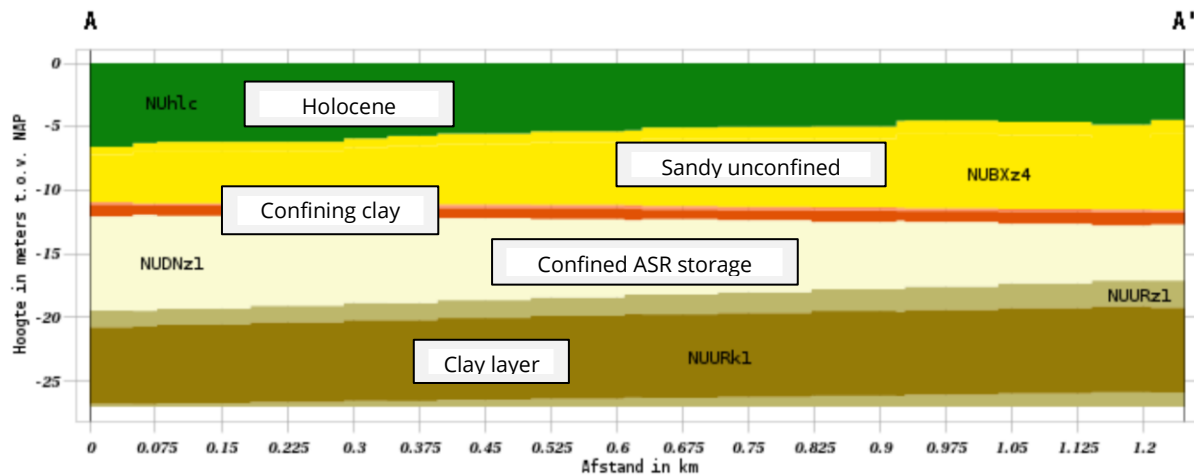
Figure 3.2. Soil layers at DS3 from 0 to -27 m bgl in a ~1.2 km cross section. Source: TNO – GDN, 2025

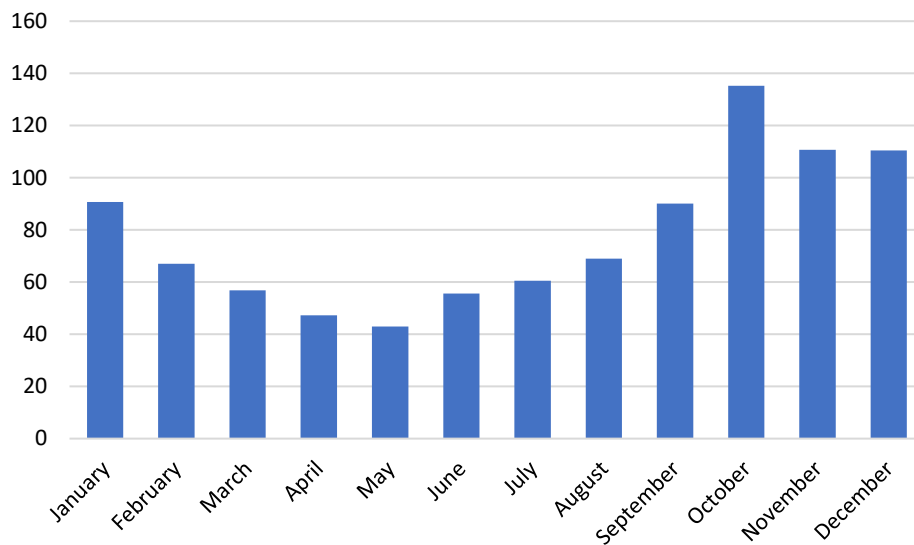
Figure 3.3. Mean monthly precipitation, Den Burg, NL, 1991-2023. Source: KNMI

Texel's climate is characterized by mild summers with average maximum temperatures of 20 °C and relatively mild winters with average maximum temperatures of 6-7 °C. Rainfall is highest in October and November and lowest in April and May (Figure 3.3). The mean annual rainfall is approximately 700 to 900 mm.

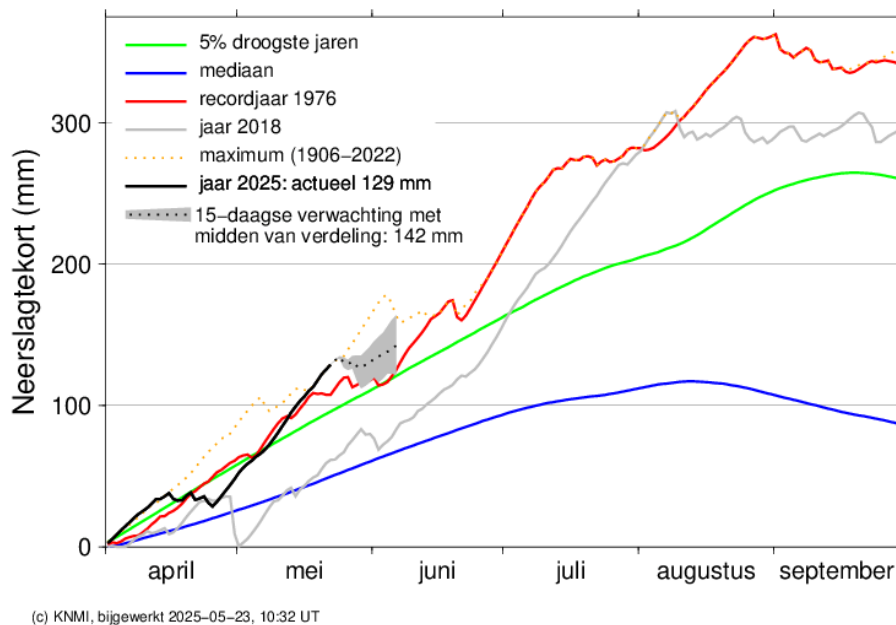
Figure 3.4. Precipitation deficit in The Netherlands in 2025 in mm, averaged over 13 stations. 5% driest years (green), median (blue), record dry year 1976 (red), very dry year 2018 (grey), maximum precipitation deficit 1906-2022 (orange dashed), year 2025 (black), and 15-day predicted deficit with an average of 142 mm (grey shaded)

From December 2024 through May 2025, the Netherlands experienced the driest winter and spring since 1976. The precipitation deficit, or the difference between precipitation and evaporation, was up to 129 mm on 23 May (Figure 3.4) (KNMI, 2025). This drought was especially pronounced on the western half of the country, including Texel.

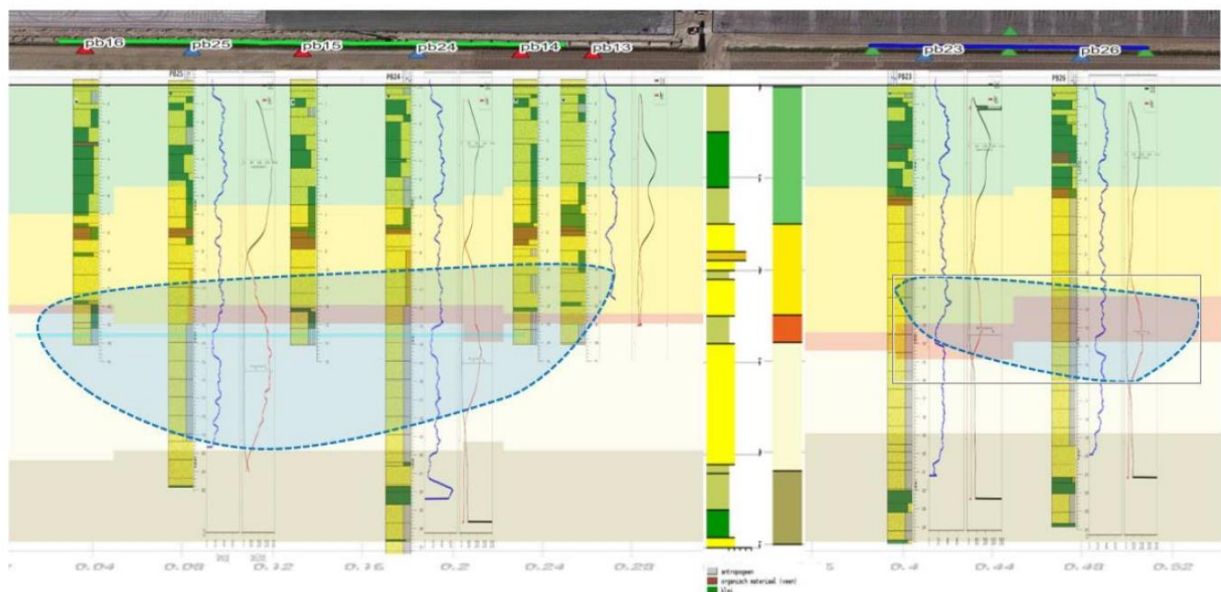
Figure 3.5. Freshwater bubbles at the Slot (left) and Broekman (right) plots, 2024. Note that the bubble penetrates upwards to the lower 203 meters of the covering layers due to infiltration taking place under pressure. SOURCE: TU Delft – Agricoast
