# MARCLAIMED

Progress Report Demo Sites

Deliverable D4.3

WP4: CoPs-Based Implementation and Validation at the Demo Sites

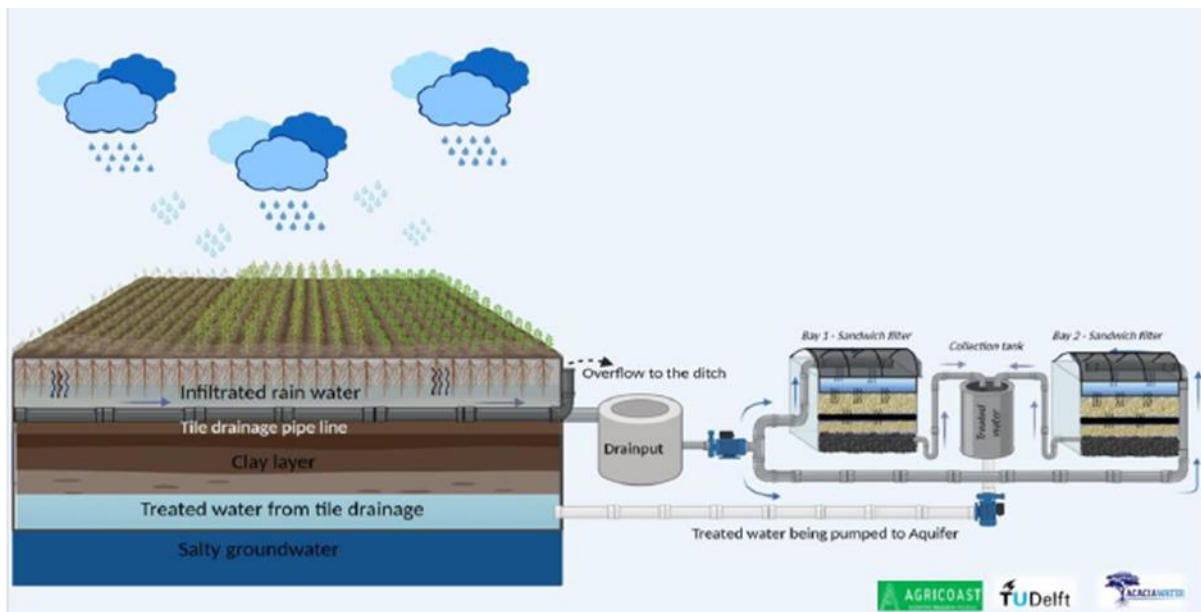
Figure 3.6. Conceptual scheme of MAR system at DS3

At approximately 0.8 m depth, there is a system of tile drains. Tile drains are used throughout the polder areas of the Netherlands to drain agricultural fields to allow for grazing or crop growth. In these systems, piping with filter screens (the tile drains) are distributed in a network across the fields. These pipes flow directly to ditches that run between the plots. When groundwater rises to the level of the pipes, it drains to the ditches and eventually to the sea, rather than flooding the cropland. The schematic in Figure 3.6 also shows the tile drainage system.

DS3 is an Aquifer Storage and Recovery (ASR) MAR system which collects water from a tile drainage water (TDW) network approximately 1 m below a 30-ha agricultural parcel. This drainage network normally discharges water to the surface water, but in this system all tile drains end up in one of three collection wells, which discharges into the MAR system, a Slow Sand Filtration (SSF) in combination with Granular Activated Carbon (GAC) schema running through two horizontal injection wells into a confined sandy aquifer (Figure 3.6).

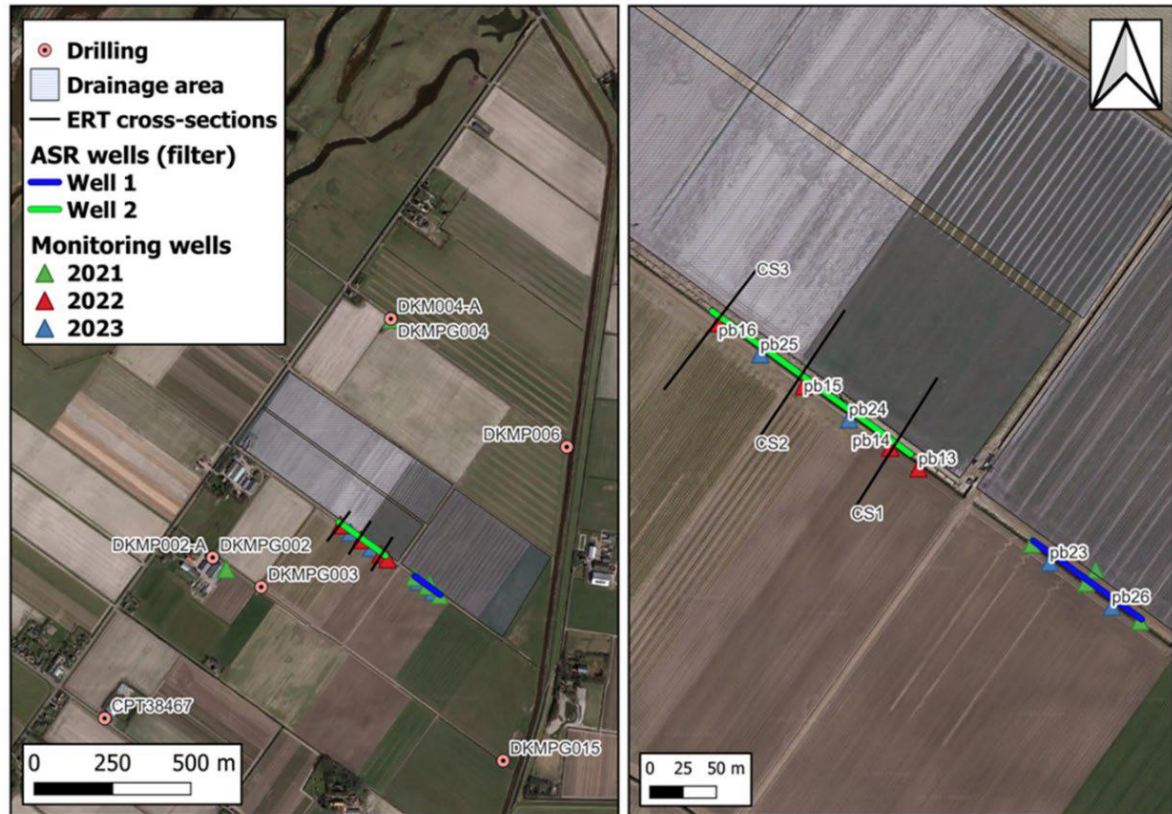
Figure 3.7 Horizontal ASR wells and piezometers at the Slot plot (Well 1) and Broekman plot (Well 2)

The two separate plots that provide water to the MAR system, Broekman and Slot, contribute with water through tile drains and collection wells, which is combined before entering the SSF/GAC filtration system in the rainy season. Water is injected into two

horizontal wells at about 13 m bgl one in each plot. Along these horizontal wells there are a series of piezometers that measure piezometric head and salinity of the aquifer (Figure 3.7).

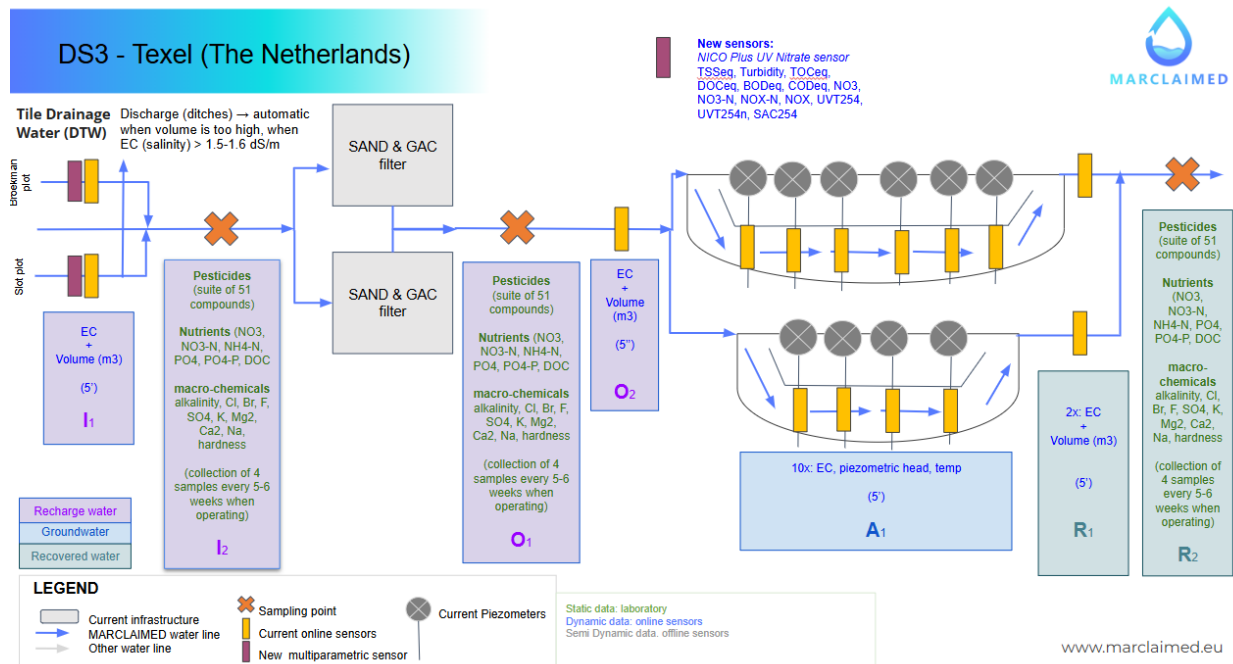
Figure 3.8. Schematic of the DS3 MAR system operation and sampling points

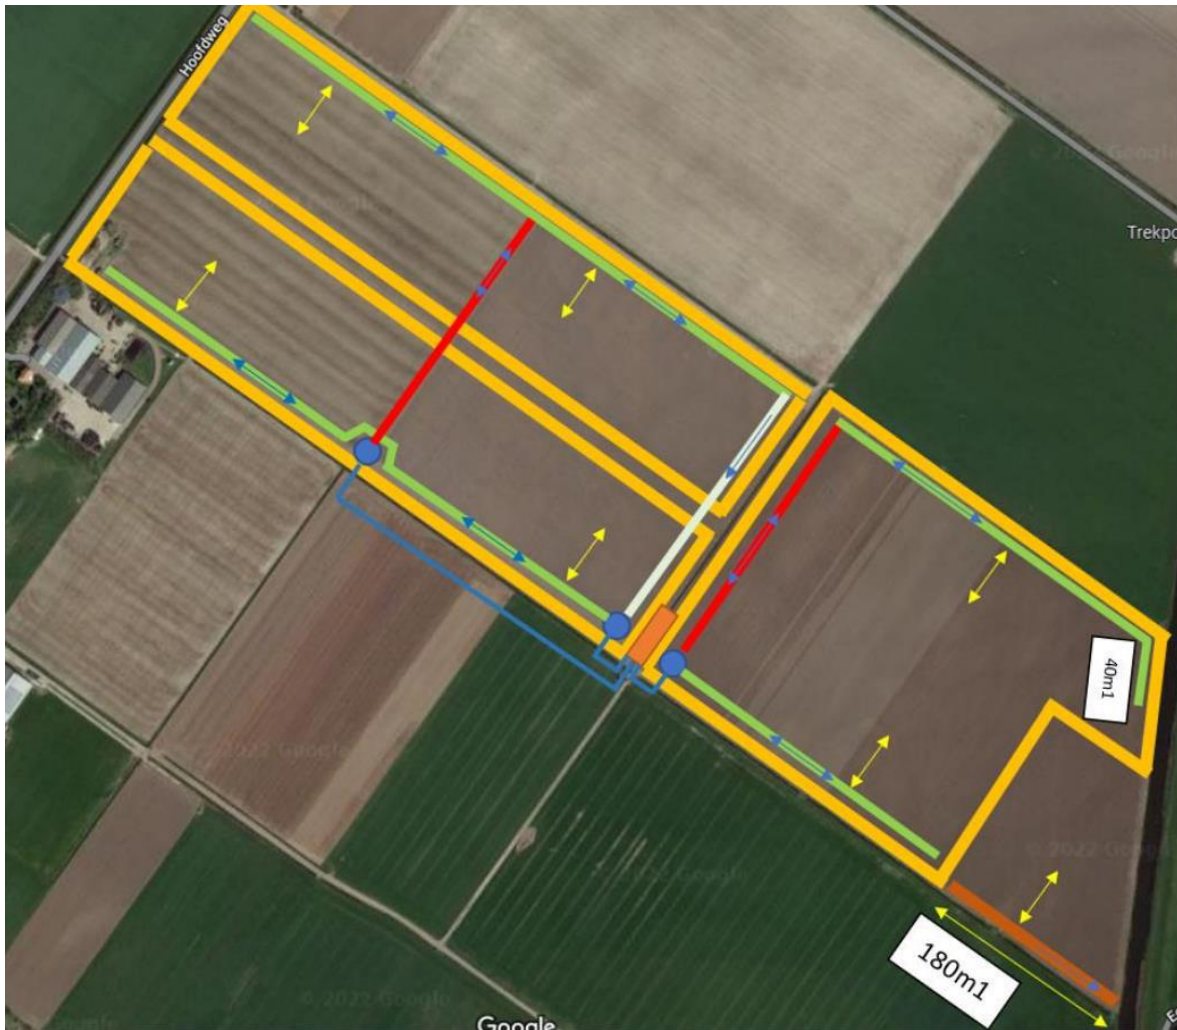
Figure 3.9 An overview of the Texel Demo Site at the Hoofdweg

The sensors were placed in two collection wells named 'Slot' and 'Broekman', collecting agricultural tile drainage water, on December 10<sup>th</sup>, 2024. On the Texel demo site there are three collection wells in total: two for the Broekman field and one for the Slot field. In Figure 3.9, these three collection wells are indicated by a blue dot. The two collection wells closest to each other were chosen to place the sensors in. In between these two wells is the filter installation (an orange rectangle in the figure).

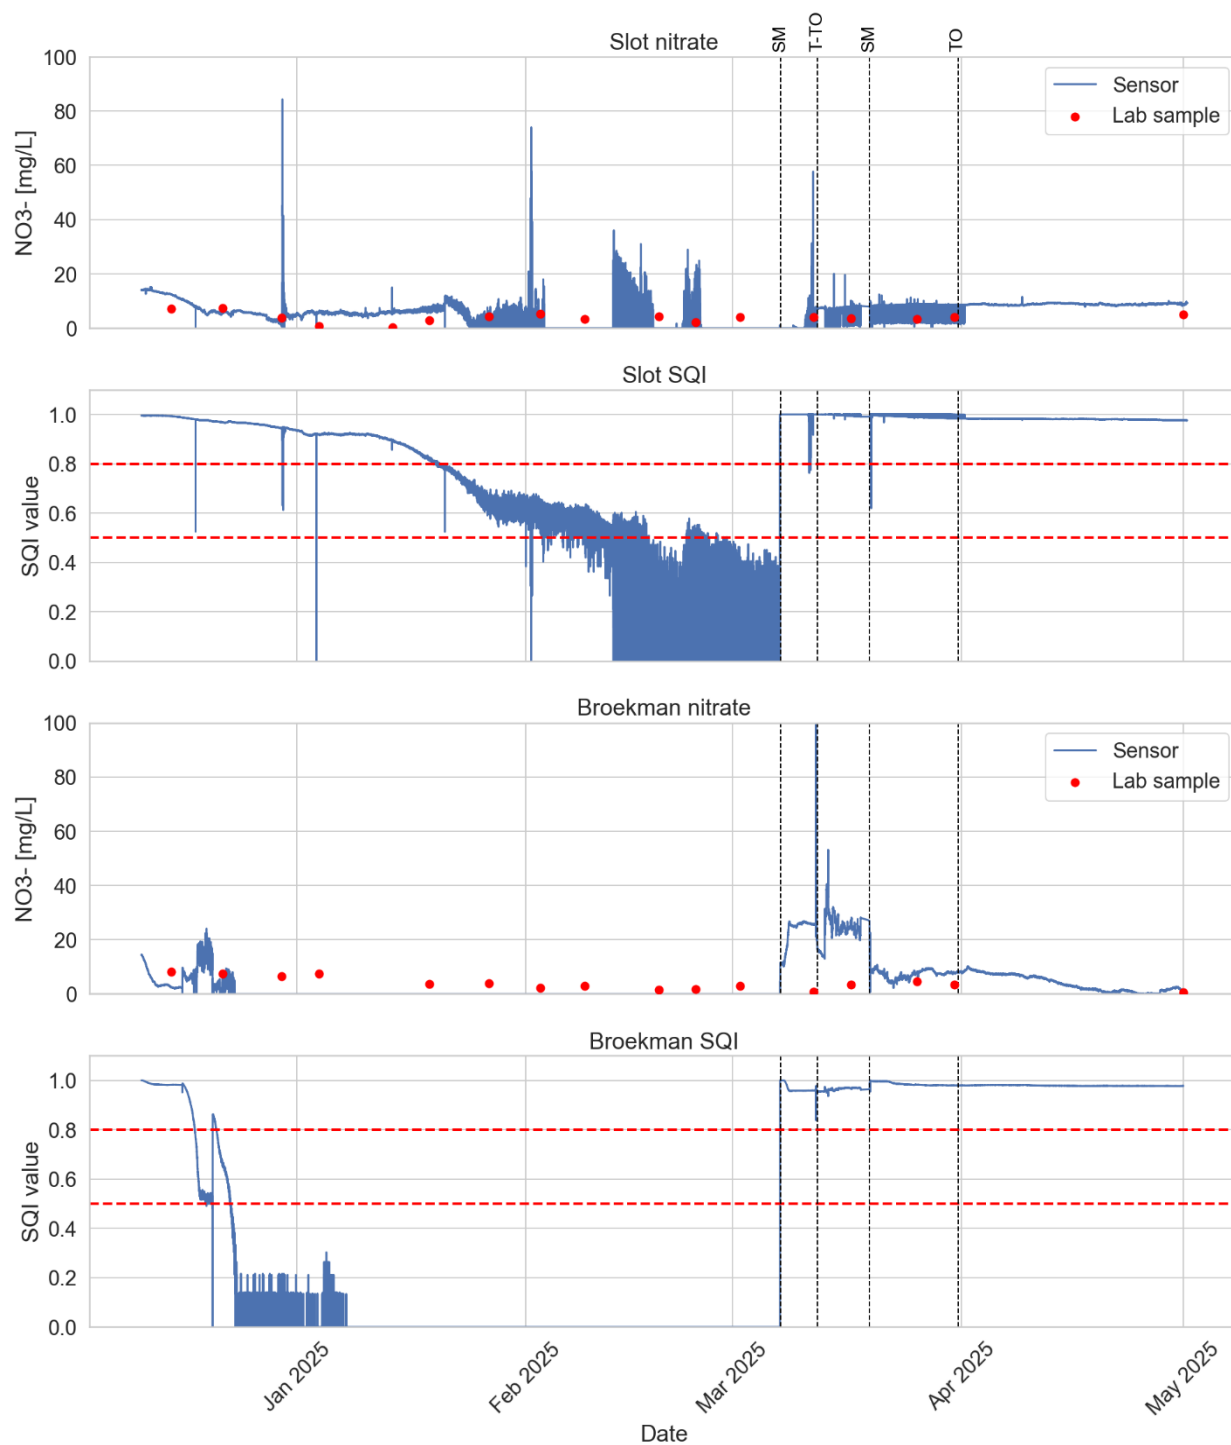
Figure 3.10. Sensor data from the Slot well (upper two graphs) and the Broekman well (lower two graphs)

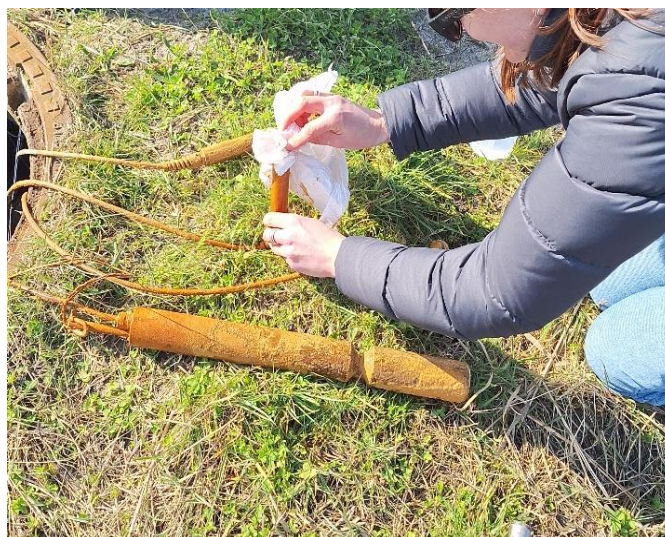
*Figure 3.11. Acacia colleagues cleaning the Broekman sensors covered in a red-brown sludge on March 7<sup>th</sup>, 2025*

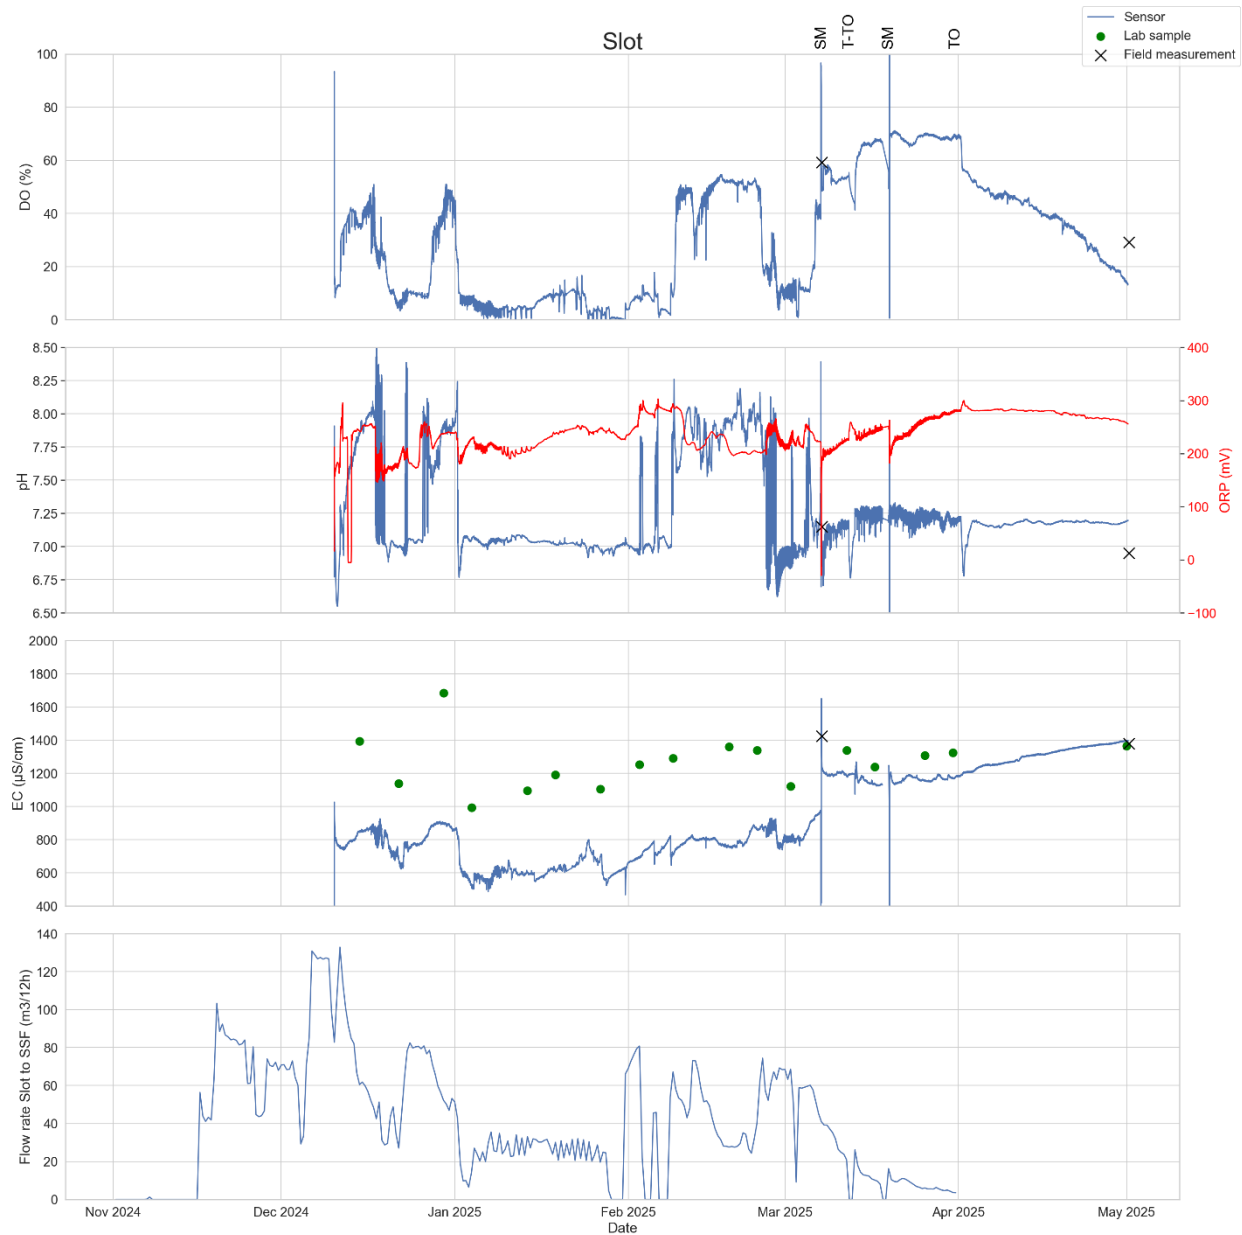
Figure 3.12 Results of the sensor data in the Slot well

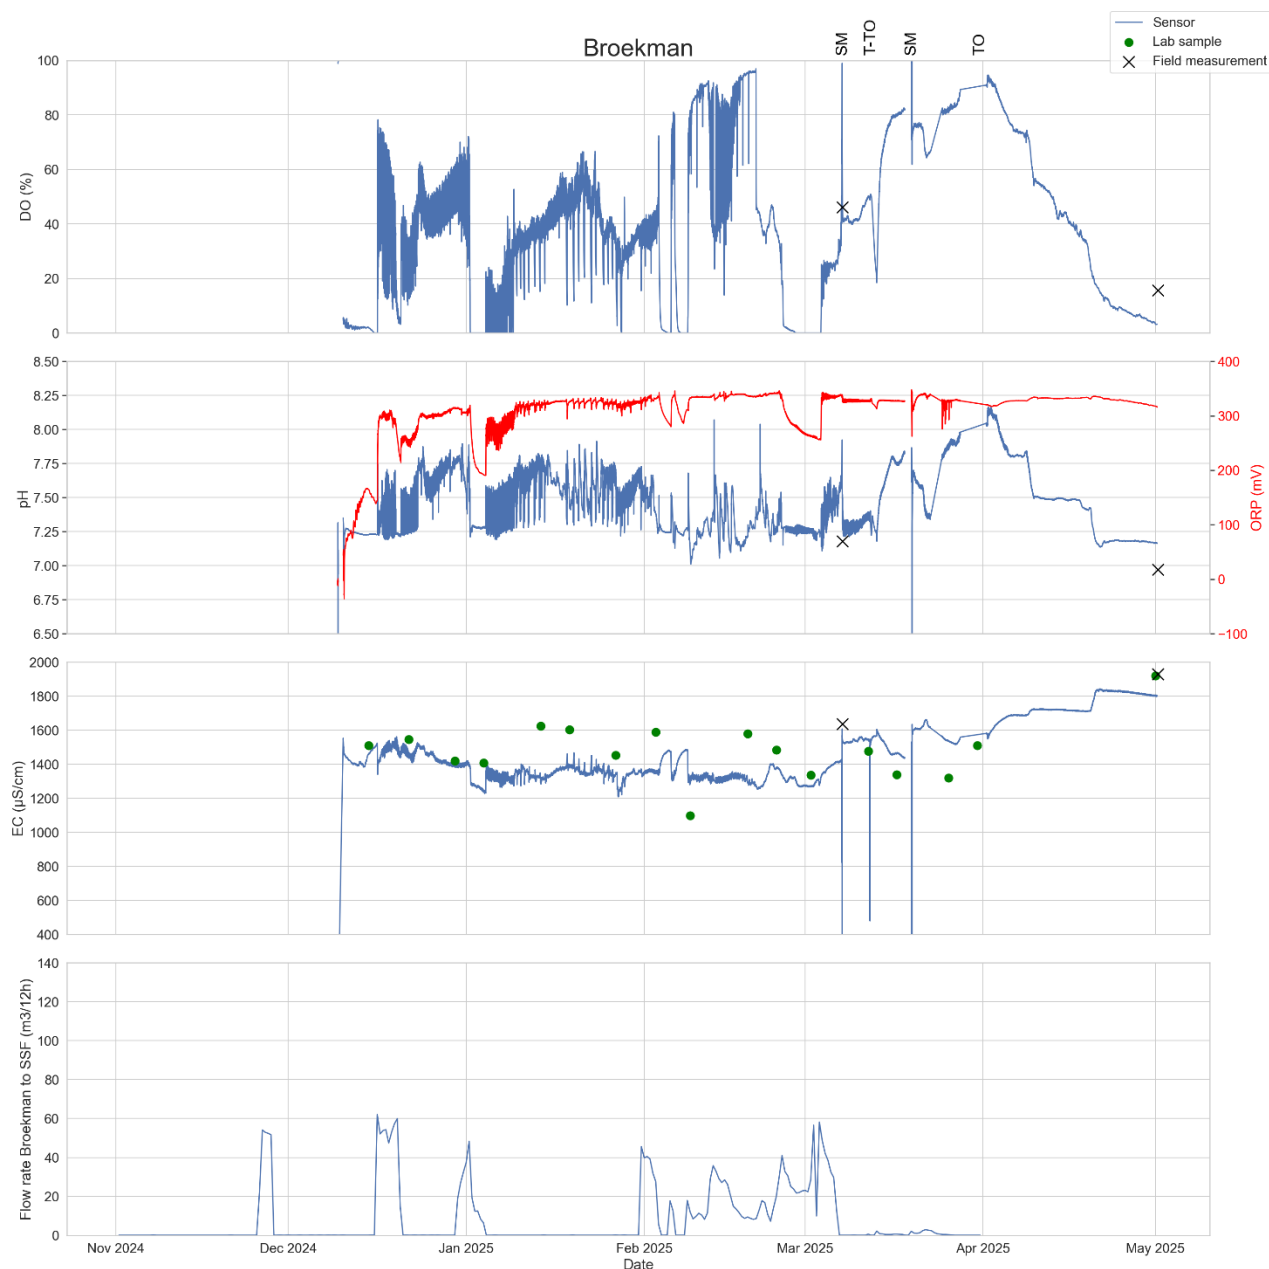
Figure 3.13 Results of the sensor data in the Broekman well

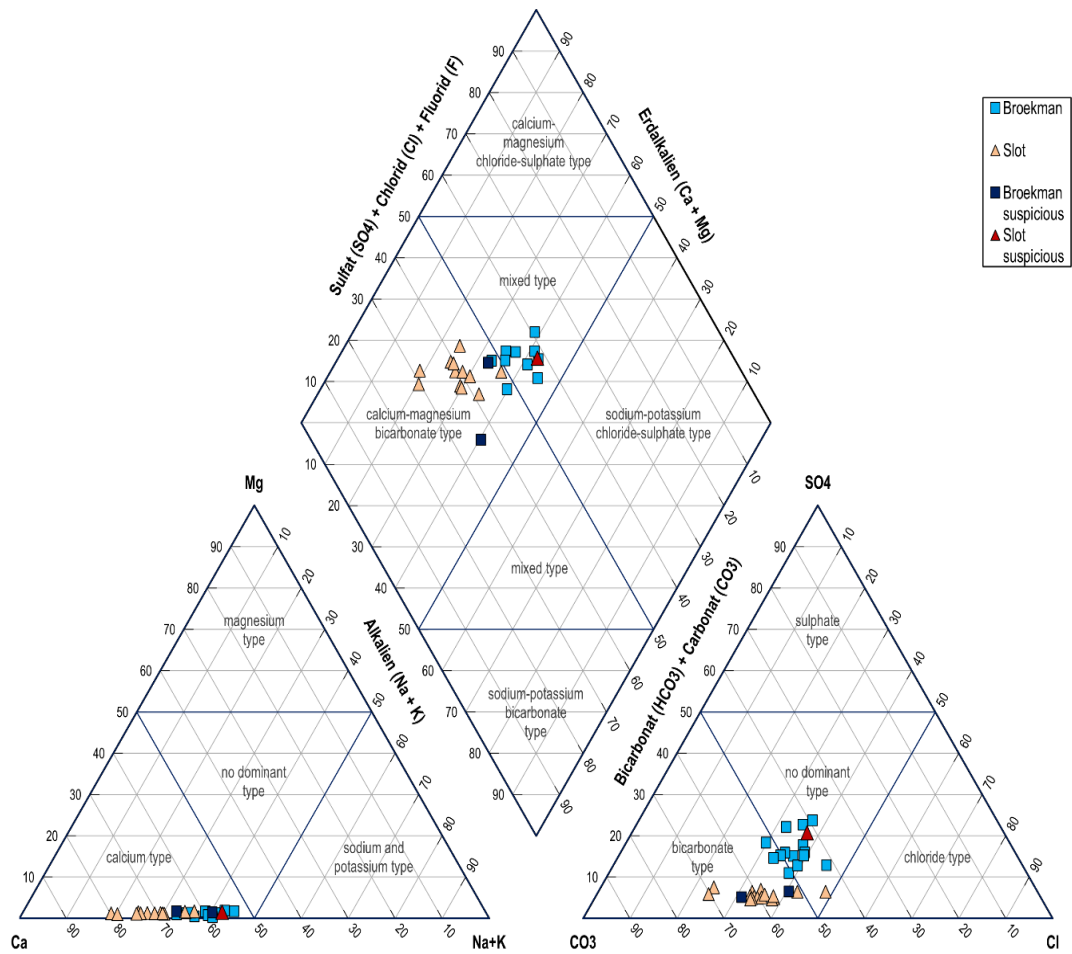
Figure 3.14 Piper diagram showing the chemical composition of the water samples from the Broekman and Slot wells. Three samples are highlighted which have raised suspicions on whether the samples have been labelled correctly

The laboratory samples were taken weekly by the farmer and picked up monthly by Acacia to its Water lab. Aside from measuring nitrate, TOC and EC to confirm sensor results, Acacia has also measured other cations and anions (the IC that measures nitrate automatically includes these as well). The results of these laboratory samples are plotted in the Piper diagram in Figure 3.14. This plot provides a visual representation of the chemical composition of the water samples, based on the major cations and anions. Three of the samples have raised some suspicions, as they were labelled either 'Slot' or 'Broekman', but their chemical composition appears more consistent with the other location. This becomes even clearer when looking at the sulphate concentration specifically in Figure 3.15. The samples might have accidentally been swapped on December 30<sup>th</sup>, and the farmer might have taken the Slot sample twice by accident on February 9<sup>th</sup>.

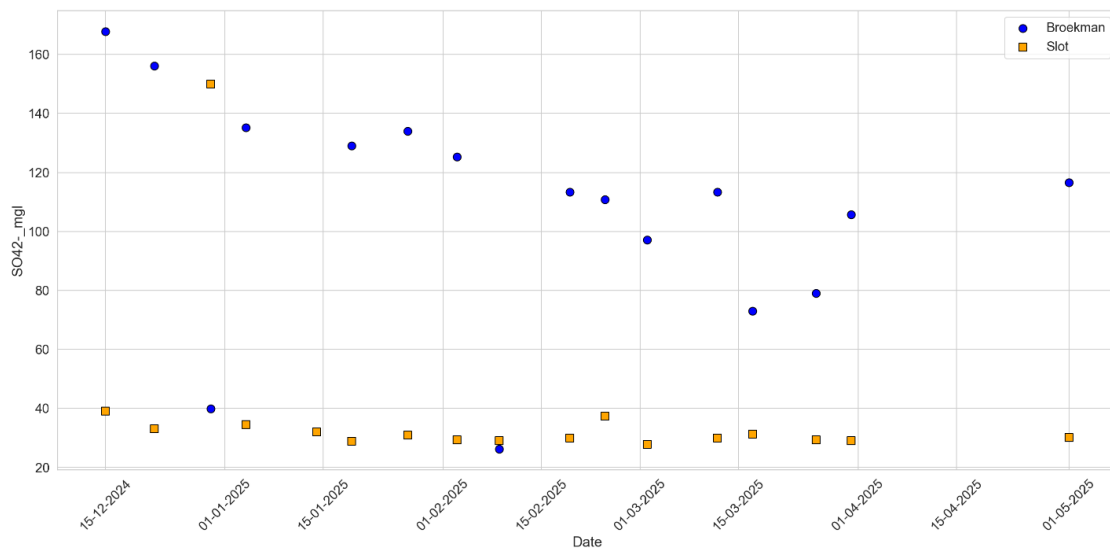
Figure 3.15 Sulphate concentrations from the laboratory samples. Three samples have raised suspicions on whether the samples have been labelled correctly (Broekman Dec 30<sup>th</sup>, Broekman Feb 9<sup>th</sup>, Slot Dec 30<sup>th</sup>)
